Report: TAB Report
Function: Test, Adjust, & Balance
Date: 05/02/2025
Completed By: National TAB

PROJECT
04-28-25 CULVERS ROCKMART, GA

Project: 04-28-25 CULVERS ROCKMART, GA

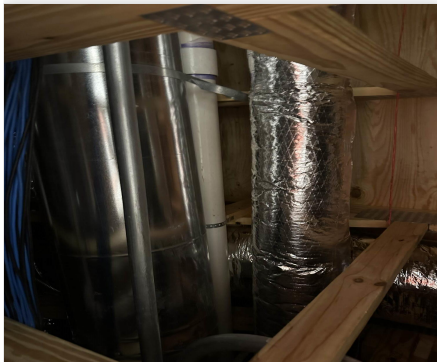
Issue Name : DUCTWORK IS MISSING INSULATION
Description : There is a line of ductwork that is missing insulation. This ductwork feeds the returns of AC2.
Created By : National TAB **Assigned To :** National TAB - Ben Searles
Status : Open
Priority : Low **Asset Tag :**
Originated Date : 05/01/2025 - Ben Searles - National TAB
