**Report: TAB REPORT
Function: Test, Adjust, & Balance
Date: 01/27/2023**

**PROJECT
01-23-23 NVA #283 - VINTON, VA**

Project: 01-23-23 NVA #283 - VINTON, VA

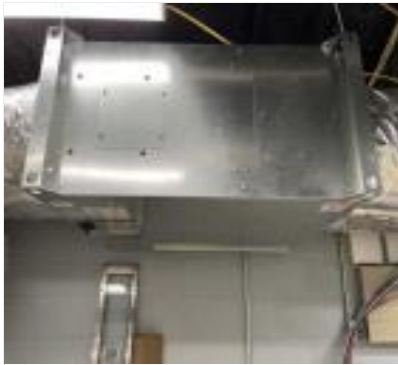
ERV-1

Exhaust Fan Test Data		
	Design	Actual
Exh-ERU CFM	950	886
Exh-ERU RPM	1451	NA
RL Voltage	-	115
RL Amperage	-	4.3

OA Fan Test Data		
	Design	Actual
OA-ERU CFM	1000	1003
OA-ERU RPM	1193	NA
RL Voltage	-	115
RL Amperage	-	6.7

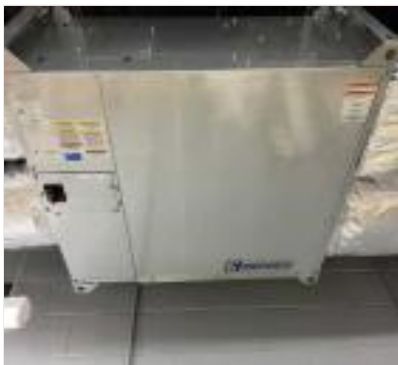
ERV-2

Exhaust Fan Test Data		
	Design	Actual
Exh-ERU CFM	505	496
Exh-ERU RPM	1075	NA
RL Voltage	-	115
RL Amperage	-	1.01

OA Fan Test Data		
	Design	Actual
OA-ERU CFM	675	645
OA-ERU RPM	1199	NA
RL Voltage	-	115
RL Amperage	-	1.52

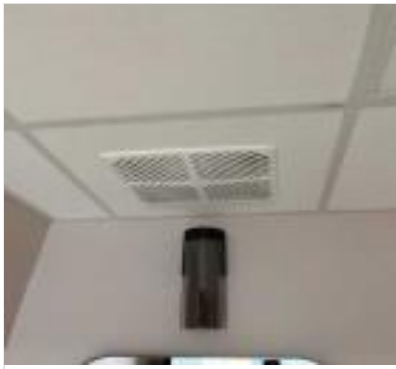
EF-1

Test Data		
	Design	Actual
CFM	50	53
Fan Rotation	-	CW
RL Voltage	-	115
RL Amperage	-	0.06
Total ESP	-	0.34"
Fan Inlet SP	-	-0.34"
Fan Discharge SP	-	ATM

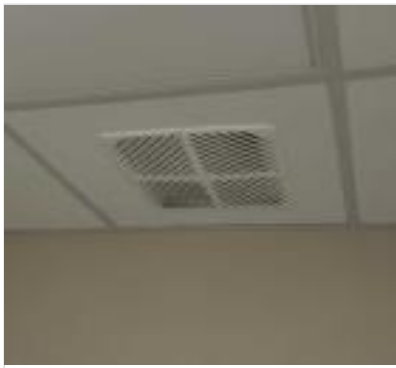
EF-2

Test Data		
	Design	Actual
CFM	50	51
Fan Rotation	-	CW
RL Voltage	-	115
RL Amperage	-	0.08
Total ESP	-	0.41"
Fan Inlet SP	-	-0.41"
Fan Discharge SP	-	ATM

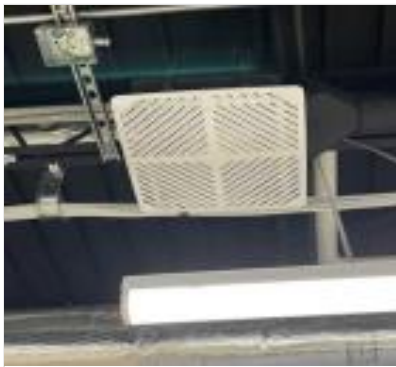
[1] : EF-3 IS NOT OPERABLE.

Notes: THIS FAN IS NON OPERABLE.
