**Report: TAB REPORT  
Function: Test, Adjust, & Balance  
Date: 01/27/2023**

**PROJECT  
01-23-23 NVA #283 - VINTON, VA**

Project: 01-23-23 NVA #283 - VINTON, VA

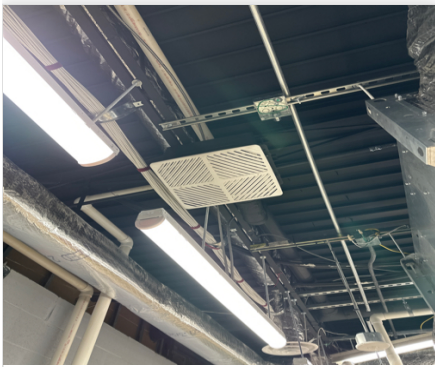
EF-3.jpeg

**Issue Name :** EF-3 NOT WORKING

**Description :** High/low was switch burnt out on the fan circuitry due to accidental faulty wiring during installation.
