**Report: TAB REPORT  
Function: Test, Adjust, & Balance  
Date: 01/27/2023**

## **01-23-23 NVA #283 - VINTON, VA**

Project: 01-23-23 NVA #283 - VINTON, VA

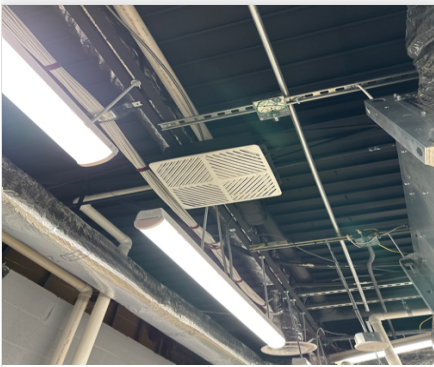
EF-3.jpeg

**Issue Name :** EF-3 NOT WORKING

**Description :** High/low was switch burnt out on the fan circuitry due to accidental faulty wiring during installation.

[1] : EF-3 IS NOT OPERABLE.

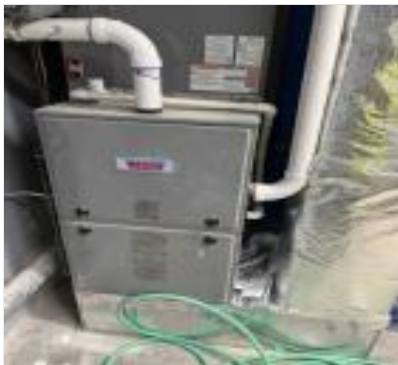
F-01

Test Data		
	Design	Actual
SF CFM	1550	1620
SF RPM	-	[1]
RA CFM	-	617
OA CFM	-	1003
RL Voltage	-	115
RL Amperage	-	6.7
SF Rotation	-	CCW

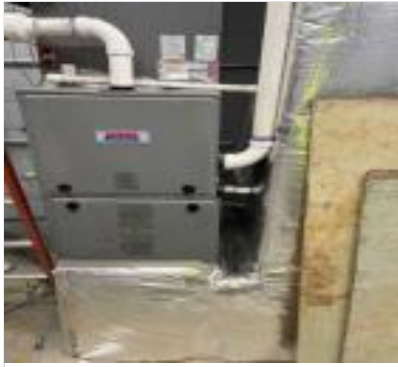
F-02

Test Data		
	Design	Actual
SF CFM	1815	1786
SF RPM	-	[1]
RA CFM	-	1141
OA CFM	-	645
RL Voltage	-	115
RL Amperage	-	7.2
SF Rotation	-	CCW

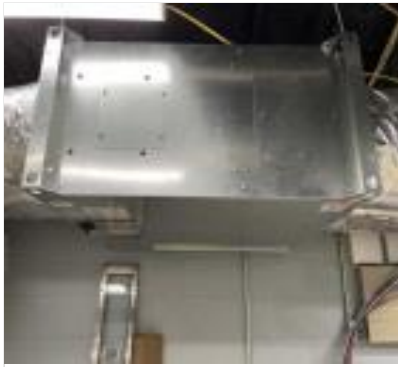
ERV-1

Exhaust Fan Test Data		
	Design	Actual
Exh-ERU CFM	950	886
Exh-ERU RPM	1451	[1]
RL Voltage	-	115
RL Amperage	-	4.3

OA Fan Test Data		
	Design	Actual
OA-ERU CFM	1000	1003
OA-ERU RPM	1193	[1]
RL Voltage	-	115
RL Amperage	-	6.7

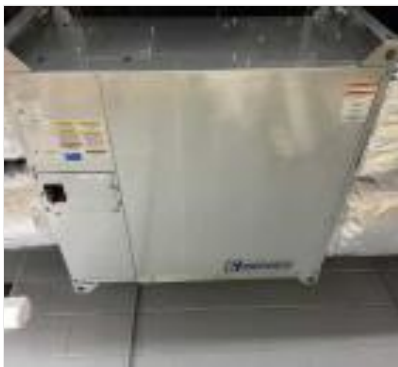
ERV-2

Exhaust Fan Test Data		
	Design	Actual
Exh-ERU CFM	505	496
Exh-ERU RPM	1075	[1]
RL Voltage	-	115
RL Amperage	-	1.01

OA Fan Test Data		
	Design	Actual
OA-ERU CFM	675	645
OA-ERU RPM	1199	[1]
RL Voltage	-	115
RL Amperage	-	1.52

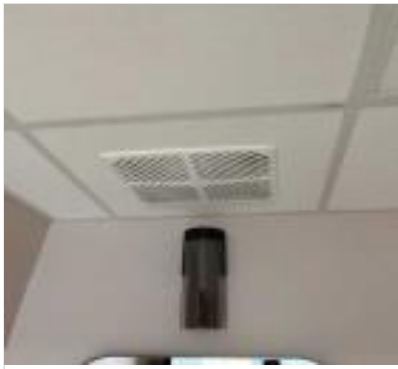
EF-1

Test Data		
	Design	Actual
<b>CFM</b>	50	53
<b>Fan Rotation</b>	-	CW
<b>RL Voltage</b>	-	115
<b>RL Amperage</b>	-	0.06
<b>Total ESP</b>	-	0.34"
<b>Fan Inlet SP</b>	-	-0.34"
<b>Fan Discharge SP</b>	-	ATM

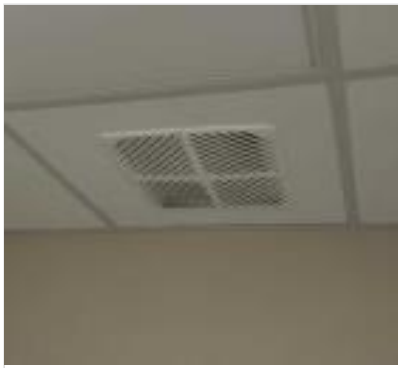
EF-2

Test Data		
	Design	Actual
<b>CFM</b>	50	51
<b>Fan Rotation</b>	-	CW
<b>RL Voltage</b>	-	115
<b>RL Amperage</b>	-	0.08
<b>Total ESP</b>	-	0.41"
<b>Fan Inlet SP</b>	-	-0.41"
<b>Fan Discharge SP</b>	-	ATM

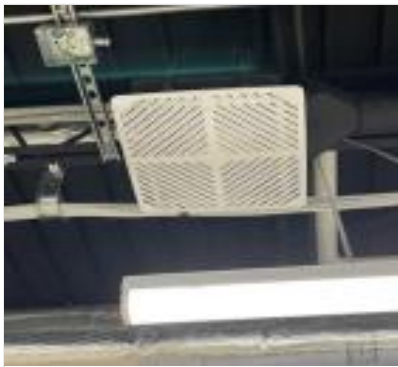
EF-3

Notes: THIS FAN IS NON OPERABLE.
