Report: TAB REPORT
Function: Test, Adjust, & Balance
Date: 05/19/2023

PROJECT
05-15-23 CULVERS - COOPER CITY, FL

3700 NORTH UNIVERSITY DRIVE

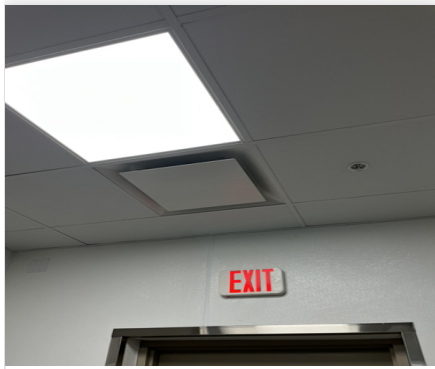
Diffuser1-14
05/18/2023

Issue Name : *CRITICAL* Diffuser 2-14 is above design air flow
Description : Currently at 753 CFM when design is at 600 CFM. Damper is stuck in place, recommended to fix to turn diffuser into design.
Created By : National TAB **Assigned To :** National TAB - Will Turnbough
Status : Open
Originated Date : 05/18/2023 - Ian Fuller - National TAB

Asset	Notes	Date	Written By
SGRD14	BROKEN DAMPER CANNOT TURN DIFFUSER INTO DESIGN AIRFLOW.

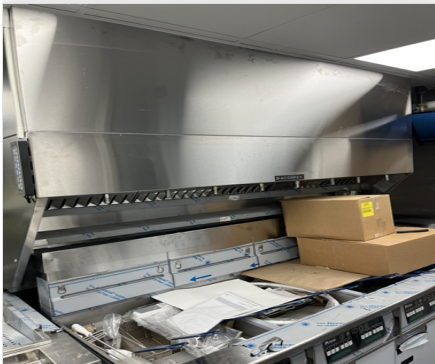
Hood2
05/18/2023

Issue Name : *CRITICAL* Hood#2 has not been completely wired.
Description : (RESOLVED) Hood currently does not have power going to it. Motor has not been completely wired. Unable to balance. Set to 5.5 V which is typical of XXEP-83 Accurex hoods.
Created By : National TAB **Assigned To :** National TAB - Will Turnbough
Status : Closed
Originated Date : 05/18/2023 - Ian Fuller - National TAB

HOOD2 HAS NO POWER

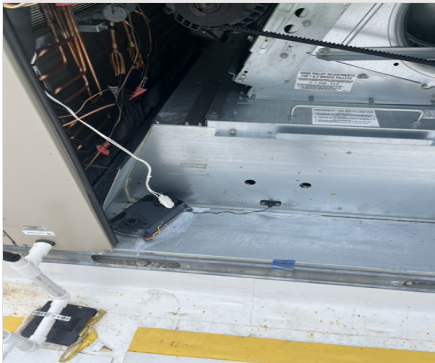
**SmokeAlarm
05/18/2023**

Issue Name : *NON-CRITICAL* Smoke alarms need to be installed in both units.

Description : Recommended to install.
