**Report: TAB REPORT
Function: Test, Adjust, & Balance
Date: 05/19/2023**

**PROJECT
05-15-23 CULVERS - COOPER CITY, FL**

3700 NORTH UNIVERSITY DRIVE

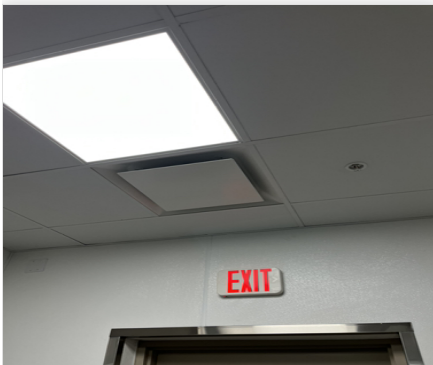
Diffuser1-14
05/18/2023

Issue Name : *CRITICAL* Diffuser 1-14 is above design air flow
Description : Currently at 753 CFM when design is at 600 CFM. Damper is stuck in place, recommended to fix to turn diffuser into design.
Created By : National TAB **Assigned To :** National TAB - Will Turnbough
Status : Open
Originated Date : 05/18/2023 - Ian Fuller - National TAB

Asset	Notes	Date
SGRD14	BROKEN DAMPER CANNOT TURN DIFFUSER INTO DESIGN AIRFLOW.	05/17/2023

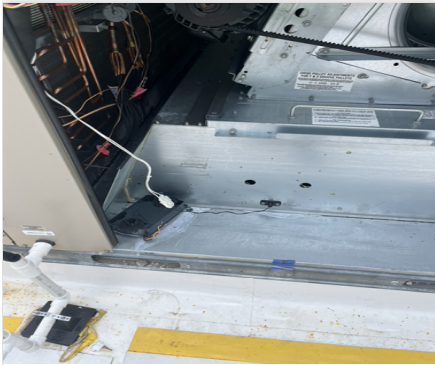
SmokeAlarm
05/18/2023

Issue Name : *NON-CRITICAL* Smoke alarms need to be installed in both units.
Description : Recommended to install.
Created By : National TAB **Assigned To :** National TAB - Will Turnbough
Status : Open
Originated Date : 05/18/2023 - Ian Fuller - National TAB

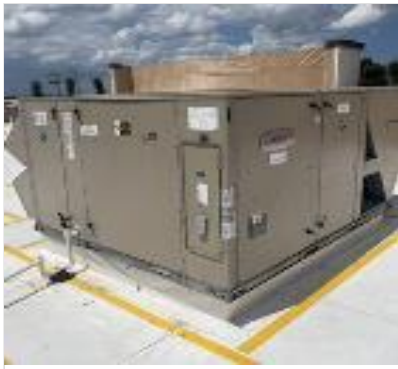
RTU1
05/18/2023

Test Data		
	Design	Actual
SF CFM	5850	6137
SF RPM	-	779
RA CFM	3950	4231
OA CFM	1900	1906
RL Voltage	-	209/210/209
RL Amperage	-	8.6/8.1/8.5
SF Rotation	-	CCW
RA Damper Position	-	50%
Min OA Damper Position	-	50%
Min OA Damper Type	-	ECONOMIZER
OA Enthalpy Setpt	-	5

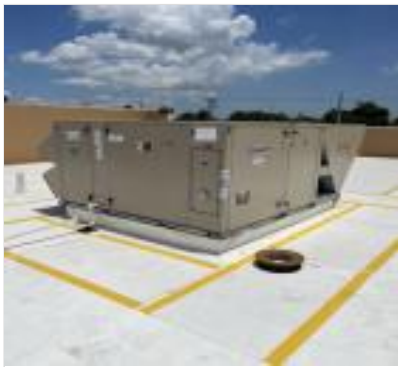
RTU2
05/18/2023

Test Data		
	Design	Actual
SF CFM	6150	6211
SF RPM	-	804
RA CFM	4250	4280
OA CFM	1900	1931
RL Voltage	-	210/212/210
RL Amperage	-	8.5/8.7/8.5
SF Rotation	-	CCW
RA Damper Position	-	50%
Min OA Damper Position	-	50%
Min OA Damper Type	-	ECONOMIZER
OA Enthalpy Setpt	-	5

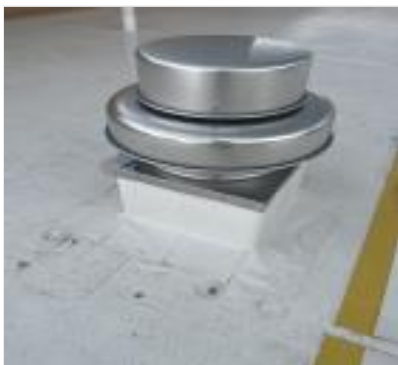
PRV1
05/18/2023

Test Data		
	Design	Actual
CFM	375	369
Fan RPM	1465	10 V
Fan Rotation	-	CCW
Motor RPM	-	10 V
System SetPt	-	10 V
RL Voltage	-	122
RL Amperage	-	1.2
Total ESP	0.5	0.47"
Fan Inlet SP	-	-0.47"
Fan Discharge SP	-	ATM

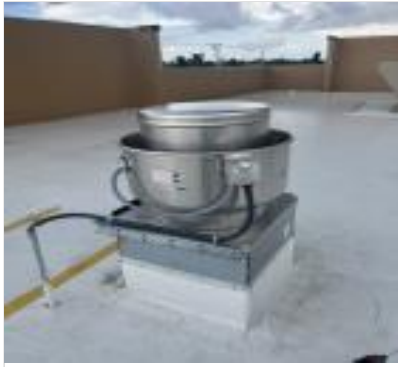
PRV2
05/18/2023

Test Data		
	Design	Actual
CFM	1500	1575
Fan RPM	2411	7.0 V
Fan Rotation	-	CCW
Motor RPM	-	7.0 V
RL Voltage	-	122
RL Amperage	-	8.1
Suction ESP	-	-0.87"
Discharge ESP	-	ATM
Total ESP	2.337"	0.87"

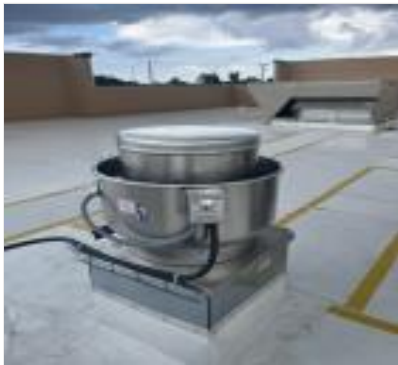
PRV3
05/18/2023

Test Data		
	Design	Actual
CFM	1500	0
Fan RPM	1377	0
Fan Rotation	-	NA
Total ESP	1.0"	0

Notes: WIRING ISSUE WITH FAN

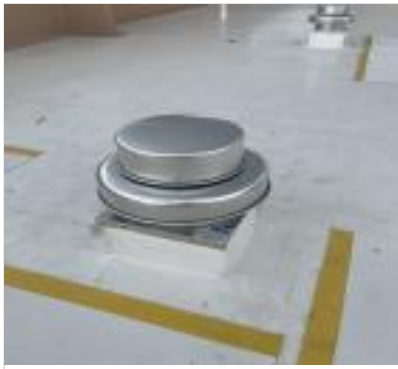
PRV4
05/18/2023

Test Data		
	Design	Actual
CFM	350	363
Fan RPM	1486	5.5 V
Fan Rotation	-	CCW
Motor RPM	-	5.5 V
System SetPt	-	5.5 V
RL Voltage	-	122
RL Amperage	-	1.3
Total ESP	0.6"	0.38"
Fan Inlet SP	-	-0.38"
Fan Discharge SP	-	ATM

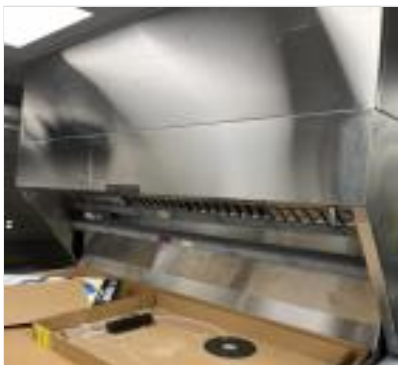
Hood1
05/18/2023

Test Data Exhaust		
	Design	Actual
Filter Type	GREASE GRABBER	GREASE GRABBER
Filter Size 1	16X16	16X16
Filter Qty 1	4	4
Filter AK factor size 1	1.53	1.53
Filter Total AK Area	6.12	6.12
Filter1 FPM	-	198
Filter2 FPM	-	185
Filter3 FPM	-	196
Filter4 FPM	-	214
Filter Ave FPM(corr)	-	198
CFM	1500	1575

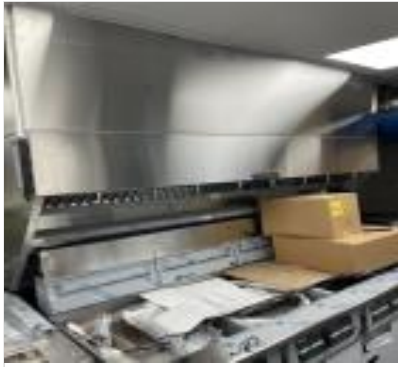
Hood2
05/18/2023

Issue Name : *CRITICAL* Hood#2 has not been completely wired.
Description : Hood currently does not have power going to it. Motor has not been completely wired. Unable to balance. Set to 5.5 V which is typical of XXEP-83 Accurex hoods.
Created By : National TAB **Assigned To :** National TAB - Will Turnbough
Status : Open
Originated Date : 05/18/2023 - Ian Fuller - National TAB

Design	Actual
Filter Type	XTRACTOR	XTRACTOR
Filter Size 1	16X16	16X16
Filter Qty 1	5	5
Filter AK factor size 1	1.53	1.53
Filter Total AK Area	7.65	7.65
Filter1 FPM	-	0
Filter2 FPM	-	0
Filter3 FPM	-	0
Filter4 FPM	-	0
Filter5 FPM	-	0
Filter Ave FPM(corr)	-	0
CFM	1500	0

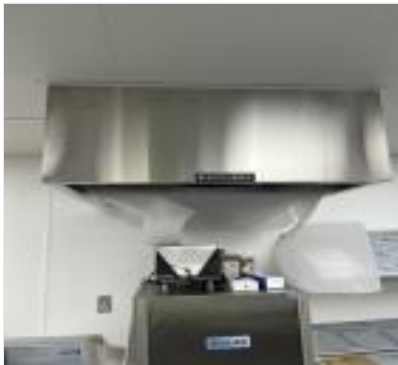
Hood3
05/18/2023

Test Data		
	Design	Actual
Exhaust CFM	350	363
