Report: TAB Report
Function: Test, Adjust, & Balance
Date: 10/22/2025
Completed By: National TAB

PROJECT
10-20-25 QT #0783 MCDONOUGH, GA

Project: 10-20-25 QT #0783 MCDONOUGH, GA

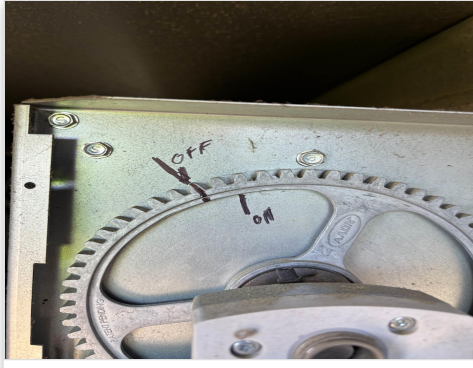
Unit Data - PHOTO LOG

Asset: RT-1

Unit Data		
	Design	Actual
MFG	NA	AAON
Serial Num	-	202303-ANEK26001
Model Num	NA	RN-013-8-HA0A-152
Num OA Filters 1	-	1
OA Filter Size 1	-	45X22
Num Final Filter 1	-	4
Final Filter Size 1	-	20X25X2

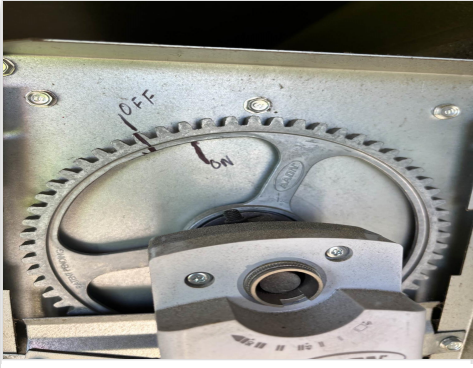
Unit Data - PHOTO LOG

Asset: RT-2

Unit Data		
	Design	Actual
MFG	NA	AAON
Serial Num	-	202303-ANEK26002
Model Num	NA	RN-013-8-HA0A-152
Num OA Filters 1	-	1
OA Filter Size 1	-	45X22
Num Final Filter 1	-	4
Final Filter Size 1	-	20X25X2
