Report: TAB Report
Function: Test, Adjust, & Balance
Date: 10/22/2025
Completed By: National TAB

PROJECT
10-20-25 QT #0783 MCDONOUGH, GA

Project: 10-20-25 QT #0783 MCDONOUGH, GA

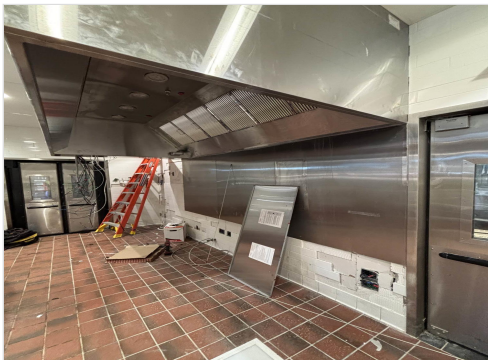
Asset: HD1

Design	Actual
MFG	CAPTIVEAIRE	CAPTIVEAIRE
Model Num	6030ND-2-F	6030ND-2-F
Job / Serial Num	-	7644844
Type	-	TYPE 1 CANOPY
Hood length	-	108"
Hood Width	-	60"

Design	Actual
Filter Type	-	CAPTRATE
Filter Size 1	-	16X20
Filter Qty 1	-	6
Filter AK factor size 1	-	2.08
Filter Total AK Area	-	12.48
Filter1 FPM	-	108
Filter2 FPM	-	121
Filter3 FPM	-	112
Filter4 FPM	-	113
Filter5 FPM	-	114
Filter6 FPM	-	104
Filter Ave FPM(corr)	-	112
CFM	1350	1398
