Report: TAB Report
Function: Test, Adjust, & Balance
Date: 10/22/2025
Completed By: National TAB

PROJECT
10-20-25 QT #0783 MCDONOUGH, GA

Project: 10-20-25 QT #0783 MCDONOUGH, GA

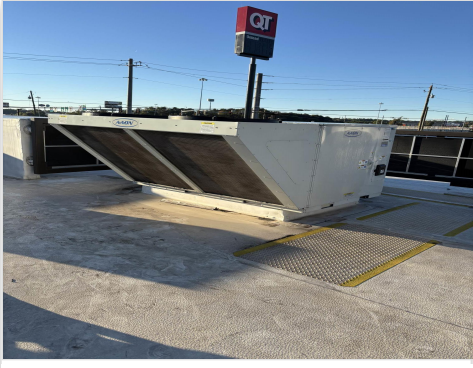
Unit Data - PHOTO LOG

Asset: RT-1

Unit Data		
	Design	Actual
MFG	NA	AAON
Serial Num	-	202303-ANEK26001
Model Num	NA	RN-013-8-HA0A-152
Num OA Filters 1	-	1
OA Filter Size 1	-	45X22
Num Final Filter 1	-	4
Final Filter Size 1	-	20X25X2
Num Final Filter 2	-	
Final Filter Size 2	-

Test Data		
	Design	Actual
SF CFM	4200	4156
SF RPM	-	1437
OA CFM (Hoods On)	800	839
OA CFM (Hoods Off)	350	378
RL Voltage	-	176 VFD
RL Amperage	-	8.31 VFD
VFD Max SetPt	-	49 HZ
VFD Min SetPt	-	24 HZ
OA Damper Position (Hoods On)	-	46%
OA Damper Position (Hoods Off)	-	26%

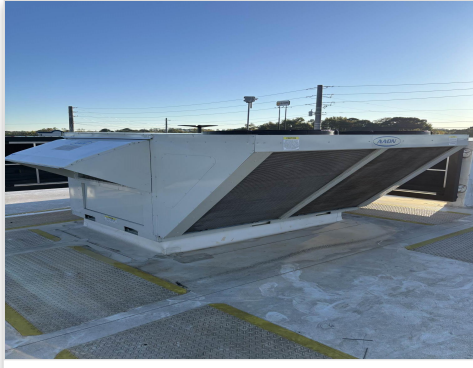
Unit Data - PHOTO LOG

Asset: RT-2

Unit Data		
	Design	Actual
MFG	NA	AAON
Serial Num	-	202303-ANEK26002
Model Num	NA	RN-013-8-HA0A-152
Num OA Filters 1	-	1
OA Filter Size 1	-	45X22
Num Final Filter 1	-	4
Final Filter Size 1	-	20X25X2

Test Data		
	Design	Actual
SF CFM	4200	4149
SF RPM	-	1437
OA CFM (Hoods On)	800	805
OA CFM (Hoods Off)	350	372
RL Voltage	-	177 VFD
RL Amperage	-	8.62 VFD
VFD Max SetPt	-	49 HZ
VFD Min SetPt	-	24 HZ
OA Damper Position (Hoods On)	-	46%
OA Damper Position (Hoods Off)	-	26%

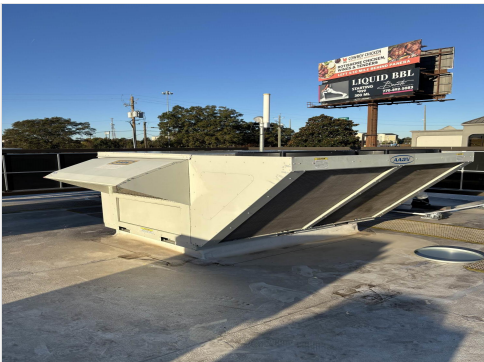
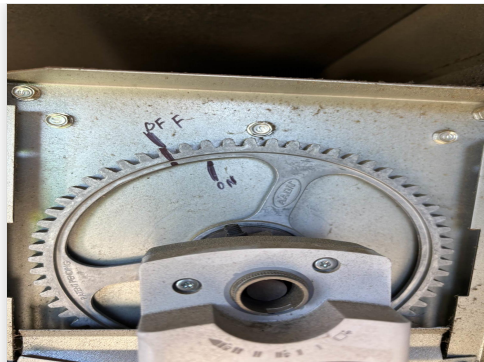
Unit Data - PHOTO LOG

Asset: RT-3

Unit Data		
	Design	Actual
MFG	NA	AAON
Serial Num	-	202303-ANEK26003
Model Num	NA	RN-013-8-HA0A-152
Num OA Filters 1	-	1
OA Filter Size 1	-	45X22
Num Final Filter 1	-	4
Final Filter Size 1	-	20X25X2

Test Data		
	Design	Actual
SF CFM	4200	4013
SF RPM	-	1437
OA CFM (Hoods On)	800	812
OA CFM (Hoods Off)	350	372
RL Voltage	-	178 VFD
RL Amperage	-	9.03 VFD
VFD Max SetPt	-	49 HZ
VFD Min SetPt	-	24 HZ
OA Damper Position (Hoods On)	-	46%
OA Damper Position (Hoods Off)	-	26%

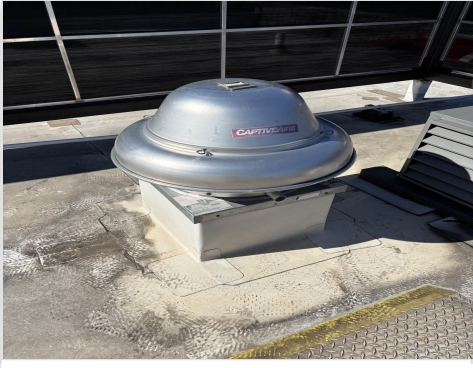
Unit Data - PHOTO LOG

Asset: EF1

Unit Data		
	Design	Actual
MFG	NA	CAPTIVEAIRE
Model Num	NA	DR50HFA
Serial Num	-	5780624
Type	-	DOWNBLAST
Configuration	-	VERTICAL

Test Data		
	Design	Actual
CFM	750	
Fan Rotation	-	CCW
System SetPt	-	LOW
RL Voltage	-	[1]
RL Amperage	-	[1]
Total ESP	-	
Fan Inlet SP	-	
Fan Discharge SP	-	1 ATM

[1] UNABLE TO READ VOLTS AND AMPS SAFELY

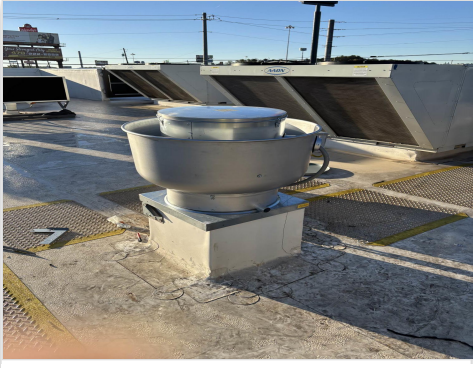
Unit Data - PHOTO LOG

Asset: EF3

Unit Data		
	Design	Actual
MFG	NA	CAPTIVEAIRE
Model Num	NA	DU50HFA
Serial Num	-	7644844
Type	UPBLAST	UPBLAST
Configuration	VERTICAL	VERTICAL

Test Data		
	Design	Actual
CFM	1350	1398
Fan RPM	-	1194
Fan Rotation	-	CCW
Motor RPM	-	1194
System SetPt	-	52.8 HZ
RL Voltage	-	209
RL Amperage	-	1.8
Total ESP	-	0.23"
Fan Inlet SP	-	-0.23"
Fan Discharge SP	-	1 ATM

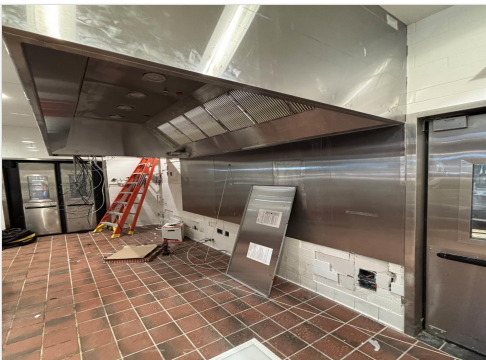
Unit Data - PHOTO LOG

Asset: HD1

Unit Data		
	Design	Actual
MFG	CAPTIVEAIRE	CAPTIVEAIRE
Model Num	6030ND-2-F	6030ND-2-F
Job / Serial Num	-	7644844
Type	-	TYPE 1 CANOPY
Hood length	-	108"
Hood Width	-	60"

Test Data Exhaust		
	Design	Actual
Filter Type	-	CAPTRATE
Filter Size 1	-	16X20
Filter Qty 1	-	6
Filter AK factor size 1	-	2.08
Filter Total AK Area	-	12.48
Filter1 FPM	-	108
Filter2 FPM	-	121
Filter3 FPM	-	112
Filter4 FPM	-	113
Filter5 FPM	-	114
Filter6 FPM	-	104
Filter Ave FPM(corr)	-	112
CFM	1350	1398
