Report By:

Report: TAB REPORT
Function: Test, Adjust, & Balance
Date: 10/10/2023

PROJECT
10-09-23 NIKE UNITE - ANTIOCH, TN

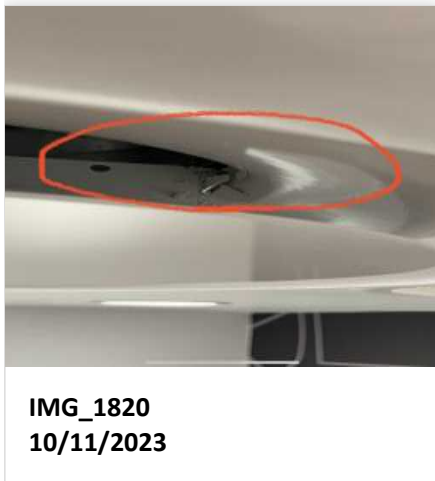
Issue Name : Unable to balance fitting room diffusers
Description : Several fitting room diffusers unable to be balanced due to screws protruding from inside diffuser. Prevents face plate from being removed to access balancing damper.
Created By : National TAB **Assigned To :** National TAB - Jordan Best
Status : Open
Originated Date : 10/11/2023 - Jordan Best - National TAB
