Report: TAB Report
Function: Test, Adjust, & Balance
Date: 06/06/2025
Completed By: National TAB

**06-09-25 WHATABURGER #1381 DUNCAN,
SC**

Project: 06-09-25 WHATABURGER #1381 DUNCAN, SC
Function: Test, Adjust, & Balance

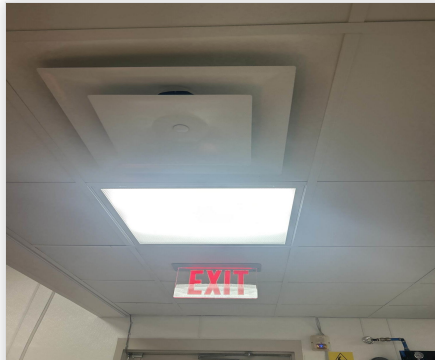
Issue Name : Diffuser not matching Design
Description : RTU-1 on 1-1 linear diffuser wasn't installed. A4 style diffuser installed.
Created By : National TAB **Assigned To :** National TAB - Brianna Biggs
Status : Open
Priority : InfoOnly **Asset Tag :** RTU1
Originated Date : 06/11/2025 - Jearod Ferrette - National TAB

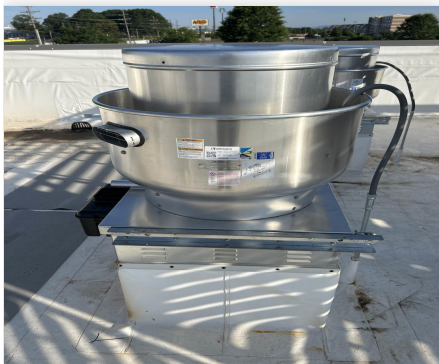
Issue Name : KEF-1 motor replacement/ building pressure
Description : KEF-1 motor is blown. Per the GC awaiting replacement. Unable to do final building pressure test.
Created By : National TAB **Assigned To :** National TAB - Brianna Biggs
Status : Open
Priority : **Urgent** **Asset Tag :** KEF1
Originated Date : 06/11/2025 - Jearod Ferrette - National TAB

PENDING KEF-1 MOTOR REPLACEMENT

CAN NOT PERFORM BUILDING PRESSURE TEST UNTIL KEF-1 MOTOR REPLACEMENT.

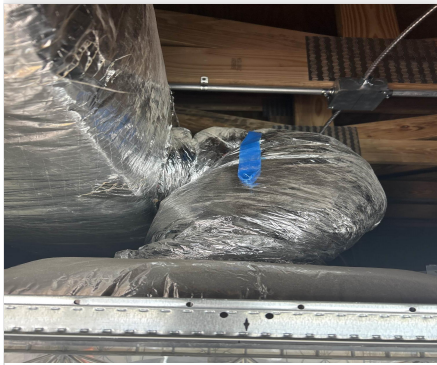
Issue Name : RTU-2 Choked diffuser
Description : RTU-2 diffuser 2-14 ductwork too close to trunk diffuser being choked.
Created By : National TAB **Assigned To :** National TAB - Brianna Biggs
Status : Open
Priority : Urgent **Asset Tag :** RTU2
Originated Date : 06/11/2025 - Jearod Ferrette - National TAB

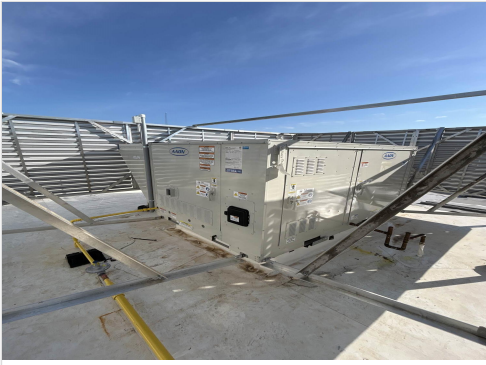
Unit Data - PHOTO LOG

Asset: RTU1

Unit Data	
	Actual
MFG	AAON
Serial Num	202501-BNGK120851
Model Num	RN-015-8-0-GB04-I69
Num OA Filters 1	3
OA Filter Size 1	18.5X23.5
Num Final Filter 1	6
Final Filter Size 1	20X25X2

Test Data		
	Design	Actual
SF CFM	3000	3027
SF RPM	-	DD/36HZ
MOTOR RPM	-	DD/36HZ
RA CFM	1100	1215
OA CFM	1900	1812
RL Voltage	-	213/214/213
RL Amperage	-	4.32
SF System SetPt	-	36HZ
RA Damper Position	-	1.5"
Min OA Damper Position	-	1.25
Min OA Damper Type	-	ECON

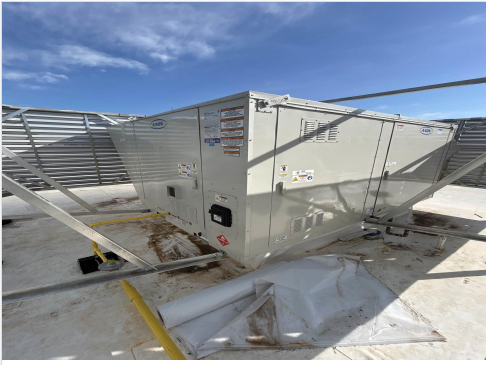
Unit Data - PHOTO LOG

Asset: RTU2

Unit Data	
	Actual
MFG	AAON
Serial Num	202501-BNGP120858
Model Num	RN-015-8-0-GB04-I69
Num OA Filters 1	2
OA Filter Size 1	18.5X23.5
Num Final Filter 1	4
Final Filter Size 1	20X25X2

Test Data		
	Design	Actual
SF CFM	3000	3004
SF RPM	-	DD/67.2HZ
MOTOR RPM	-	DD/67.2HZ
RA CFM	1100	1199
OA CFM	1900	1805
RL Voltage	-	213/213/214
RL Amperage	-	4.01
SF System SetPt	-	67.2HZ
RA Damper Position	-	0.6 on dail
Min OA Damper Position	-	1.5"
Min OA Damper Type	-	ECON

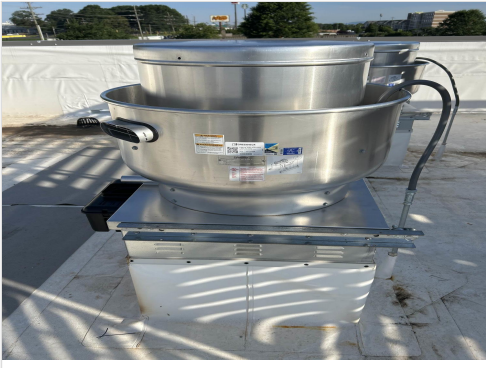
Unit Data - PHOTO LOG

Asset: KEF1

Unit Data		
	Design	Actual
MFG	GREENHECK	GREENHECK
Model Num	CUE-VG	CUE-VG
Serial Num	-	25734388
Type	UPBLAST	UPBLAST
Configuration	VERTICAL	VERTICAL

Motor Data		
	Design	Actual
Motor MFG	-	US MOTORS
Frame	-	56H
Horsepower	.75	1
Motor Rpm	-	1725
Phase	-	1
Voltage (rated)	-	115
Amperage (rated)	-	15.0
Service Factor	-	1.25

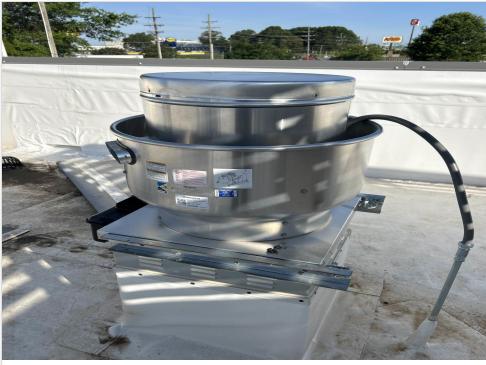
Unit Data - PHOTO LOG

Asset: KEF2

Unit Data		
	Design	Actual
MFG	GREENHECK	GREENHECK
Model Num	CUE-VG	CUE-VG
Serial Num	-	25734391
Type	UPBLAST	UPBLAST
Configuration	VERTICAL	VERTICAL

Test Data		
	Design	Actual
CFM	1216	1151
Fan RPM	-	1312
Fan Rotation	-	CW
Motor RPM	-	1762
RL Voltage	-	118
RL Amperage	-	3.3
Suction ESP	-	-0.37"
Discharge ESP	-	ATMO
Total ESP	.75"	0.37"

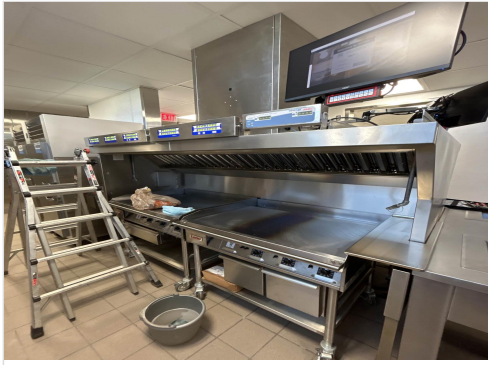
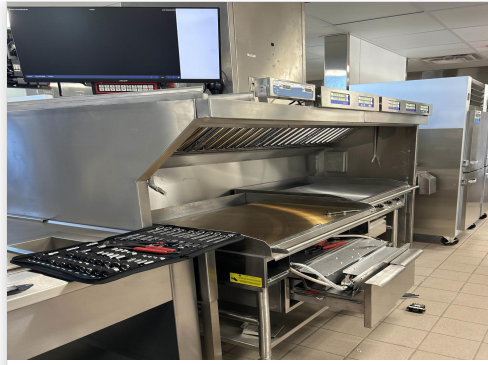
Unit Data - PHOTO LOG

Asset: HD1

Unit Data		
	Design	Actual
MFG	NAH&K INTERNATIONAL	NAH&K INTERNATIONAL
Model Num	HKD027	HKD027
Job / Serial Num	-	8157825-001
Type	TYPE I CANOPY	TYPE I CANOPY
Hood length	87"	87"
Hood Width	56"	56"

Test Data Exhaust		
	Design	Actual
Filter Type	BAFFLE	BAFFLE
Filter Size 1	12"X20"	12"X20"
Filter Qty 1	8	8
Filter AK factor size 1	1.55	1.55
Filter Total AK Area	-	12.4
Filter1 FPM	-	
Filter2 FPM	-	
Filter3 FPM	-	
Filter4 FPM	-	
Filter5 FPM	-	
Filter6 FPM	-	
Filter7 FPM	-	
Filter8 FPM	-	
Filter Ave FPM(corr)	-	
CFM	1995

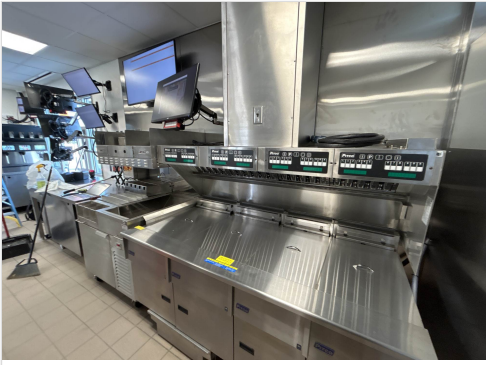
Unit Data - PHOTO LOG

Asset: HD2

Unit Data		
	Design	Actual
MFG	NA	H&K INTERNATIONAL
Model Num	NA	HKD0023
Job / Serial Num	-	8157825-001
Type	TYPE I CANOPY	TYPE I CANOPY
Hood length	73"	73"
Hood Width	26"	26"

Test Data Exhaust		
	Design	Actual
Filter Type	BAFFLE	BAFFLE
Filter Size 1	-	19.5"X11.5"
Filter Size 2	-	15.75"X11.5"
Filter Qty 1	1	1
Filter Qty 2	3	3
Filter AK factor size 1	1.59	1.59
Filters AK factor size 2	1.23	1.23
Filter Total AK Area	5.28	5.28
Filter1 FPM	-	200
Filter2 FPM	-	209
Filter3 FPM	-	242
Filter4 FPM	-	220
Filter Ave FPM(corr)	-	218
CFM	1216	1151
