Report: FINAL TAB REPORT
Function: Test, Adjust, & Balance
Date: 10/31/2022

PROJECT
10-24 CULVERS - PERRYSBURG, OH

Project: 10-24 CULVERS - PERRYSBURG, OH

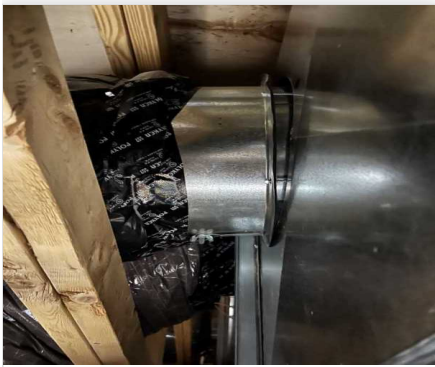
IMG_0077.jpg

Issue Name : DIFFUSER 2-7

Description : Takeoff is coming off the duct, HVAC will be on site to remedy tomorrow morning. I do not have the tools on site to fix.

- **10/27/2022 National TAB - Austin McFall**
 - GC was able to put HVAC tape to help with sealing the ductwork. Was able to complete the TAB, MC will be on site tomorrow AM to fix the issue 100%

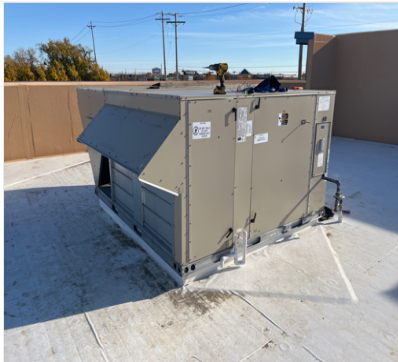
RTU-1

Unit Data		
	Design	Actual
MFG	LENNOX	LENNOX
Serial Num	-	5622C02456
Model Num	LGH210-H4B	LGH210-H4B
Type	RTU	RTU
Configuration	VERTICAL	VERTICAL
Num OA Filters 1	-	3
OA Filter Size 1	-	13X23.25"
Num Final Filter 1	-	6
Final Filter Size 1	-	24X24X2

Test Data		
	Design	Actual
SF CFM	6150	6238
RA CFM	4350	4342
OA CFM	1800	1896
RL Voltage	-	212/212/212
RL Amperage	-	9.4/9.1/9.0
SF Rotation	-	CW
RA Damper Position	-	66%
Min OA Damper Position	-	34%
Min OA Damper Type	-	ECON

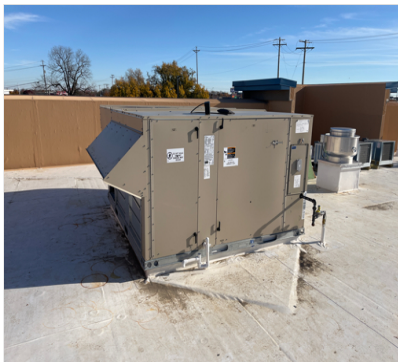
RTU-2

Unit Data		
	Design	Actual
MFG	LENNOX	LENNOX
Serial Num	-	5622E01866
Model Num	LGH210-H4B	LGH210-H4B
Type	RTU	RTU
Configuration	VERTICAL	VERTICAL
Num OA Filters 1	-	3
OA Filter Size 1	-	13"X23.25"
Num Final Filter 1	-	6
Final Filter Size 1	-	24X24X2
Num Final Filter 2	-	-
Final Filter Size 2	-	-

Test Data		
	Design	Actual
SF CFM	6225	6307
RA CFM	4525	4559
OA CFM	1700	1748
RL Voltage	-	212/213/212
RL Amperage	-	9.0/8.7/8.7
SF Rotation	-	CW
RA Damper Position	-	72%
Min OA Damper Position	-	28%
Min OA Damper Type	-	ECON

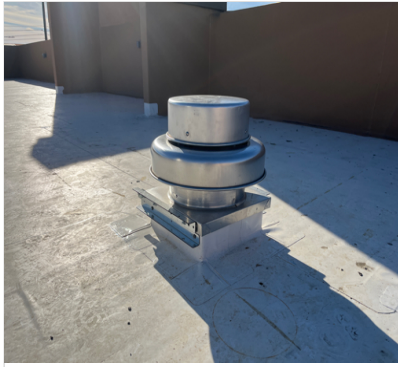
PRV1

Unit Data		
	Design	Actual
MFG	ACCUREX	ACCUREX
Model Num	XRED090VG	XRED090VG
Serial Num	-	20253971
Type	DOWNBLAST	DOWNBLAST
Configuration	VERTICAL	VERTICAL

Test Data		
	Design	Actual
CFM	300	311
Fan RPM	1465	1518
Fan Rotation	-	CCW
Motor RPM	-	300-1750
System SetPt	-	5.0
RL Voltage	-	116
RL Amperage	-	1.1
Total ESP	0.5"	0.33"
Fan Inlet SP	-	-0.33"
Fan Discharge SP	-	ATM

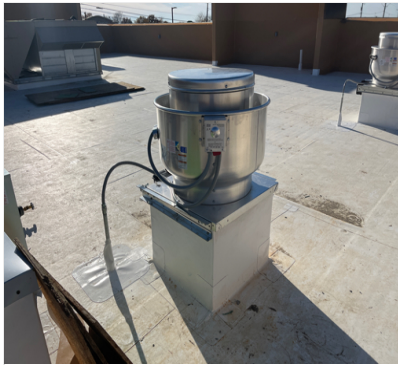
PRV-2

Unit Data		
	Design	Actual
MFG	ACCUREX	ACCUREX
Model Num	XRUB160XP-15	XRUB160XP-15
Serial Num	-	20254066
Type	UPBLAST	UPBLAST
Configuration	VERTICAL	VERTICAL

Test Data		
	Design	Actual
CFM	1500	1536
Fan RPM	2411	2468
Fan Rotation	-	CCW
Motor RPM	-	1760
RL Voltage	-	212/211/212
RL Amperage	-	2.7/2.8/2.7
Suction ESP	-	1.21"
Discharge ESP	-	ATM
Total ESP	2.337"	1.21'

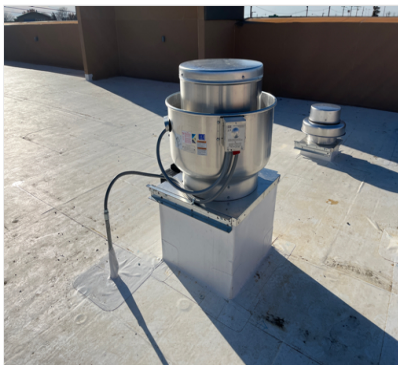
PRV-3

Unit Data		
	Design	Actual
MFG	ACCUREX	ACCUREX
Model Num	XRUB140-7	XRUB140-7
Serial Num	-	20254129
Type	UPBLAST	UPBLAST
Configuration	VERTICAL	VERTICAL

Test Data		
	Design	Actual
CFM	1500	1614
Fan RPM	1377	1481
Fan Rotation	-	CCW
Motor RPM	-	1760
RL Voltage	-	211/212/212
RL Amperage	-	1.7/1.8/1.7
Suction ESP	-	-0.78"
Discharge ESP	-	ATM
Total ESP	1"	0.78"

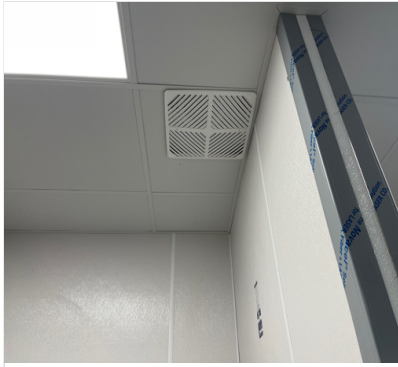
EF-1A

Unit Data		
	Design	Actual
MFG	ACCUREX	ACCUREX
Model Num	XCR-B80	XCR-B80
Serial Num	-	20260970
Type	CEILING	CEILING
Configuration	VERTICAL	VERTICAL

Test Data		
	Design	Actual
CFM	75	69
Fan RPM	885	814
Fan Rotation	-	CCW
Motor RPM	-	900
System SetPt	-	HIGH SPEED
RL Voltage	-	116
RL Amperage	-	0.14

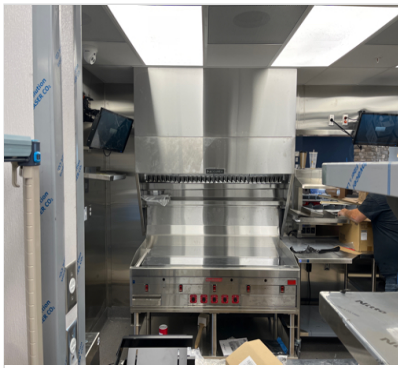
HOOD-1

Unit Data		
	Design	Actual
MFG	ACCUREX	ACCUREX
Model Num	XGEP64-S	XGEP64-S
Job / Serial Num	-	20209523
Type	TYPE I LOW PROXIMITY	TYPE I LOW PROX
Hood length	64	64"
Hood Width	23	23"

Test Data Exhaust		
	Design	Actual
Filter Type	GREASE GRABBER	GREASE GRABBER
Filter Size 1	16X16	16X16
Filter Qty 1	4	4
Filter AK factor size 1	1.53	1.53
Filter Total AK Area	6.12	6.12
Filter1 FPM	-	284
Filter2 FPM	-	253
Filter3 FPM	-	232
Filter4 FPM	-	234
Filter Ave FPM(corr)	-	251
CFM	1500	1536

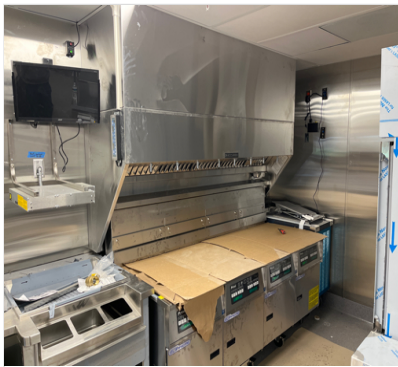
HOOD-2

Design	Actual
MFG	ACCUREX	ACCUREX
Model Num	XXEP83-S	XXEP83-S
Job / Serial Num	-	20209522
Type	TYPE I LOW PROXIMITY	TYPE I LOW PROX
Hood length	83	83"
Hood Width	23	23"

Design	Actual
Filter Type	XTRACTOR	XTRACTOR
Filter Size 1	16X16	16X16
Filter Qty 1	5	5
Filter AK factor size 1	1.53	1.53
Filter Total AK Area	7.65	7.65
Filter1 FPM	-	224
Filter2 FPM	-	203
Filter3 FPM	-	204
Filter4 FPM	-	208
Filter5 FPM	-	218
Filter Ave FPM(corr)	-	211
CFM	1500	1614
