Report: TAB Report
Function: Test, Adjust, & Balance
Date: 01/20/2026
Completed By: National TAB

03-16-26 WAWA #7222 SILVERTON, OH

Project: 03-16-26 WAWA #7222 SILVERTON, OH

Project Summary

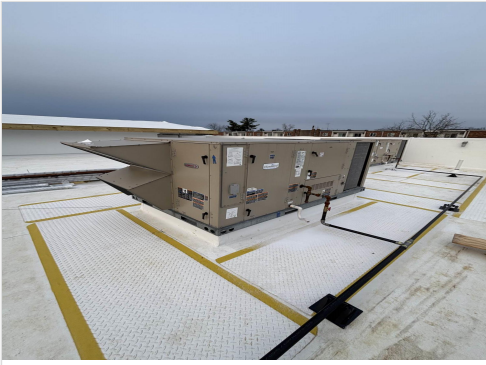
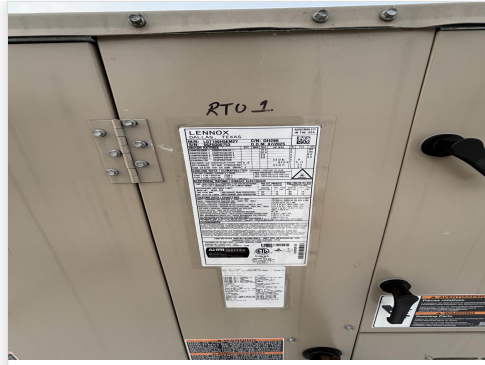
Asset: RTU-1

Unit Data		
	Design	Actual
MFG	LENNOX	LENNOX
Serial Num	-	5625G00753
Model Num	LGT150H5E	LGT150H5E
Type	RTU	RTU
Configuration	VERTICAL	VERTICAL
Num OA Filters 1	-	2
OA Filter Size 1	-	14"x23"
Num Final Filter 1	-	4
Final Filter Size 1	-	20"x25"x2"

Test Data		
	Design	Actual
SF CFM	4500	4574
RA CFM	3775	3828
OA CFM	725	746
RL Voltage	-	211/212/210
RL Amperage	-	4.7/4.8/4.7
SF System SetPt	-	81%
RA Damper Position	-	74%
RA Damper Type	-	ECONOMIZER
OA Damper Position	-	26%
OA Damper Type	-	ECONOMIZER

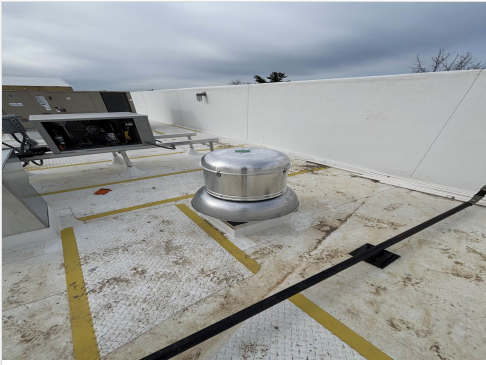
Asset: EF-2

Unit Data		
	Design	Actual
MFG	GREENHECK	LOREN COOK
Model Num	GB-098-6	NA
Serial Num	-	NA
Type	DOWNBLAST	DOWNBLAST
Configuration	VERTICAL	VERTICAL

Test Data		
	Design	Actual
CFM	1000	1023
Fan Rotation	-	CORRECT
RL Voltage	-	INACCESSIBLE
RL Amperage	-	INACCESSIBLE
Suction ESP	-	-0.49"
Discharge ESP	-	ATM
Total ESP	0.38"	0.49"

Notes:
No unit tags
