National TAB
1329 E. KEMPER ROAD
SUITE 4210
CINCINNATI, OH 45246

Report: TAB Report
Function: Test, Adjust, & Balance
Date: 01/20/2026
Completed By: National TAB

03-16-26 WAWA #7222 SILVERTON, OH

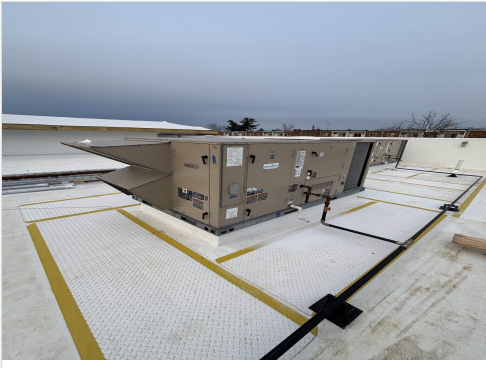
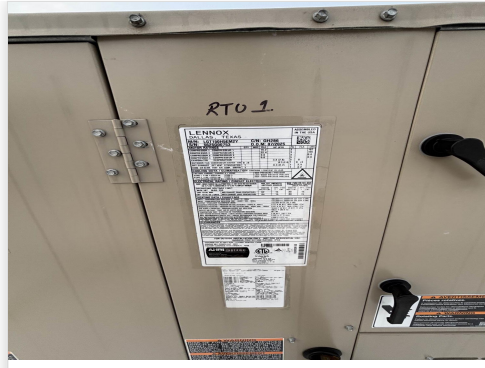
Unit Data - PHOTO LOG

Asset: RTU-1

Unit Data		
	Design	Actual
MFG	LENNOX	LENNOX
Serial Num	-	5625G00753
Model Num	LGT150H5E	LGT150H5E
Type	RTU	RTU
Configuration	VERTICAL	VERTICAL
Num OA Filters 1	-	2
OA Filter Size 1	-	14"x23"
Num Final Filter 1	-	4
Final Filter Size 1	-	20"x25"x2"

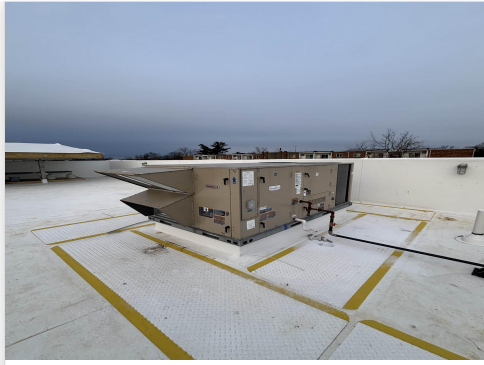
Unit Data - PHOTO LOG

Asset: RTU-2

Return diffusers not able to be balanced due to missing damper on diffuser 2

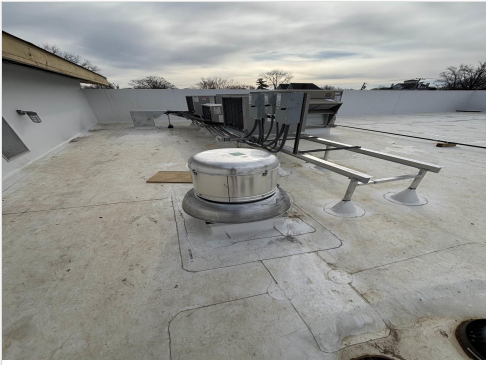
Unit Data - PHOTO LOG

Asset: EF-1

No unit tags. Diffusers not able to be balanced due to lack of face dampers.
