**Report: TAB Report**  
**Function: Test, Adjust, & Balance**  
**Date: 01/20/2026**  
**Completed By: National TAB**

**03-16-26 WAWA #7222 SILVERTON, OH**

Project: 03-16-26 WAWA #7222 SILVERTON, OH

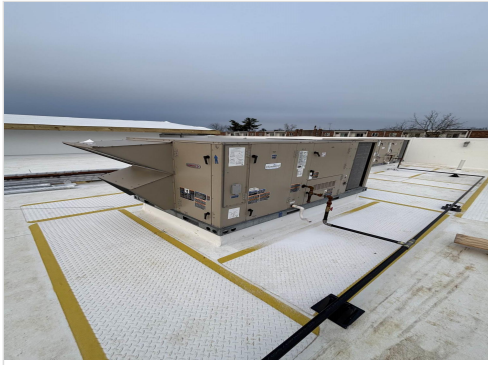
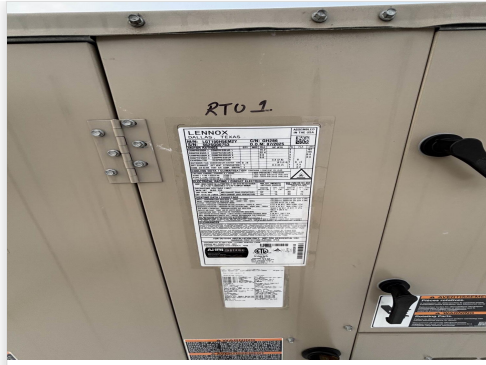
Asset: RTU-1

Unit Data		
	Design	Actual
MFG	LENNOX	LENNOX
Serial Num	-	5625G00753
Model Num	LGT150H5E	LGT150H5E
Type	RTU	RTU
Configuration	VERTICAL	VERTICAL
Num OA Filters 1	-	2
OA Filter Size 1	-	14"x23"
Num Final Filter 1	-	4
Final Filter Size 1	-	20"x25"x2"

Test Data		
	Design	Actual
SF CFM	4500	4574
RA CFM	3775	3828
OA CFM	725	746
RL Voltage	-	211/212/210
RL Amperage	-	4.7/4.8/4.7
SF System SetPt	-	81%
RA Damper Position	-	74%
RA Damper Type	-	ECONOMIZER
OA Damper Position	-	26%
OA Damper Type	-	ECONOMIZER

Performance Data		
	Design	Actual
MA Plenum SP	-	-0.61"
Fan Suction SP	-	-0.88"
Fan Discharge SP	-	0.70"
Total ESP	0.70"	1.31"
Fan Total SP	-	1.58"

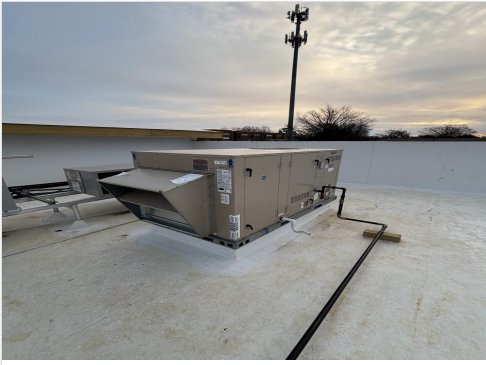
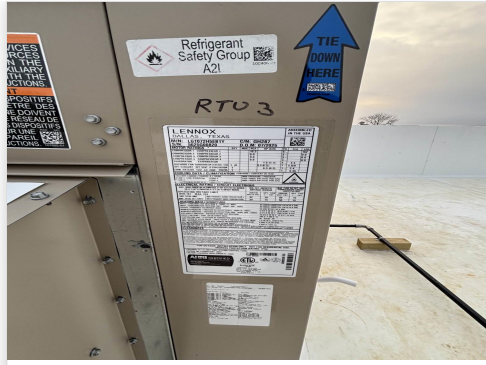
Asset: RTU-3

Unit Data		
	Design	Actual
MFG	LENNOX	LENNOX
Serial Num	-	5625G00820
Model Num	LGT072H5E	LGT072H5E
Type	RTU	RTU
Configuration	VERTICAL	VERTICAL
Num OA Filters 1	-	2
OA Filter Size 1	-	14"x14"
Num Final Filter 1	-	4
Final Filter Size 1	-	20"x20"x2"

Test Data		
	Design	Actual
SF CFM	2400	2450
RA CFM	1850	1882
OA CFM	550	568
RL Voltage	-	210/209/211
RL Amperage	-	3.5/3.4/3.5
SF System SetPt	-	92%
RA Damper Position	-	67%
RA Damper Type	-	MECHANICALLY LINKED
OA Damper Position	-	33%
OA Damper Type	-	ECONOMIZER

Performance Data		
	Design	Actual
MA Plenum SP	-	-0.35"
Fan Suction SP	-	-0.51"
Fan Discharge SP	-	0.40"
Total ESP	0.50"	0.75"
Fan Total SP	-	0.91"
