Report: TAB Report
Function: Test, Adjust, & Balance
Date: 01/20/2026
Completed By: National TAB

01-19-26 QT #0721 BROOKHAVEN, GA

3249 BUFORD HWY NE

QUIKTRIP
4705 SOUTH 129TH EAST AVENUE
TULSA, OK 74134

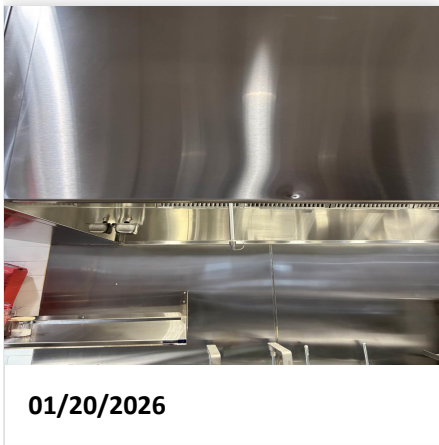
Project Issue File Details

Issue Name : Kitchen Hood Damaged
Description : A dents was found on the hood. It was made some time during installation week, but it does not impact Test and Balance.
Created By : National TAB **Assigned To :** National TAB - Dan Hertenstein
Status : Open
Priority : InfoOnly **Asset Tag :**
Originated Date : 01/20/2026 - Sagar Patel - National TAB

Damage is only on the front of the hood. This does not effect Test and Balance.

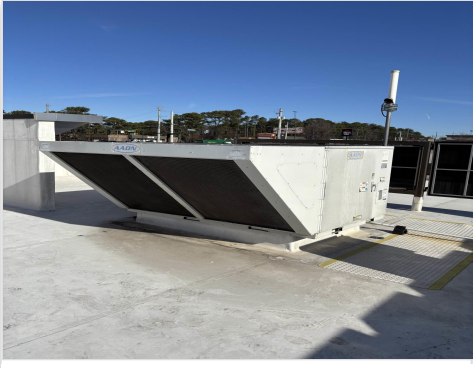
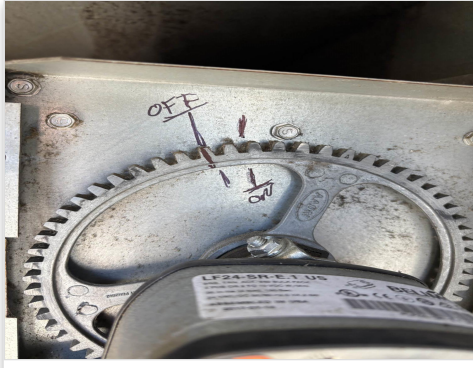
Unit Data - PHOTO LOG

Asset: RT-1

Unit Data	
	Actual
MFG	AAON
Serial Num	201708-ANEK16191
Model Num	RN-013-8-0-EA0A-152
Num OA Filters 1	1
OA Filter Size 1	22X45
Num Final Filter 1	4
Final Filter Size 1	20X25X2

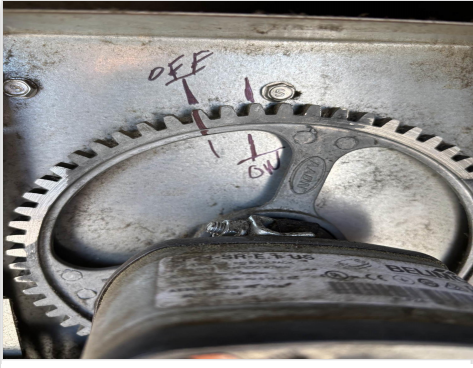
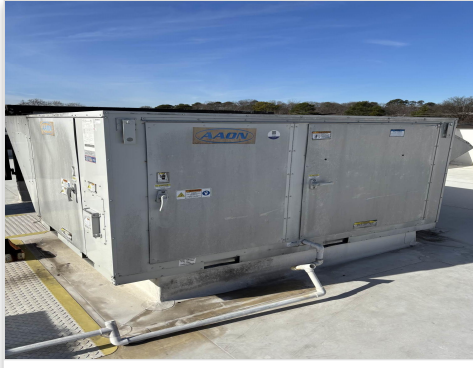
Unit Data - PHOTO LOG

Asset: RT-2

Unit Data	
	Actual
MFG	AAON
Serial Num	201708-ANEK16189
Model Num	RN-013-8-0-EA0A-152
Num OA Filters 1	1
OA Filter Size 1	22X45
Num Final Filter 1	4
Final Filter Size 1	20X25X5

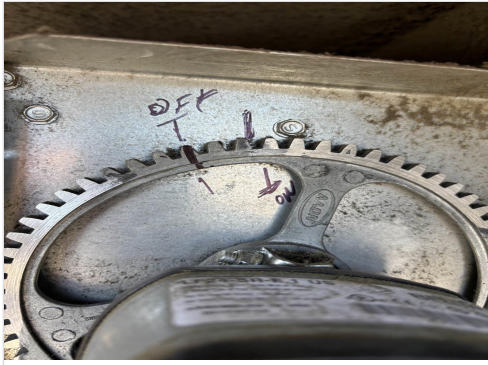
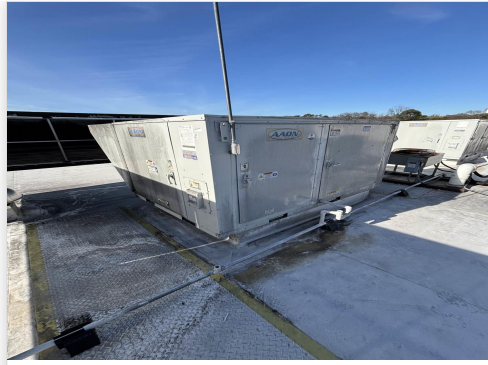
Unit Data - PHOTO LOG

Asset: RT-3

Unit Data	
	Actual
MFG	AAON
Serial Num	201708-ANEK16190
Model Num	RN-013-8-0-EA0A-152
Num OA Filters 1	1
OA Filter Size 1	22X45
Num Final Filter 1	4
Final Filter Size 1	20X25X2

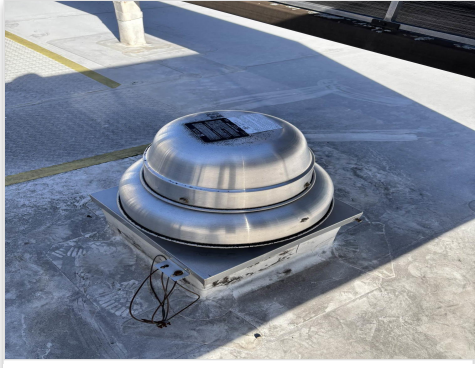
Unit Data - PHOTO LOG

Asset: EF1

Unit Data		
	Design	Actual
MFG	NA	COOK COMPANY
Model Num	NA	90ACEG 90C15DH
Serial Num	-	050SH22062-00
Type	-	DOWNBLAST
Configuration	-	VERTICAL

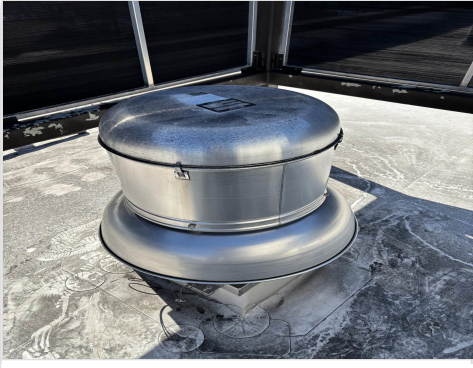
Unit Data - PHOTO LOG

Asset: EF2

Unit Data		
	Design	Actual
MFG	NA	COOK COMPANY
Model Num	NA	120 ACE 120C13D 33
Serial Num	-	050SH22062-00
Type	-	DOWNBLAST
Configuration	-	VERTICAL

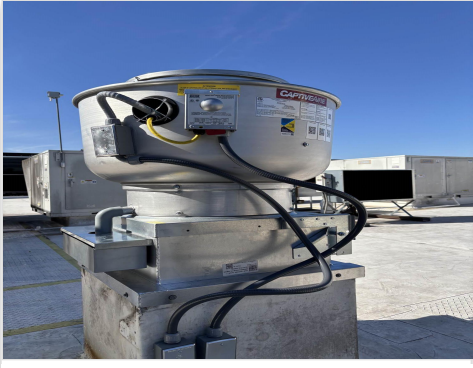
Unit Data - PHOTO LOG

Asset: EF3

Unit Data		
	Design	Actual
MFG	NA	CAPTIVEAIRE
Model Num	NA	DU50HFA
Serial Num	-	8225588
Type	UPBLAST	UPBLAST
Configuration	VERTICAL	VERTICAL

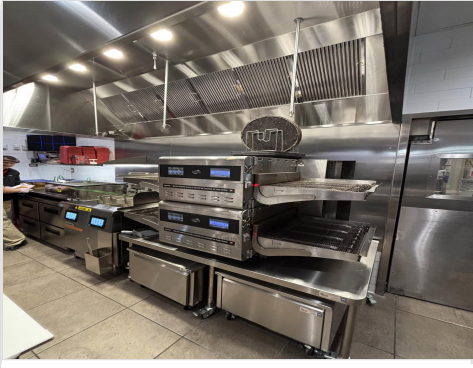
Unit Data - PHOTO LOG

Asset: HD1

Design	Actual
MFG	CAPTIVEAIRE	CAPTIVEAIRE
Model Num	6030ND-2-F	6030ND-2-F
Job / Serial Num	-	8225588
Type	-	TYPE 1 CANOPY
Hood length	-	108"
Hood Width	-	60"
