**Report: TAB Report**  
**Function: Test, Adjust, & Balance**  
**Date: 01/20/2026**  
**Completed By: National TAB**

**01-19-26 QT #0721 BROOKHAVEN, GA**

3249 BUFORD HWY NE

BROOKHAVEN, GA

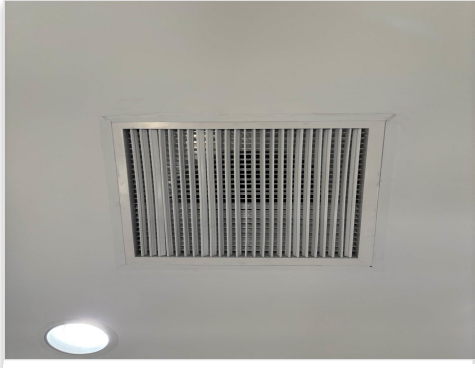
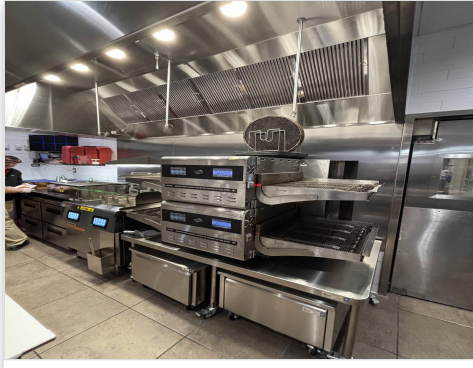
**Unit Data - PHOTO LOG**

Asset: HD1

Design	Actual
MFG	CAPTIVEAIRE	CAPTIVEAIRE
Model Num	6030ND-2-F	6030ND-2-F
Job / Serial Num	-	8225588
Type	-	TYPE 1 CANOPY
Hood length	-	108"
Hood Width	-	60"
