**Report: TAB REPORT**  
**Function: Test, Adjust, & Balance**  
**Date: 07/10/2024**  
**Completed By: National TAB**

**PROJECT**  
**07-08-24 CULVERS OXFORD, AL**

Project: 07-08-24 CULVERS OXFORD, AL

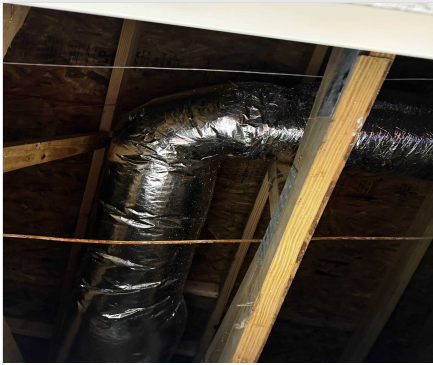
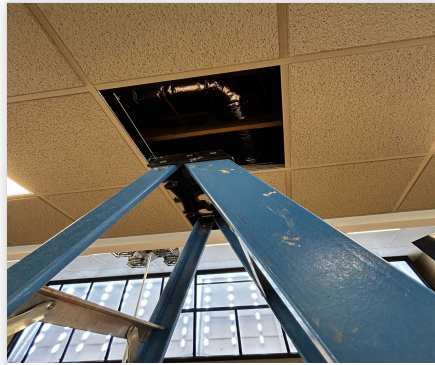
**Issue Name :** RTU 1 Diffuser Damper  
**Description :** RTU1 Diffuser damper 1-30 (See GRD), was not installed. Recommend installing in order to adjust diffuser air flow.  
**Created By :** National TAB                      **Assigned To :** National TAB - Will Turnbough  
**Status :** Open  
**Priority :** Urgent                                      **Asset Tag :**  
**Originated Date :** 07/09/2024 - Kristopher Passley - National TAB

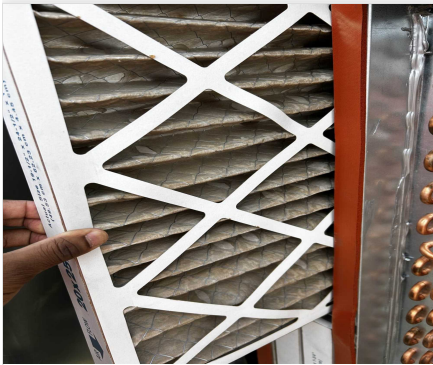
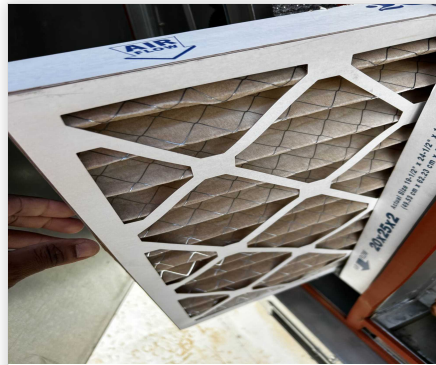
**Issue Name :** RTU 1 Final Filter  
**Description :** Final filters in until are dirty. Recommend replacing filters  
**Created By :** National TAB                      **Assigned To :** National TAB - Will Turnbough  
**Status :** Open  
**Priority :** Medium                                      **Asset Tag :**  
**Originated Date :** 07/10/2024 - Kristopher Passley - National TAB

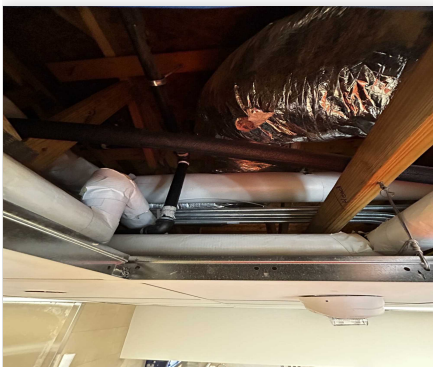
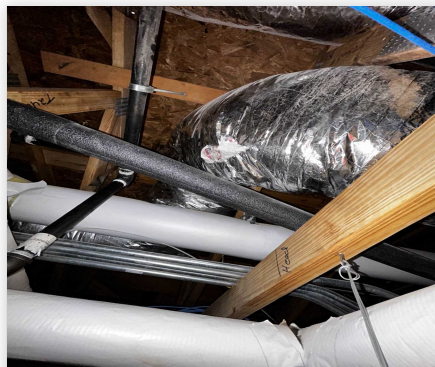
**Issue Name :** RTU 2 Diffuser Damper  
**Description :** Rtu 2 Diffuser 2-1 Damper(see GRD), was not installed or not in a position that is accessible. Recommend mechanical place damper handle in an accessible position or install a damper.  
**Created By :** National TAB                      **Assigned To :** National TAB - Will Turnbough  
**Status :** Open  
**Priority :** Urgent                                      **Asset Tag :**  
**Originated Date :** 07/09/2024 - Kristopher Passley - National TAB

DAMPER WAS ADDED TO RTU 2 DIFFUSER 2-1(SEE GRD LAYOUT), SGRD1, AFTER LEAVING SITE. NO COMFORT ISSUES WERE NOTICED, AND NO FURTHER ACTION IS RECOMMENDED AT THIS TIME.

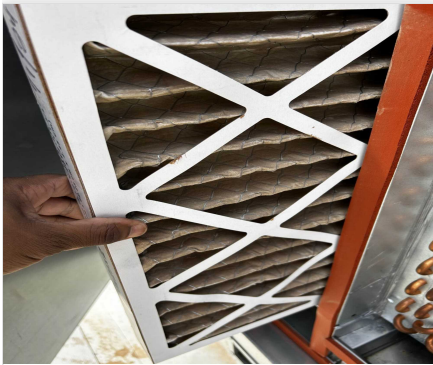
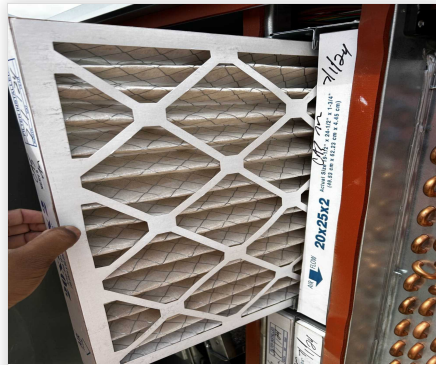
**Issue Name :** RTU 2 Final Filters  
**Description :** The final filters in unit are dirty. Recommend replacing with clean filters.  
**Created By :** National TAB                      **Assigned To :** National TAB - Will Turnbough  
**Status :** Open  
**Priority :** Medium                                      **Asset Tag :**  
**Originated Date :** 07/10/2024 - Kristopher Passley - National TAB

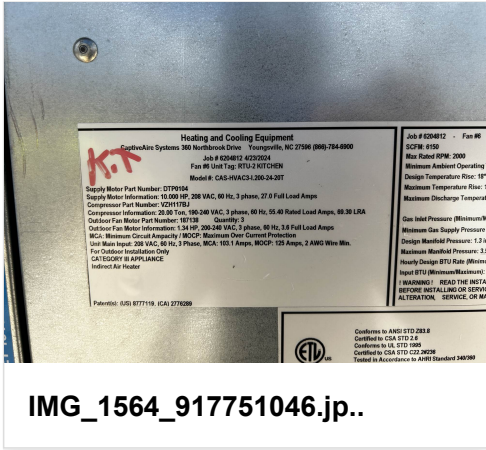
## Unit Data - PHOTO LOG

Unit Data		
	Design	Actual
MFG	LENNOX	CAPTIVEAIRE
Serial Num	-	6204812
Model Num	ENLIGHT	CAS-HVAC3-I.200-24-20T
Type	RTU	DOAS
Configuration	VERTICAL	VERTICAL
Num OA Filters 1	-	1
OA Filter Size 1	-	34"X45.75"
Num Final Filter 1	-	8
Final Filter Size 1	-	20X25X2

General	
	Actual
Fan Rotation Correct	CORRECT
Unit Filters Clean	DIRTY
Condensate Drain Installed	INSTALLED

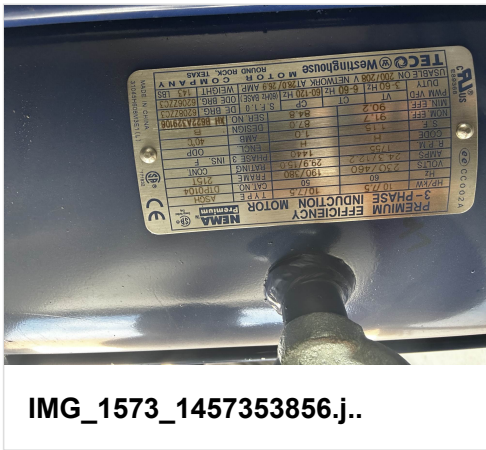
## Motor Data - PHOTO LOG

Motor Data		
	Design	Actual
Motor MFG	-	TECO WESTINGHOUSE
Frame	-	215T
Horsepower	-	10/7.5
Motor Rpm	-	1755
Phase	3	3
Rated Voltage	208	230/460
Rated Amperage	-	24.3

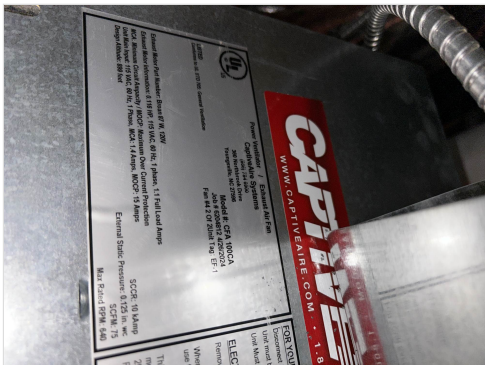
## Unit Data - PHOTO LOG

Unit Data		
	Design	Actual
MFG	CAPTIVEAIRE	CAPTIVEAIRE
Model Num	CFA100CA	CFA100CA
Serial Num	-	6204812
Type	INLINE	INLINE
Configuration	VERTICAL	HORIZONTAL
