**Report: TAB Report**  
**Function: Test, Adjust, & Balance**  
**Date: 11/26/2025**  
**Completed By: National TAB**

**PROJECT**  
**12-08-25 QT #1130 PIEDMONT, SC**

3450 HWY 153

PIEDMONT, SC

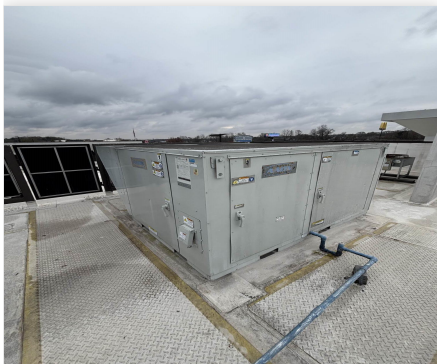
Project Issue File Details

**Issue Name :** RTU 2 low flow  
**Description :** RTU 2 is having flow issues. At 43Hz the unit was barely doing 3,000cfm. After troubleshooting most likely the unit's fan is spinning in the wrong direction. At that speed the unit was overramping, left low until issue is fixed.  
**Created By :** National TAB                      **Assigned To :** National TAB - Dan Hertenstein  
**Status :** Open  
**Priority :** High                                      **Asset Tag :** RT-2  
**Originated Date :** 12/08/2025 - Christian Moller - National TAB

Notes:  
RECOMMEND ROTATION IS VERIFIED. MOTOR WAS OVERRAMPING AT DESIGN.

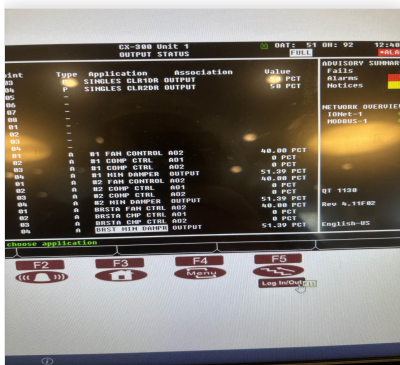
##### RTU's/AHU's

Evaporator coils are clean?

Pass

Condenser coils are clean?

Gas piping is installed and valves are turned on?

**Unit free of noticeable noise and vibration**

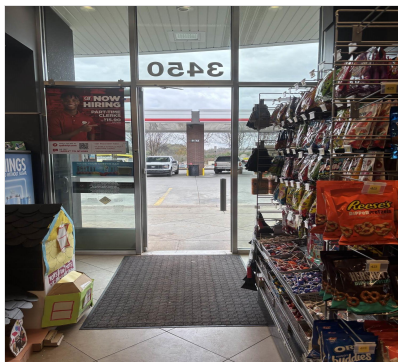
Building was not fully enclosed, could not take a pressure.

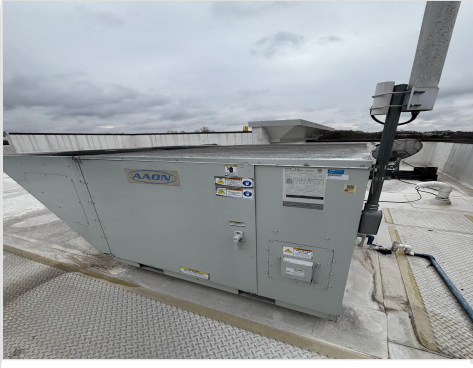
**Unit Data - PHOTO LOG**

Test Data		
	Design	Actual
SF CFM	4200	4567
SF RPM	-	DD
OA CFM (Hoods On)	800	813
OA CFM (Hoods Off)	350	367
RL Voltage	-	209/209/208
RL Amperage	-	5.5/5.3/6.0
VFD Max SetPt	-	37.2Hz
VFD Min SetPt	-	24Hz
OA Damper Position (Hoods On)	-	51.39%
OA Damper Position (Hoods Off)	-	27%

Performance Data		
	Design	Actual
MA Plenum SP	-	-0.40"
Fan Suction SP	-	-0.55"
Fan Discharge SP	-	0.53"
Total ESP	-	0.95"
Fan Total SP	-	1.08"

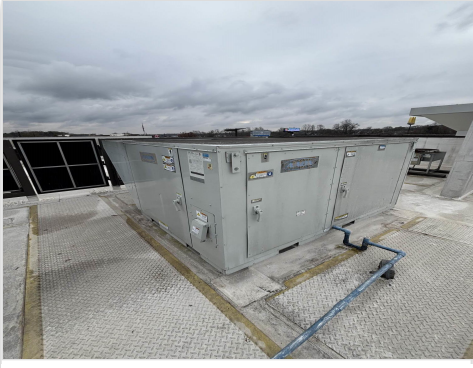
## Unit Data - PHOTO LOG

Test Data		
	Design	Actual
SF CFM	4200	2422
SF RPM	-	DD
OA CFM (Hoods On)	800	810
OA CFM (Hoods Off)	350	343
RL Voltage	-	209/209/208
RL Amperage	-	8.1/7.5/7.0
VFD Max SetPt	-	38.2Hz
VFD Min SetPt	-	24Hz
OA Damper Position (Hoods On)	-	51.39%
OA Damper Position (Hoods Off)	-	27%

Performance Data		
	Design	Actual
MA Plenum SP	-	-0.03"
Fan Suction SP	-	-0.06"
Fan Discharge SP	-	0.06"
Total ESP	-	0.09"
Fan Total SP	-	0.12"

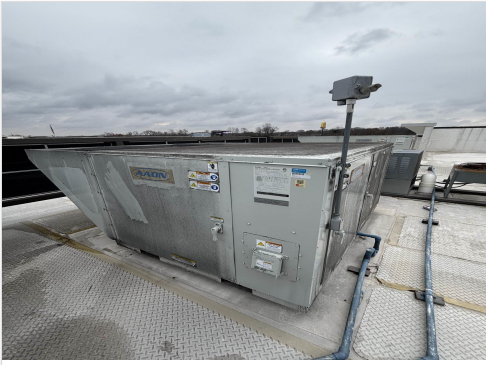
## Unit Data - PHOTO LOG

Test Data		
	Design	Actual
SF CFM	4200	4502
SF RPM	-	DD
OA CFM (Hoods On)	800	824
OA CFM (Hoods Off)	350	348
RL Voltage	-	209/208/208
RL Amperage	-	4.5/4.3/4.7
VFD Max SetPt	-	33Hz
VFD Min SetPt	-	24Hz
OA Damper Position (Hoods On)	-	51.39%
OA Damper Position (Hoods Off)	-	21%

Performance Data		
	Design	Actual
MA Plenum SP	-	-0.23"
Fan Suction SP	-	-0.36"
Fan Discharge SP	-	0.34"
Total ESP	-	0.59"
Fan Total SP	-	0.70"

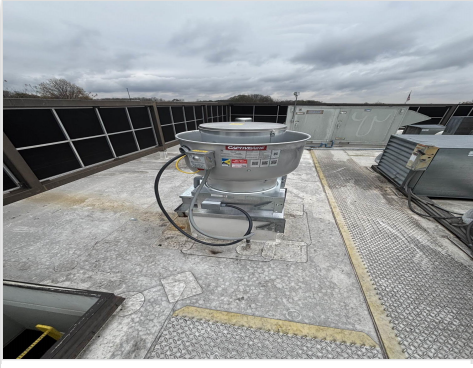
**Unit Data - PHOTO LOG**

Test Data		
	Design	Actual
CFM	1350	1422
Fan RPM	-	DD
Fan Rotation	-	CCW
Motor RPM	-	DD
System SetPt	-	HMI/55.8Hz
RL Voltage	-	206
RL Amperage	-	2.7
Total ESP	-	0.34"
Fan Inlet SP	-	-0.34"
Fan Discharge SP	-	ATM

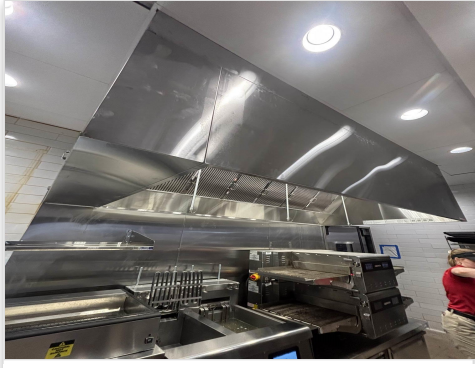
**Unit Data - PHOTO LOG**

Design	Actual
Filter Type	-	BAFFLE FILTERS
Filter Size 1	-	16X20
Filter Qty 1	-	6
Filter AK factor size 1	-	2.08
Filter Total AK Area	-	12.48
Filter1 FPM	-	106
Filter2 FPM	-	113
Filter3 FPM	-	123
Filter4 FPM	-	117
Filter5 FPM	-	114
Filter6 FPM	-	113
Filter Ave FPM(corr)	-	114
CFM	1350	1422
