TAB Pre-Grid Inspection Report

List
TAB Punch List

L05075_Cedarbrook Plaza (Wyncote, PA) FSU

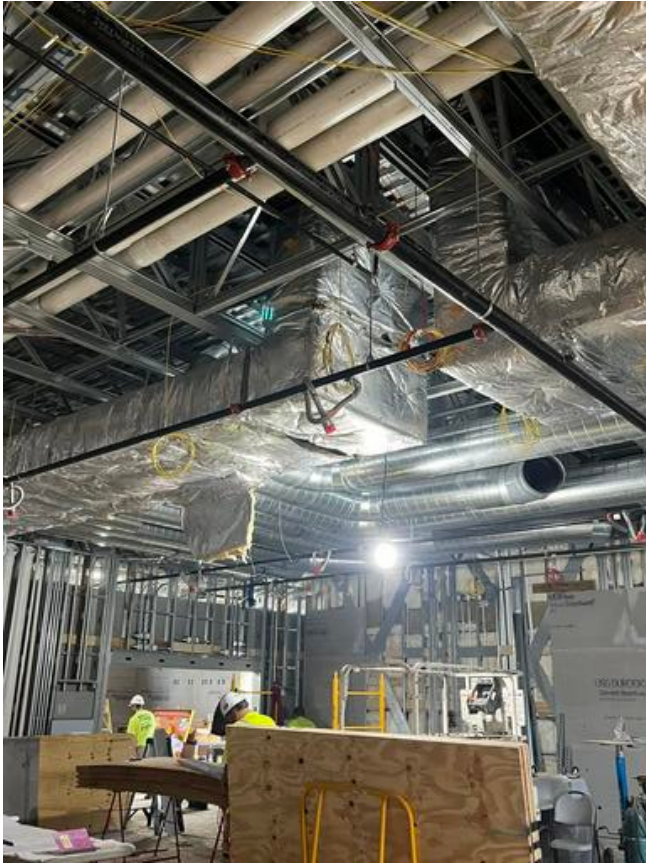
#21 [DUCT 507] [NEW] Ductwork is not fully insulated. (IN PROGRESS)

Duct insulation is in progress. Once complete Ensure all insulation has no gaps and is secured. Insulation used so far is R-6 and approved.

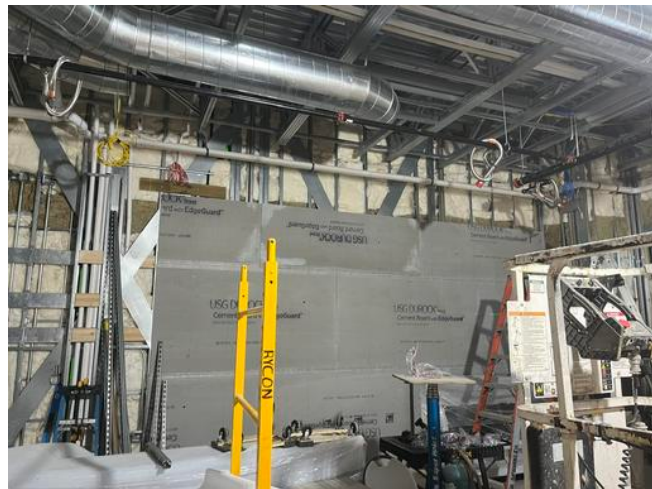
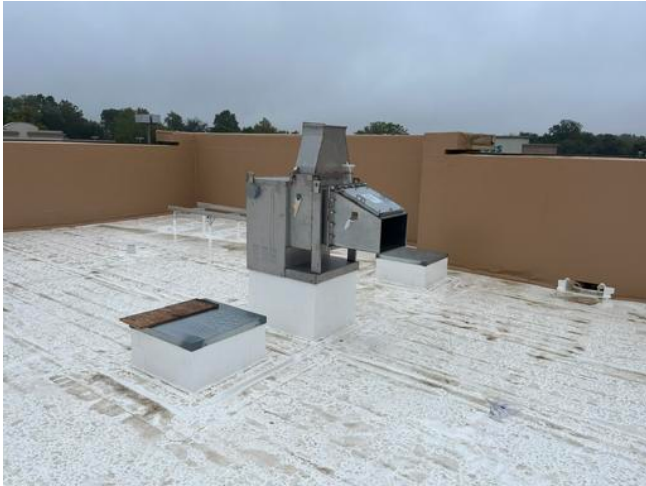
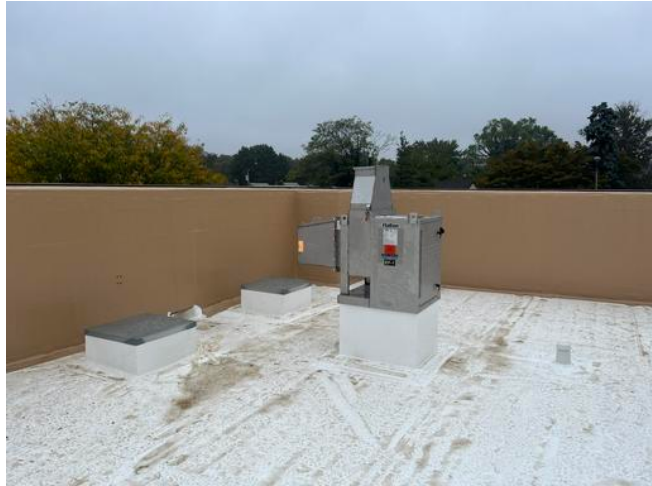
#20 [EXHA 499] [NEW] CRITICAL (MISC) – Grease Duct not yet installed

Grease Duct installation has not yet been started. Ensure all specifications and guidelines are followed: Halton Ells are used, Straight Sections are fabricated to account for duct slope, Cleanout doors are located in specified locations.

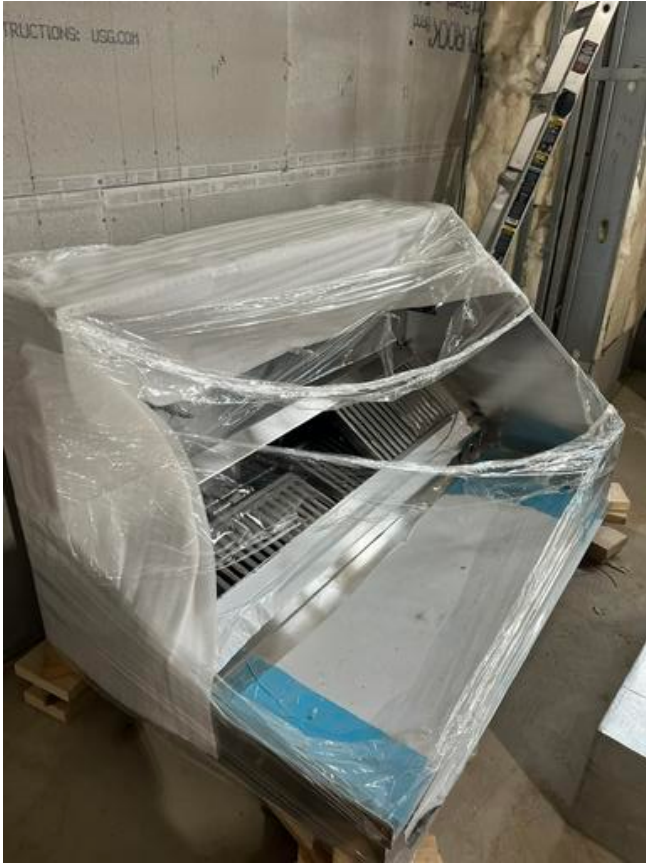
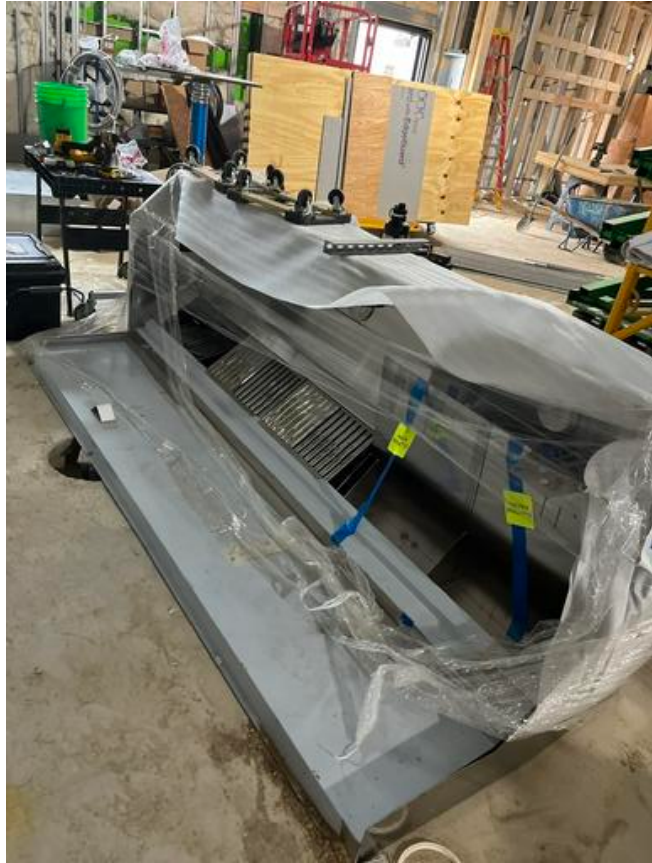
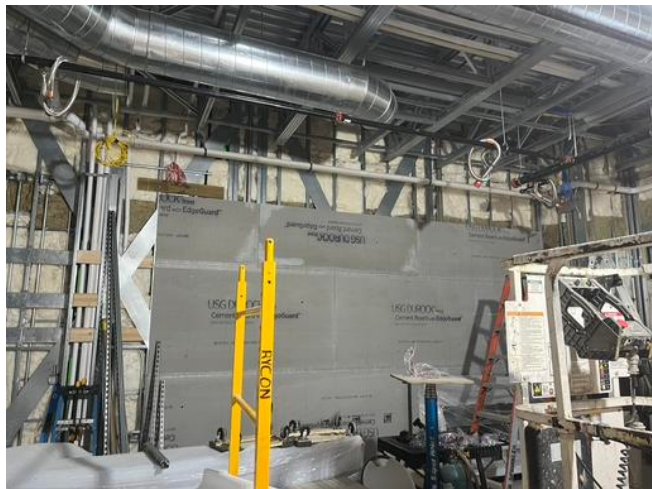
#19 [HOOD 499] [NEW] CRITICAL (MISC) – Hood Install not yet completed

Hoods not yet installed,
Enusre hoods are hung 64"
AFF and hung following all
guidelines

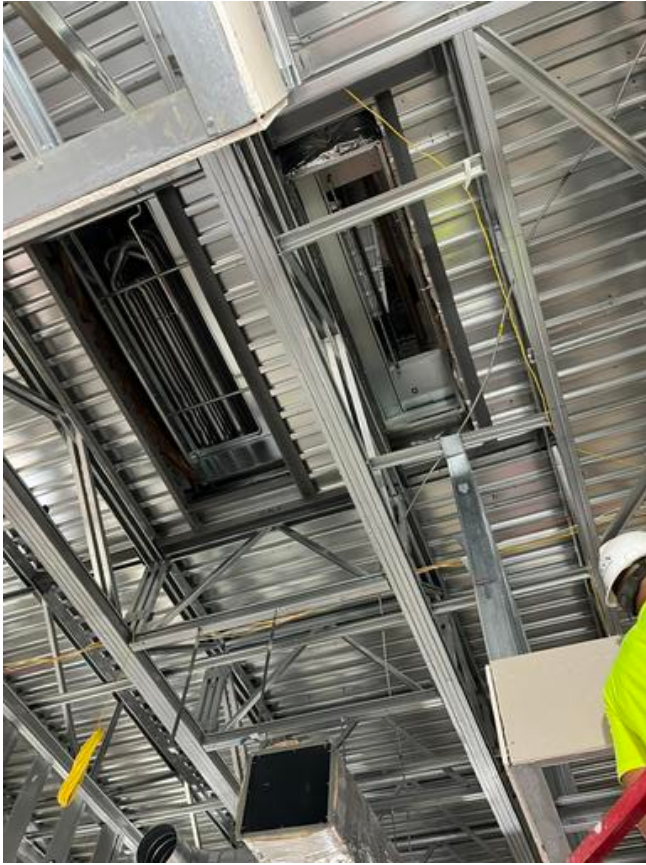
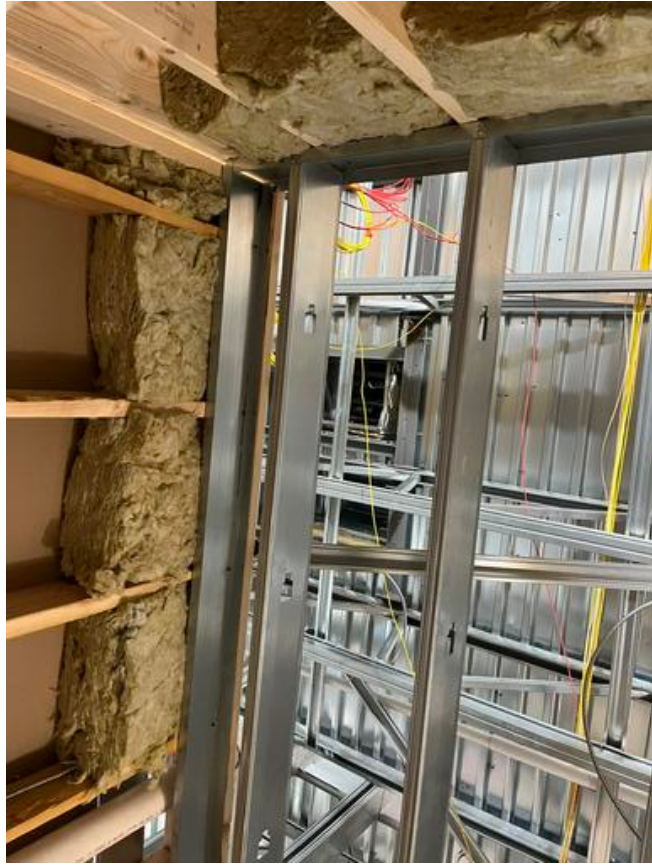
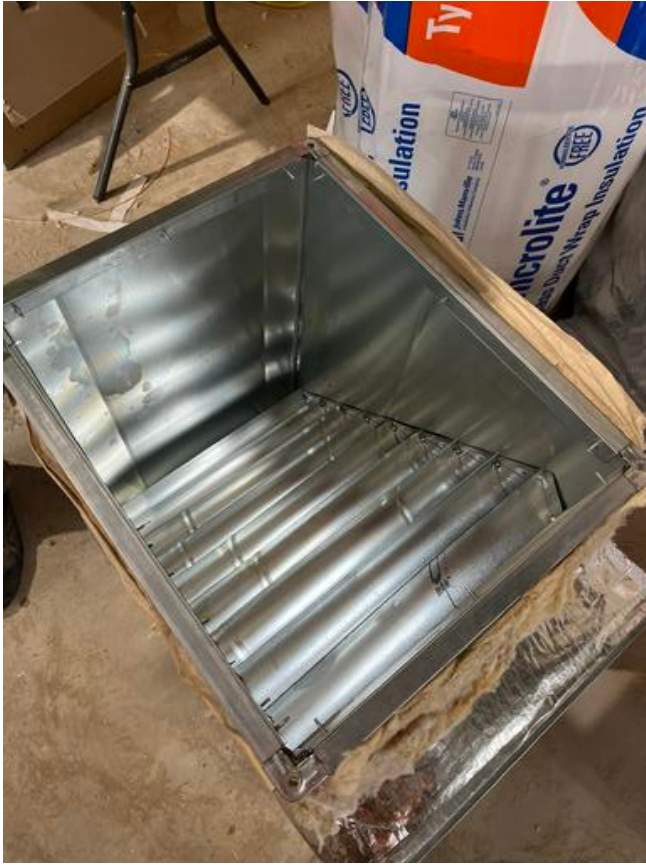
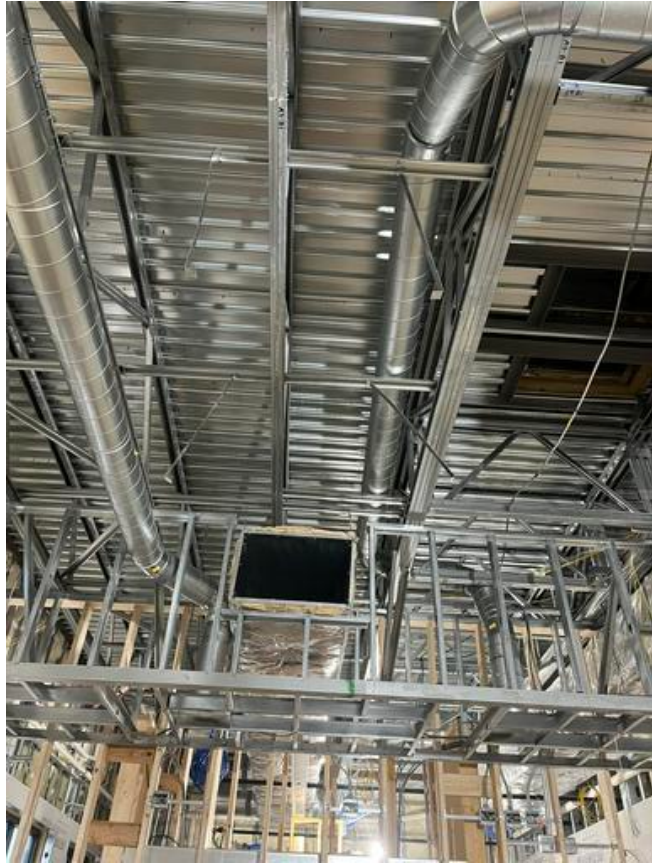
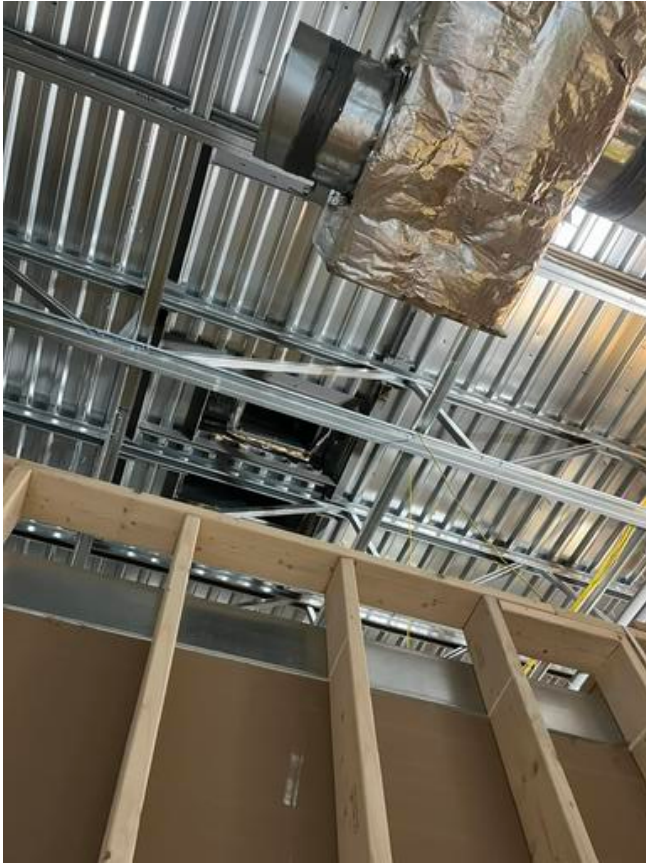
#18 [DUCT 004] [NEW] CRITICAL – Duct drop (IN PROGRESS)

Duct drop transitions are not yet installed. Install per mechanical specification floor plan/detail. Supply drops to have single thickness vanes and Return drops are to have no turning vanes. AC-1 is installed at time of inspection and passed.

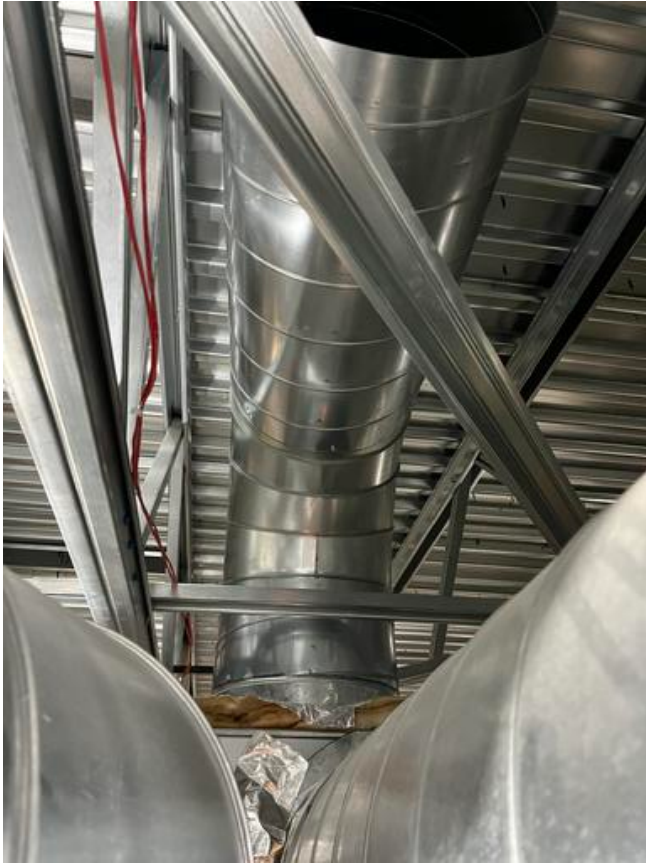
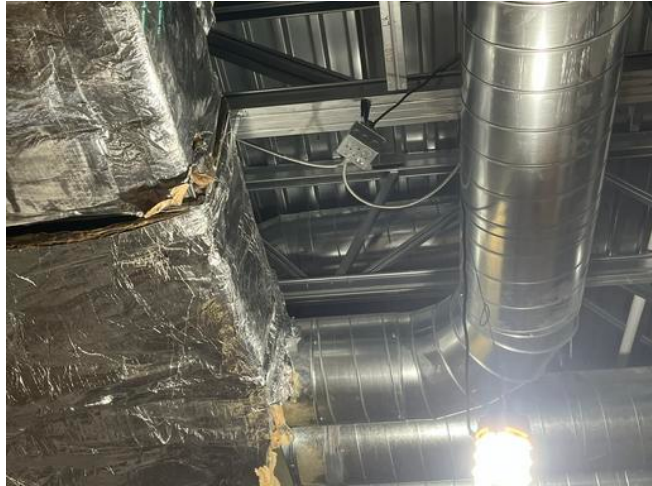
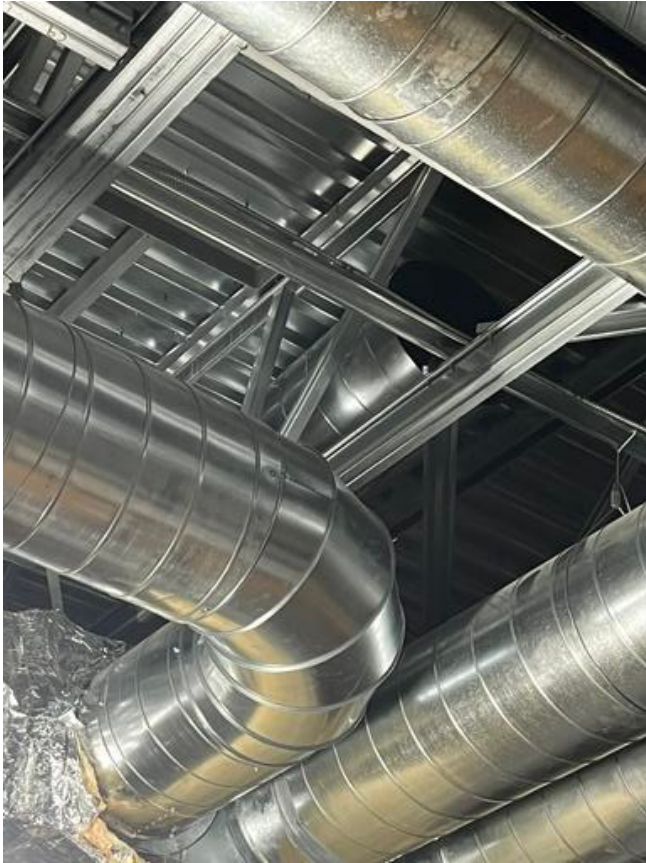
#17 [DUCT 017] [NEW] CRITICAL – Duct not installed per plans.

Duct is constructed in a way that impedes proper airflow or will hurt efficiency. Ensure duct sizes are installed according to floor plan or detail for system. Applies to the duct start collar location for AC-1

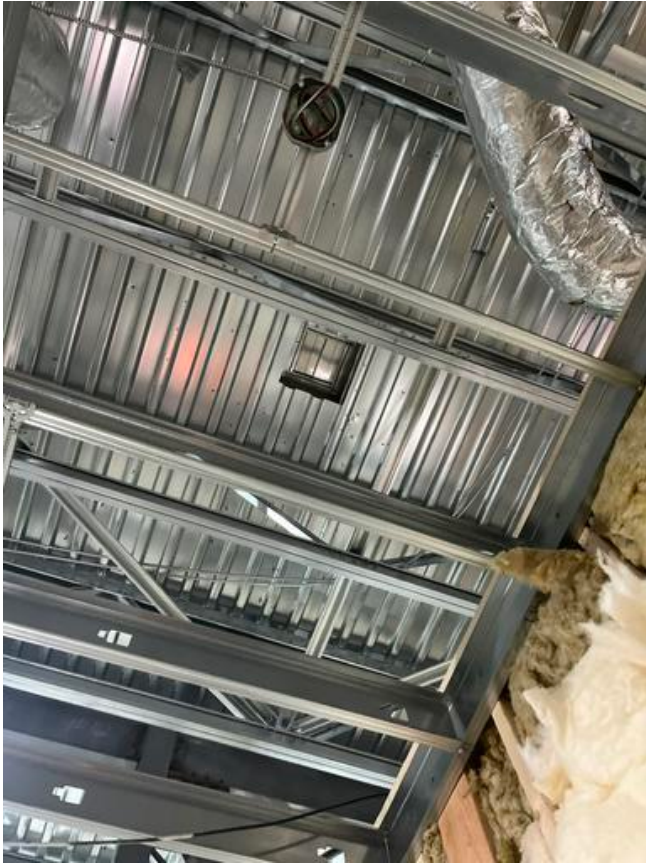
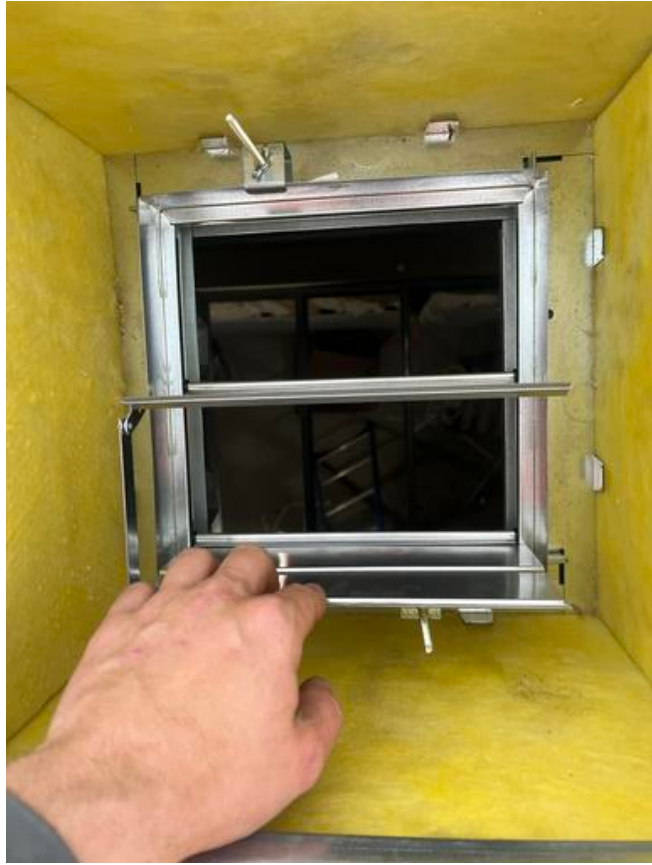
#15 [EXHA 500] [NEW] Restroom rectangular duct riser. (Not Yet completed)

Not Yet installed: Restroom exhaust rectangular duct riser. Ensure it is correctly lined per specification.

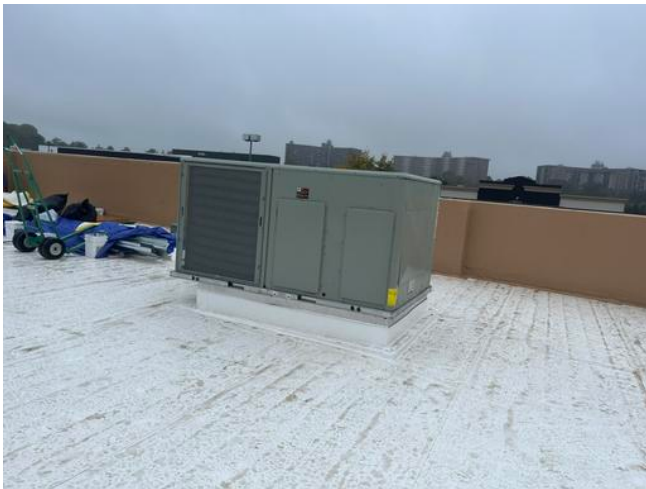
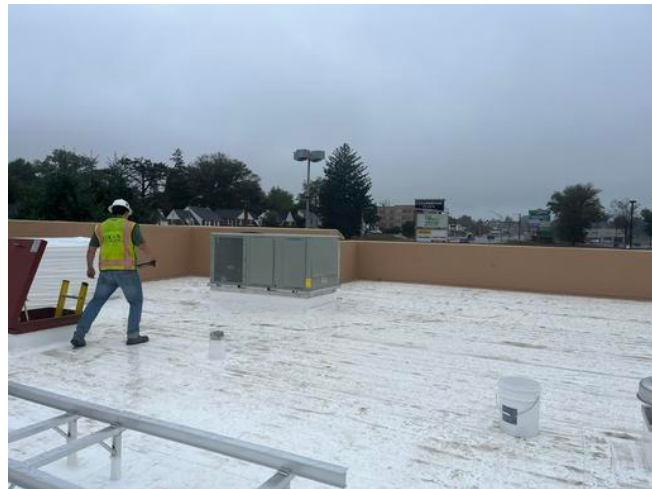
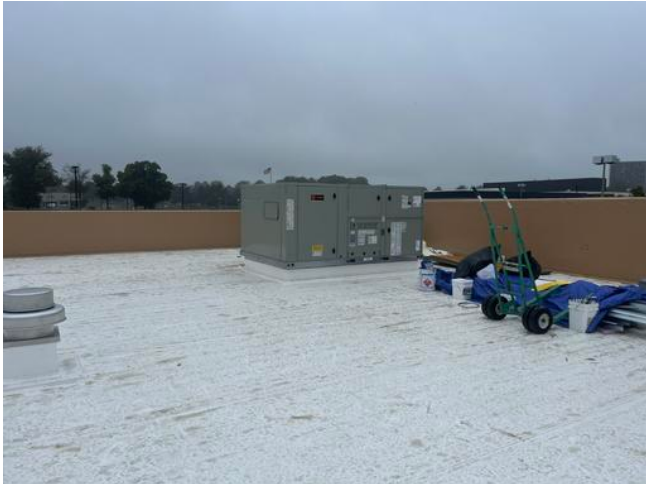
#14 [UNIT 999] [NEW] (MISC) To Complete: UNIT Setup

Unit Setup not yet completed. Once ready Economizers and all equipment accessories to be installed and completed prior to TAB

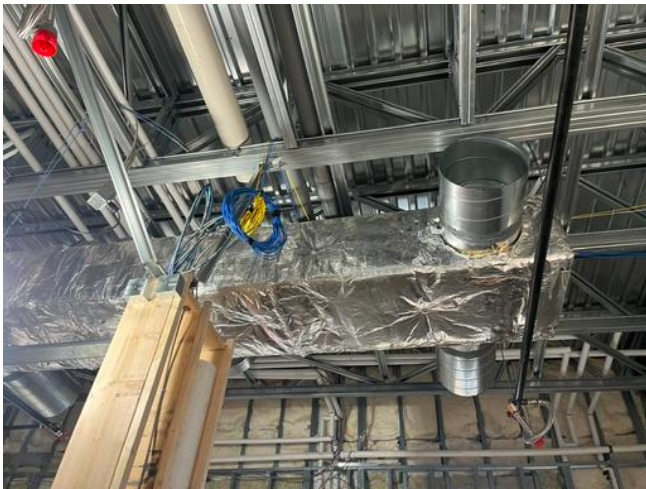
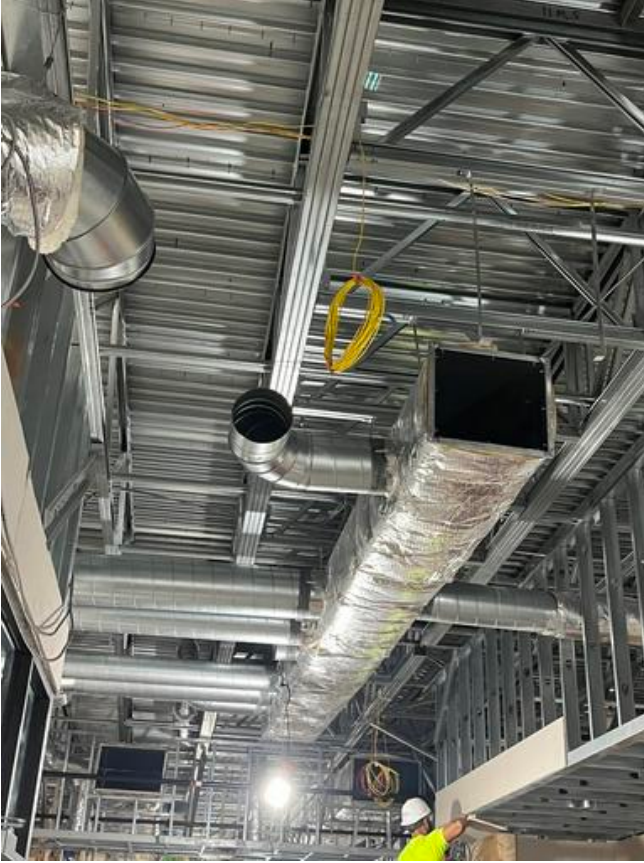
#12 [DUCT 503] [NEW] Damper flags.

Dampers are not flagged per specification.
