Report: TAB Report
Function: Test, Adjust, & Balance
Date: 05/27/2025
Completed By: National TAB

05-19-25 WAWA #8196 POTTSTOWN, PA

Project: 05-19-25 WAWA #8196 POTTSTOWN, PA

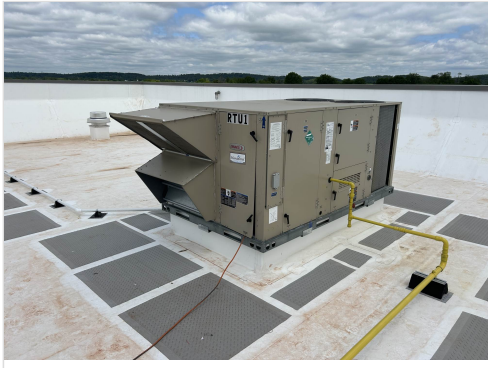
Unit Data - PHOTO LOG

Unit Data		
	Design	Actual
MFG	LENNOX ENLIGHT	LENNOX ENLIGHT
Serial Num	-	5624D03230
Model Num	LGT102H4E	LGT102H4ES1Y
Type	RTU	RTU
Configuration	VERTICAL	VERTICAL
Num OA Filters 1	-	2
OA Filter Size 1	-	23x14.25
Num Final Filter 1	-	4
Final Filter Size 1	-	20x25x2

Test Data		
	Design	Actual
SF CFM	3400	3346
SF RPM	-	1364
MOTOR RPM	-	1364
RA CFM	3000	2932
OA CFM	400	414
RL Voltage	-	210/209/211
RL Amperage	-	2.5/2.4/2.5
SF System SetPt	-	62%
RA Damper Position	-	73%
OA Damper Position	-	27%
OA Damper Type	-	ECONOMIZER
