Report: TAB Report
Function: Test, Adjust, & Balance
Date: 05/27/2025
Completed By: National TAB

05-19-25 WAWA #8196 POTTSTOWN, PA

157 EVERGREEN RD

Project: 05-19-25 WAWA #8196 POTTSTOWN, PA

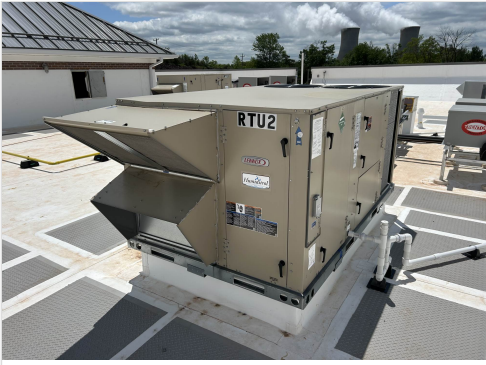
Unit Data - PHOTO LOG

Unit Data		
	Design	Actual
MFG	LENNOX ENLIGHT	LENNOX ENLIGHT
Serial Num	-	5624E05272
Model Num	LCT150H4E	LCT150H4EN1Y
Type	RTU	RTU
Configuration	VERTICAL	VERTICAL
Num OA Filters 1	-	2
OA Filter Size 1	-	23x14.25
Num Final Filter 1	-	4
Final Filter Size 1	-	20x25x2

Test Data		
	Design	Actual
SF CFM	5000	4884
SF RPM	-	1870
MOTOR RPM	-	1870
RA CFM	4340	4210
OA CFM	660	674
RL Voltage	-	210/209/211
RL Amperage	-	5.7/5.8/5.7
SF System SetPt	-	85%
RA Damper Position	-	73%
OA Damper Position	-	27%
OA Damper Type	-	ECONOMIZER

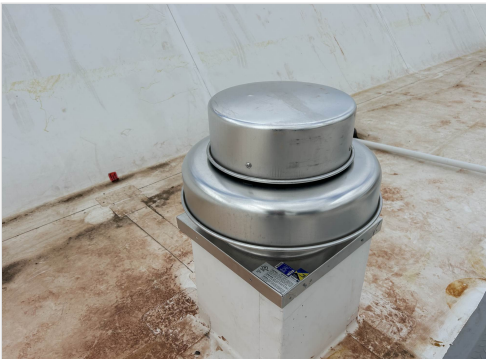
Unit Data - PHOTO LOG

Unit Data		
	Design	Actual
MFG	PENNBARRY	GREENHECK
Model Num	DX08Q	G-070-D--1-17-X
Serial Num	-	25885087
Type	DOWNBLAST	DOWNBLAST
Configuration	VERTICAL	VERTICAL

Test Data		
	Design	Actual
CFM	100	102
Fan RPM	1725	1550
Fan Rotation	-	CW
Motor RPM	-	1550
System SetPt	-	MAX
RL Voltage	-	122
RL Amperage	-	1.0
Total ESP	0.125"	0.12"
Fan Inlet SP	-	-0.12"
Fan Discharge SP	-	ATM
