**Report: TAB REPORT**  
**Function: Test, Adjust, & Balance**  
**Date: 10/05/2023**

**PROJECT**  
**10-02-23 CARMAX #7290 -**  
**CHARLOTTESVILLE, VA**

1448 RICHMOND RD

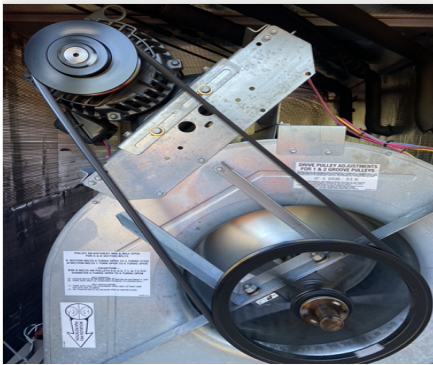
**RTU8PULLEY  
10/05/2023**

**Issue Name :** RTU-8 Motor Sheave Seized  
**Description :** Unit is operating 11% above design (111%). Motor sheave is seized and unable to adjust. Recommended to loosen or replace, and reduce fan speed by 10%. Unit is operating below FLA. Outside air set proportionally high to accommodate. Design OA: 5000CFM / Actual: 5556CFM  
**Created By :** National TAB                      **Assigned To :** National TAB - Antonio Flores-De La Cruz  
**Status :** Open  
**Originated Date :** 10/05/2023 - Antonio Flores-De La Cruz - National TAB

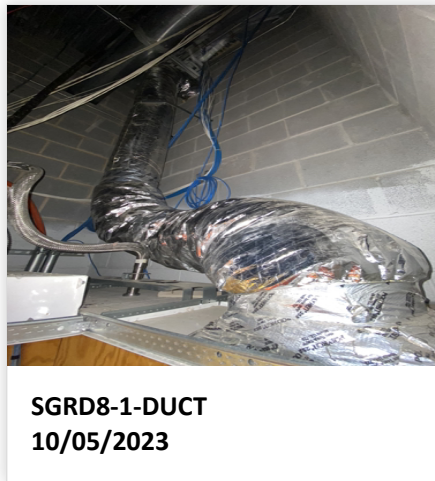
**Issue Name :** RTU8-SGRD1 Low Flow  
**Description :** SGRD8-1 is unable to be set to design. After the ductwork was checked, flex duct position was adjusted and small openings were patched and only 50 CFM was added to finish at 111 CFM. Damper is 100% open as well. Dampers in Garage area were attempted to close, but rust did not allow for them to work properly. SGRD8-1 is located in a Storage/Data room
