Report: TAB REPORT
Function: Test, Adjust, & Balance
Date: 10/05/2023

PROJECT
10-02-23 CARMAX #7290 -
CHARLOTTESVILLE, VA

1448 RICHMOND RD
CHARLOTTESVILLE,, VA

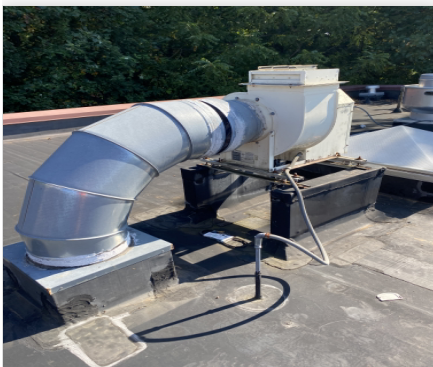
EF10
10/05/2023

Issue Name : EF-10 Low Flow
Description : Fan is running at 86% of design. Motor sheave is 1 Turn Out.
Created By : National TAB **Assigned To :** National TAB - Antonio Flores-De La Cruz
Status : Closed
Originated Date : 10/05/2023 - Antonio Flores-De La Cruz - National TAB

- **10/05/2023 National TAB - Stephen Tassinaro**
 - Discussed with Comfort Systems & Engineering team. It was determined it is best to leave this fan as-is at this time.

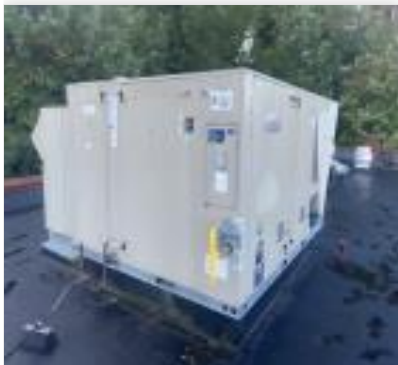
RTU8
10/05/2023

RTU-8

[1] UNIT AT 111% OF DESIGN, MOTOR SHEAVE FROZEN, UNABLE TO ADJUST. RECOMMEND SHEAVE IS BROKEN LOOSE SO FAN CAN BE SLOWED IN TO DESIGN.

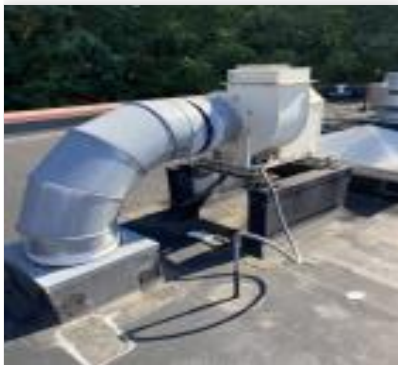
EF10
10/05/2023

EF-10
