**Report: TAB Report**  
**Function: Test, Adjust, & Balance**  
**Date: 11/17/2025**  
**Completed By: National TAB**

**PROJECT**  
**11-17-25 QT #1418 SCOTTSDALE, AZ**

QUIKTRIP  
4705 SOUTH 129TH EAST AVENUE  
TULSA, OK 74134

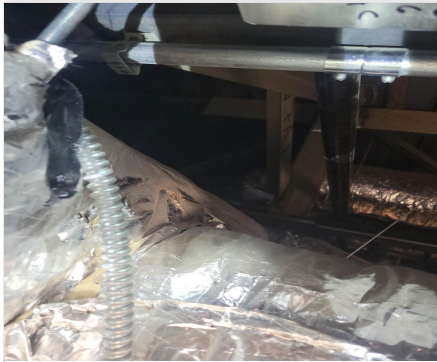
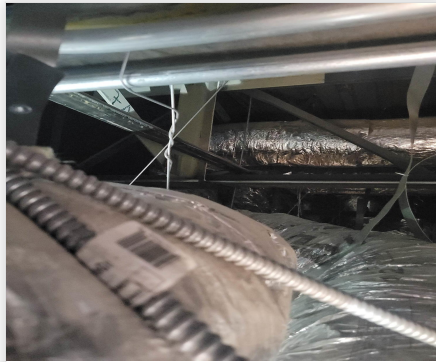
**Issue Name :** DAMPER INACCESSIBLE, SW ENTRANCE TOO WARM  
**Description :** Damper is not where it's supposed to be, and is inaccessible. Air flow is too low at SW front door, area is uncomfortable.  
**Created By :** National TAB                      **Assigned To :** National TAB - Dan Hertenstein  
**Status :** Open  
**Priority :** Medium                                      **Asset Tag :** SGRD1  
**Originated Date :** 11/14/2025 - Christine Weale - National TAB

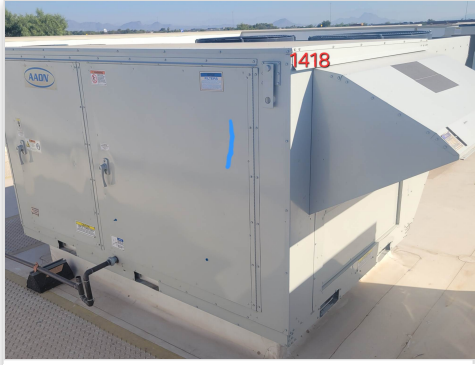
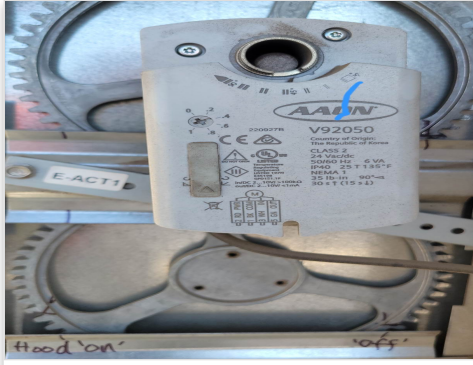
Asset: RT-1

Unit Data	
	Actual
MFG	AAON
Serial Num	202302-ANEK25454
Model Num	RN-013-8-0-EA0A-152
Num OA Filters 1	1
OA Filter Size 1	45X22
Num Final Filter 1	2
Final Filter Size 1	46X19.5X2

Test Data		
	Design	Actual
SF CFM	4200	4193
SF RPM	-	49.5 HZ
OA CFM (Hoods On)	800	866
OA CFM (Hoods Off)	350	358
RL Voltage	-	179.0
RL Amperage	-	8.22
VFD Max SetPt	-	82.5
VFD Min SetPt	-	24
OA Damper Position (Hoods On)	-	46.0
OA Damper Position (Hoods Off)	-	0.0

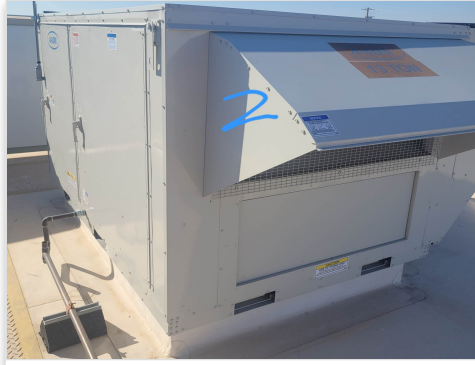
Asset: RT-2

Unit Data	
	Actual
MFG	AAON
Serial Num	202302-ANEK25455
Model Num	RN-013-8-0-EA0A-152
Num OA Filters 1	1
OA Filter Size 1	45X22
Num Final Filter 1	2
Final Filter Size 1	46X19.5X2

Test Data		
	Design	Actual
SF CFM	4200	4032
SF RPM	-	49.5 HZ
OA CFM (Hoods On)	800	873
OA CFM (Hoods Off)	350	355
RL Voltage	-	179.7
RL Amperage	-	8.45
VFD Max SetPt	-	82.5
VFD Min SetPt	-	24.0
OA Damper Position (Hoods On)	-	46.0
OA Damper Position (Hoods Off)	-	0.0

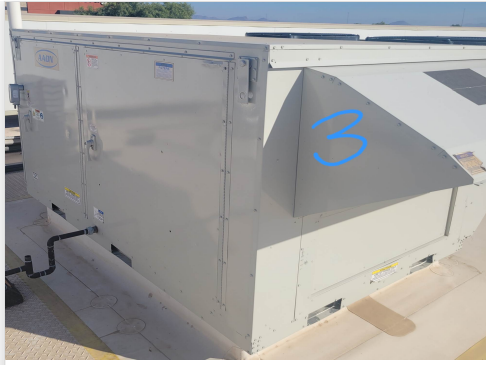
Asset: RT-3

Unit Data	
	Actual
MFG	AAON
Serial Num	202302-ANEK25456
Model Num	RN-013-8-0-EA0A-152
Num OA Filters 1	1
OA Filter Size 1	45X22
Num Final Filter 1	2
Final Filter Size 1	46X19.5X2

Test Data		
	Design	Actual
SF CFM	4200	4205
SF RPM	-	47.04 HZ
OA CFM (Hoods On)	800	853
OA CFM (Hoods Off)	350	348
RL Voltage	-	164.0
RL Amperage	-	8.1
VFD Max SetPt	-	78.4
VFD Min SetPt	-	24.0
OA Damper Position (Hoods On)	-	46.0
OA Damper Position (Hoods Off)	-	0.0

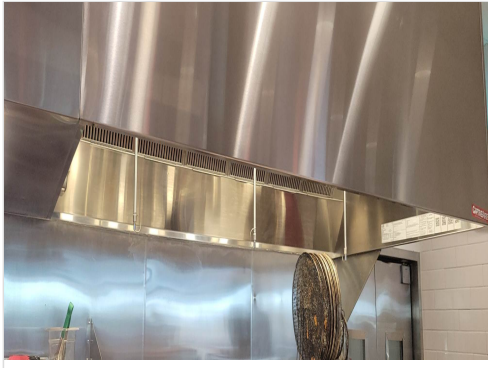
Asset: HD1

Unit Data		
	Design	Actual
MFG	CAPTIVEAIRE	CAPTIVEAIRE
Model Num	6030ND-2-F	6030ND-2-F
Job / Serial Num	-	7662831
Type	-	TYPE I CANOPY
Hood length	-	108"
Hood Width	-	60"

Test Data Exhaust		
	Design	Actual
Filter Type	-	CAPTRATE SOLO
Filter Size 1	-	16X20
Filter Qty 1	-	6
Filter AK factor size 1	-	2.08
Filter Total AK Area	-	12.48
Filter1 FPM	-	123
Filter2 FPM	-	123
Filter3 FPM	-	112
Filter4 FPM	-	104
Filter5 FPM	-	108
Filter6 FPM	-	108
Filter Ave FPM(corr)	-	113
CFM	1350	1410
