**Report: CULVERS - DECATUR, AL TAB RPT**  
**Function: Test, Adjust, & Balance**  
**Date: 6/1/2022**

**PROJECT**  
**05-09 CULVERS - DECATUR, AL**

Project: 05-09 CULVERS - DECATUR, AL

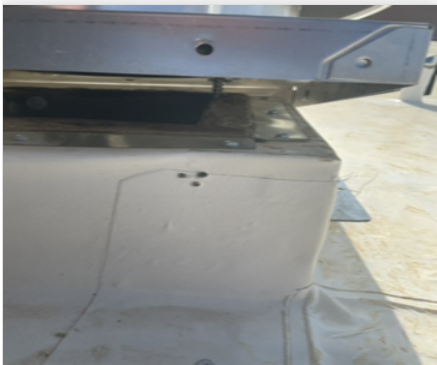
**Issue Name :** PRV1 conduit too short  
**Description :** Conduit is too short to tilt fan back. Can only tilt fan an inch from curb  
**Created By :** National TAB                      **Assigned To :** National TAB - Will Turnbough  
**Status :** Open  
**Originated Date :** 05/09/2022 - Wendy Biggs - National TAB

YES PRV2 PRV3 NO PRV1

CANNOT VISIBLY SEE BACKDRAFT DAMPER DUE TO CONDUIT BEING SHORT ON PRV1. MECHANICAL SAYS IT IS INSTALLED

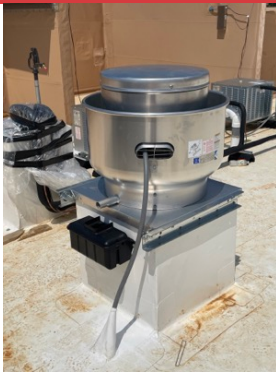
## **PRV2 GRIDDLE**

| <b>Description :</b> | Duct was installed in a way that the fan cannot be tilted back. Informed G.C to have them grind down the side where it's catching, preventing the fan from lifting up | | |

| Lean grease rated fans back. Is grease duct installation adequate and is duct ran all the way to the base of the fan? | YES PRV3. NO PRV2 CANNOT TILT FAN BACK |

NO PRV2 GRINDS WHEN TURNING // MECHANICAL HAS FIXED THIS ISSUE 5/11/22

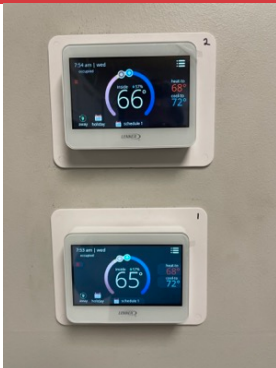
## **THERMOSTATS**

Thermostats are programmed, however temperature sensor seems not to be functioning properly. Have to leave in cooling

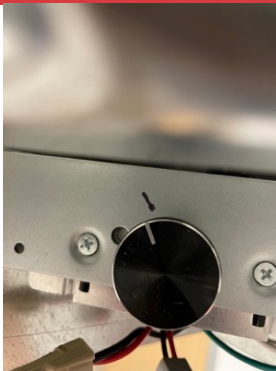
## EF1A RR SETPOINT

Set point for speed controller on the exhaust fan in the employee restroom. Set to max

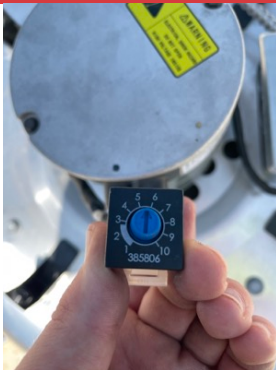
## PRV1 RR SETPOINT

Speed Setpoint for restroom exhaust fan
