Report: TAB REPORT
Function: Test, Adjust, & Balance
Date: 11/15/2022

**11-07 CHIPOTLE # 43-4174 12TH &
WASHINGTON, UT (OGDEN)**

1269 Washington Blvd.

OGDEN, UT 84404

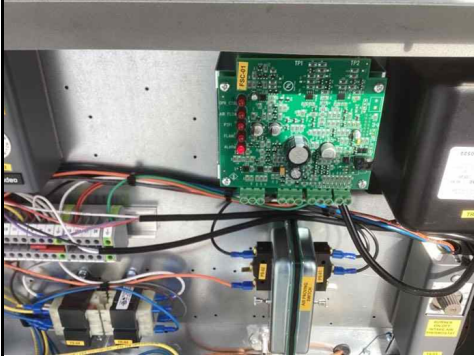
Name:	Heater tested and is functional? - No - MuA-01 sho.jpg				
Captured:	11/10/2022 11:29 AM

Issue ID:	0001	Status:	Open	Issue Priority:	
Equipment:	MAU-01				Created Date: 10-Nov-22
Issue Description:					
Heater tested and is functional? - No - MuA-01 shows alarm after attempts to heat.					
Issue Type:	Installation				
Role Assignment:	Mechanical Contractor				
Comments / Signature:					
Issue Photos:

Verification	Response	Notes	By	Date/Time
1	Gas piping is installed and valves are in on position?	Yes	CN	11/10/22 9:35
2	Heater tested and is functional?	No	CN	11/10/22 11:28
3	Heater Operates?	No	CN	11/10/22 11:28
4	Flame Status?	No	CN	11/10/22 11:28
5	Inlet Air Temp SetPt (Design 55)	55	CN	11/10/22 11:13
6	Discharge Air Temp SetPt (Design 60)	60	CN	11/10/22 11:13
7	Air Flow Switch Sp Actual	.44	CN	11/10/22 11:19

Log: MAU-01 11/10/2022 Clayton Nelson Heater tested and is functional? - No - MuA-01 shows alarm after attempts to heat.

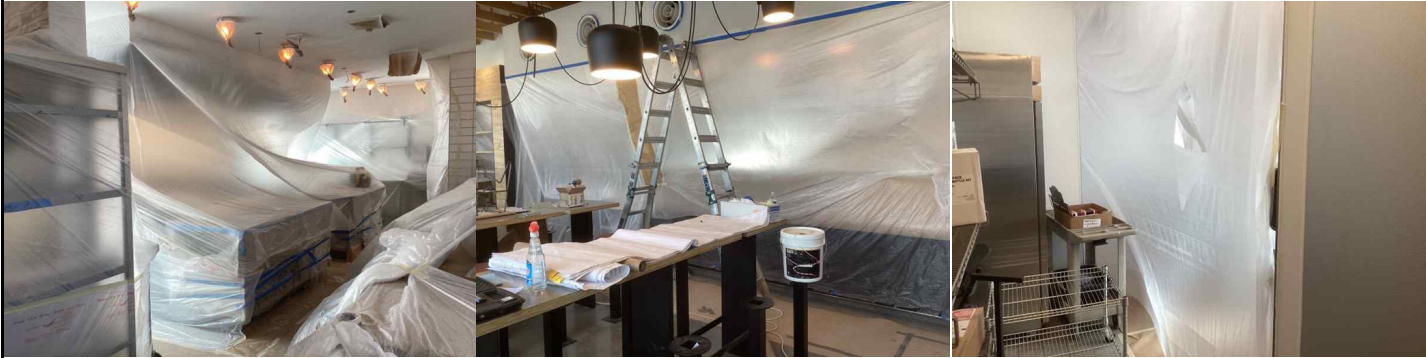
Name:	Building pressure test is likely inaccurate due to.jpg		Name:	Building pressure test is likely inaccurate due to.jpg	
Captured:	11/10/2022 1:52 PM		Captured:	11/10/2022 1:52 PM

DOOR TESTED	BUILDING PRESSURE MEASUREMENTS (IN. H2O)
FRONT	-0.0322
SIDE	-0.0342
REAR	-0.0464
AVERAGE	-0.0376

BUILDING PRESSURE TEST IS LIKELY INACCURATE DUE TO COVERINGS PUT UP BY PAINTERS AND IS EXACERBATED BY ISSUE WITH RTU-01 OA DAMPER. COVERINGS ALSO PREVENTED SMOKE TEST ON KITCHEN HOOD.

Issue ID:	0003	Status:	Open	Issue Priority:	
Equipment:	Air Balance Summary			Created Date: 10-Nov-22	
Issue Description:					
Building pressure test is likely inaccurate due to coverings put up by painters and is exacerbated by issue with RTU-01 OA damper. Coverings also prevented smoke test on kitchen hood.					
Issue Type:	Installation				
Role Assignment:	Mechanical Contractor				
Comments / Signature:					
Issue Photos:

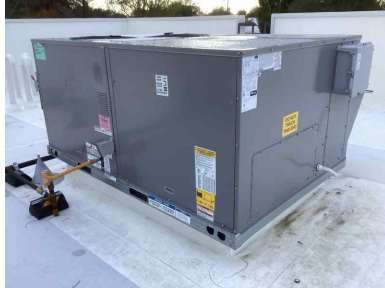
SYSTEM/UNIT: RTU-01

Design Airflow (CFM)		Final Airflow (CFM)	
Design Total	3000	Actual Total CFM	2937
Design Grille Total	3000	Actual Grille Total CFM	2937
Design Return	2500	Actual Return Air CFM	2937
Design Min O/A	500	Actual Min O/A CFM	0
Unit Design Data		Unit Data	
Submittal Make	Trane	Make (tag)	Carrier
Submittal Model #	YHC092	Model # (tag)	48TCDM08A2A5A0A0A0
Submittal Airflow	Not Provided	Serial # (tag)	3222P35512
Sched./Sub. Volts	208	Location	Roof
Sched./Sub. Phase	3	Unit Discharge	Downblast
Sched./Sub. HP	Not Listed	Cooling Coil Location	Unit / Drawthru
Submittal BHP	Not Provided	Coil Area (sq ft)	8.9
Filter MERV Rating (Sched/Sub)	Not Listed	Clg Coil Vel (FPM)	330
Design Static Pressures (in wg)		Fan Design Data	
Design Ext SP	0.8	Submittal Motor RPM	Not Provided
Submittal Total SP	Not Provided	Submittal Fan RPM	-
Submittal Clg Coil Δ SP	-	Fan Data	
Filter Data		Electrical Data	
Condition	Partially Loaded	Measurement Method	V/A Meter

Issue ID:	0002	Status:	Open	Issue Priority:	
Equipment:	RTU-01				Created Date: 10-Nov-22
Issue Description:					
OA Damper Position - Closed - OA damper does not respond to controller settings. Recommend checking wiring, and place damper to 20% open (3.6v).					
Issue Type:	Installation				
Role Assignment:	Mechanical Contractor				
Comments / Signature:

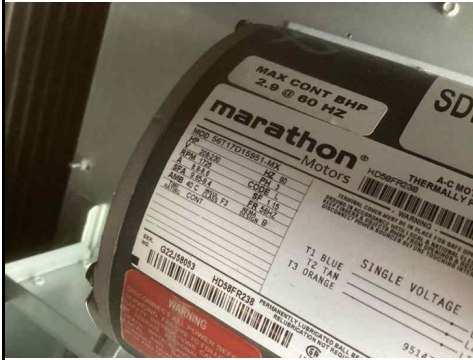
Motor Make Photo:

Filter Type	Disposable	Motor Volts 1	209
MERV Rating	-	Motor Volts 2	211
Filter Size Set 1 (in)	16x20x2		
# Filters Set 1	4		
Filter Size Set 2 (in)	-		
# Filters Set 2	-		
Motor Nameplate Data			
Motor Make	Marathon		
Motor Frame	56HZ		
Motor HP	-		
Motor RPM	1725		
Motor Volts	230		
Motor Phase	3

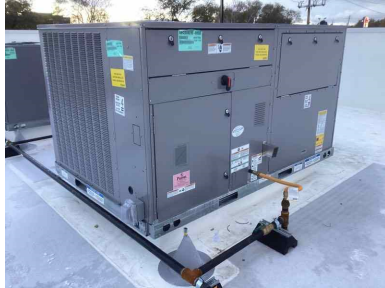
SYSTEM/UNIT: RTU-02

Design Airflow (CFM)		Final Airflow (CFM)	
Design Total	3400	Actual Total CFM	3352
Design Grille Total	3400	Actual Grille Total CFM	3352
Design Return	2400	Actual Return Air CFM	2341
Design Min O/A	1000	Actual Min O/A CFM	1011
		Fan CFM Test Method	Supply Outlet Total
		OA Method/Instrument	Face Velocity/RVA
		OA Ak (sq ft)	3.417
		OA Damper Position	39%/49%
		RA Damper Position	61%
Unit Design Data		Unit Data	
Submittal Make	Trane	Make (tag)	Carrier
Submittal Model #	YHC102	Model # (tag)	48HCED08B2M5A5W3J0
Submittal Airflow	Not Provided	Serial # (tag)	2622P77864
Sched./Sub. Volts	208	Location	Roof
Sched./Sub. Phase	3	Unit Discharge	Downblast
Sched./Sub. HP	Not Listed	Cooling Coil Location	Unit / Drawthru
Submittal BHP	Not Provided	Coil Area (sq ft)	11.1
Filter MERV Rating (Sched/Sub)	Not Listed	Clg Coil Vel (FPM)	302
		Fan Service	Supply
		Fan Type	Centrifugal (FC)
		Fan Discharge	Downblast
		Fan Arrangement	DWDI

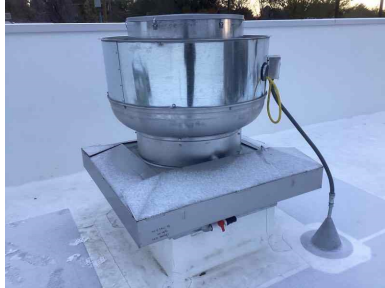
SYSTEM/UNIT: EF-01

Design Airflow (CFM)		Final Airflow (CFM)	
Design Airflow	3200	Actual Airflow	3334
Design Grille Airflow	Not Applicable	Actual Grille Airflow	Not Applicable
		Fan CFM Test Method	See Kitchen Hood Sheet
		Test Method Ak (sq ft)	-
Unit Design Data		Unit Data	
Submittal Make	CAPTIVEAIRE	Make (tag)	Captive Aire
Submittal Model #	DU240HFA	Model # (tag)	DU240HFA
Submittal Airflow	Not Provided	Serial # (tag)	5154109
Sched./Sub. Volts	208	Unit Location	Roof
Sched./Sub. Phase	3	Unit Discharge	Upblast
Sched./Sub. HP	3	Fan Service	Exhaust
Submittal BHP	Not Provided	Fan Type	Centrifugal (BI)
		Fan Discharge	Upblast
		Fan Arrangement	SWSI
Design Static Pressures (in wg)		Fan Design Data	
Design External SP	1.20	Submittal Motor RPM	Not Provided
Submittal Total SP	Not Provided	Submittal Fan RPM	-
Motor Nameplate Data		Fan Data	
Motor Make (tag)	TECO	Actual Fan RPM/Speed	Single Speed
Motor Frame (tag)	213T	Actual Motor RPM	Not Accessible

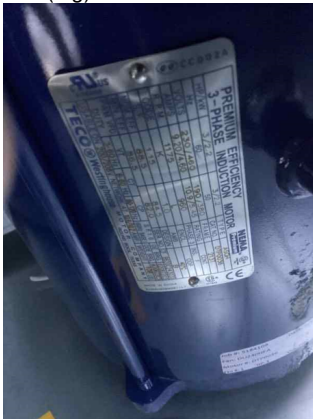
Motor Make (tag) Photo:

Motor HP (tag)	3	Speed Cont. Position	Not Applicable
Motor RPM (tag)	1175		
Motor Volts (tag)	230	Electrical Data	
Motor Phase (tag)	3	Measurement Method	VFD Display
Motor Amps (tag)	9.2	Motor Volts 1	126
Motor S.F. (tag)	1.15	Motor Volts 2	-
Mtr % PF (tag)	-	Motor Volts 3	-
Mtr % Eff. (tag)	88.5	Motor Amps 1	6.3
Other Motor Data	-	Motor Amps 2	-
		Motor Amps 3	-
		Operating HZ	44.8
		Starter Data	Internal to VFD
		Approx. BHP	1.13
Drive Data			
Drive Type	Direct Drive		
Sheave Type	-		
Fan Sheave Make	-		
Fan Shv Mod# or Size (in)	-		
Fan Sheave Bore (in.)	-		
Motor Sheave Make	-

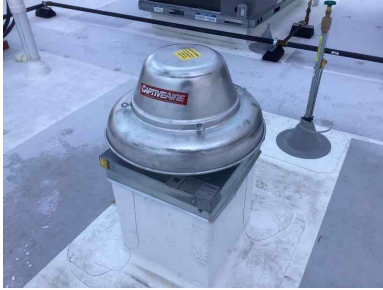
SYSTEM/UNIT: EF-02

Design Airflow (CFM)		Final Airflow (CFM)	
Design Airflow	150	Actual Airflow	157
Design Grille Airflow	150	Actual Grille Airflow	157
		Fan CFM Test Method	Inlet Total
		Test Method Ak (sq ft)	Not Applicable
Unit Design Data		Unit Data	
Submittal Make	CAPTIVEAIRE	Make (tag)	Captive Aire
Submittal Model #	DR12HFA	Model # (tag)	DR12HFA
Submittal Airflow	Not Provided	Serial # (tag)	5184109
Sched./Sub. Volts	120	Unit Location	Roof
Sched./Sub. Phase	1	Unit Discharge	Upblast
Sched./Sub. HP	0.18	Fan Service	Exhaust
Submittal BHP	Not Provided	Fan Type	Centrifugal (BI)
		Fan Discharge	Upblast
		Fan Arrangement	SWSI
Design Static Pressures (in wg)		Fan Design Data	
Design External SP	0.60	Submittal Motor RPM	Not Provided
Submittal Total SP	Not Provided	Submittal Fan RPM	-
Motor Nameplate Data		Fan Data	
Motor Make (tag)	Nema	Actual Fan RPM/Speed	Single Speed
Motor Frame (tag)	-	Actual Motor RPM	906
Motor HP (tag)	1/4	Speed Cont. Position	50%

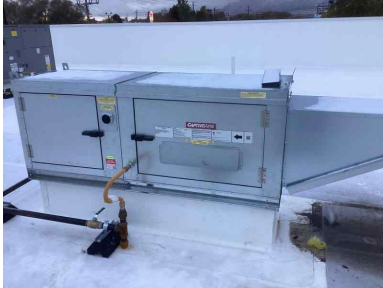
SYSTEM/UNIT: MAU-01

Design Airflow (CFM)		Final Airflow (CFM)	
Design Airflow	1950	Actual Airflow	2020
Design Grille Airflow	Not Applicable	Actual Grille Airflow	Not Applicable
		Fan CFM Test Method	See Kitchen Hood Sheet
		Test Method Ak (sq ft)	-
Unit Design Data		Unit Data	
Submittal Make	CAPTIVEAIRE	Make (tag)	Captive Aire
Submittal Model #	A1-D.250-G10	Model # (tag)	A1.0.250-15D
Submittal Airflow	Not Provided	Serial # (tag)	5184109
Sched./Sub. Volts	208	Unit Location	Roof
Sched./Sub. Phase	3	Unit Discharge	Downblast
Sched./Sub. HP	2	Fan Service	Make-Up Air
Submittal BHP	Not Provided	Fan Type	Centrifugal (FC)
		Fan Discharge	Downblast
		Fan Arrangement	DWDI
Design Static Pressures (in wg)		Fan Design Data	
Design External SP	0.80	Submittal Motor RPM	Not Provided
Submittal Total SP	Not Provided	Submittal Fan RPM	-
Motor Nameplate Data		Fan Data	
Motor Make (tag)	TECO	Actual Fan RPM/Speed	Single Speed
Motor Frame (tag)	145T	Actual Motor RPM	Not Accessible
