Report By:

National TAB
1329 E. KEMPER ROAD
SUITE 4210
CINCINNATI, OH 45246

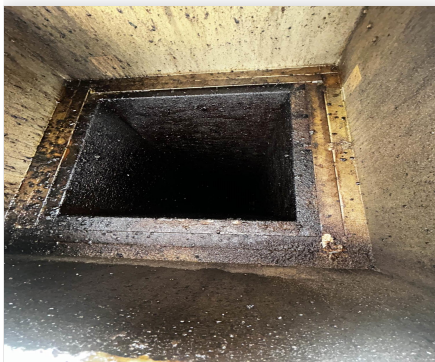
Project Issue File Details

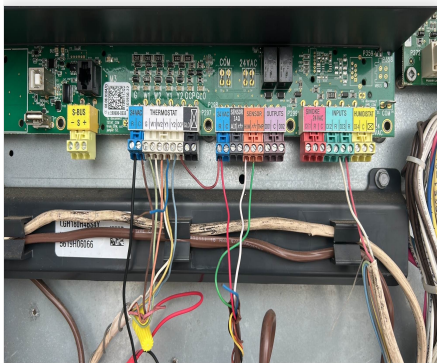
Project Issue File Details
