Report: TAB Addendum
Function: Test, Adjust, & Balance
Date: 03/10/2026
Completed By: National TAB

PROJECT
03-02-26 CULVERS - MESA, AZ

Project: 03-02-26 CULVERS - MESA, AZ

Issue List

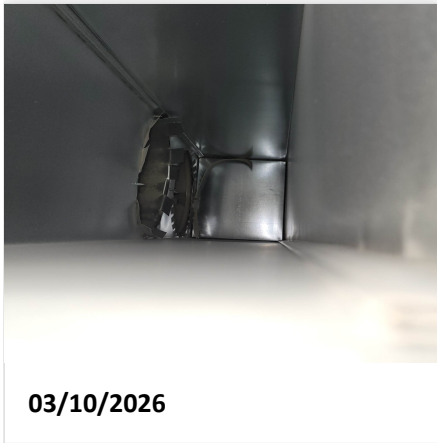
Issue Name : NO BACKDRAFT DAMPER
Description : TEF1, the RR exhaust, doesn't have a backdraft damper or birdscreen.
Created By : National TAB **Assigned To :** National TAB - Brianna Biggs
Status : Open
Priority : Low **Asset Tag :** PRV-1
Originated Date : 03/07/2026 - Christine Weale - National TAB
