Report: TAB Addendum
Function: Test, Adjust, & Balance
Date: 03/10/2026
Completed By: National TAB

PROJECT
03-02-26 CULVERS - MESA, AZ

Project: 03-02-26 CULVERS - MESA, AZ

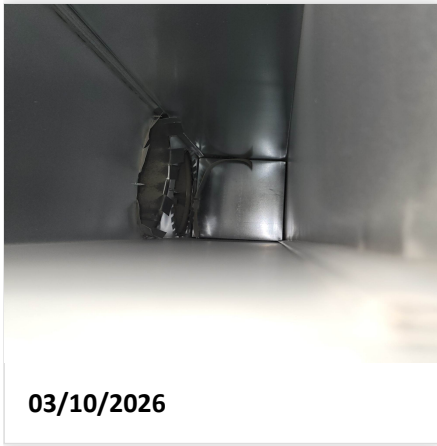
Issue Name : NO BACKDRAFT DAMPER
Description : TEF1, the RR exhaust, doesn't have a backdraft damper or birdscreen.
Created By : National TAB **Assigned To :** National TAB - Brianna Biggs
Status : Open
Priority : Low **Asset Tag :** PRV-1
Originated Date : 03/07/2026 - Christine Weale - National TAB

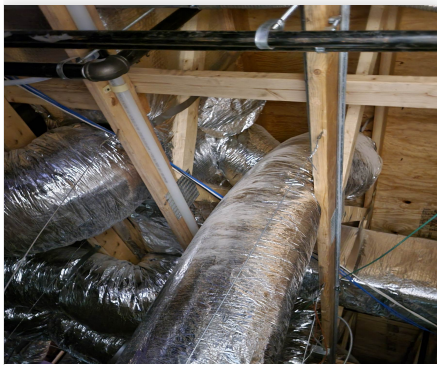
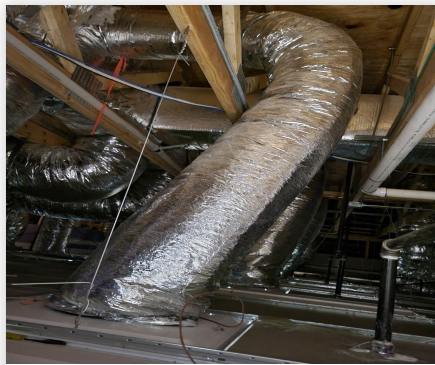
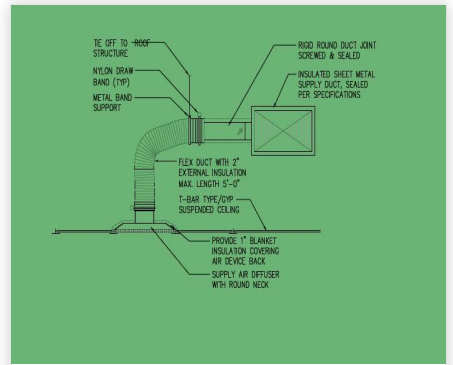
Issue Name : RIGID DUCT NOT INSTALLED
Description : MSET details cookline duct flex to come from a rigid straight pipe. Duct is flex only on some branches and is not straight. Recommend installing straight pipe from main supply drop and duct coming down straight, not curvy, so no smoke issues arise in kitchen and flow balances properly. UPDATE: FIXED, SHOWN IN 2ND PIC

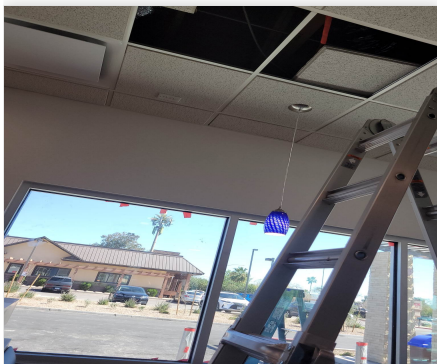
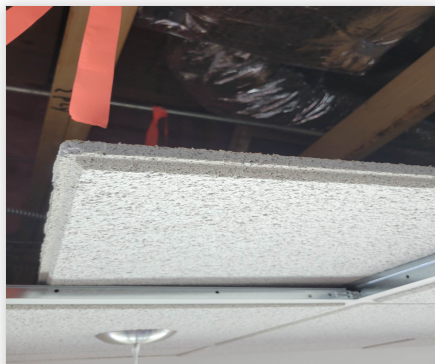
Issue Name : SGRD1-7 INACCESSIBLE DAMPER
Description : Even the mech crew couldn't access the damper w/ the tables installed. Flag placed after TAB was initiated, is placed on the conduit below it.
Created By : National TAB **Assigned To :** National TAB - Brianna Biggs
Status : Open
Priority : High **Asset Tag :** SGRD7
Originated Date : 03/07/2026 - Christine Weale - National TAB

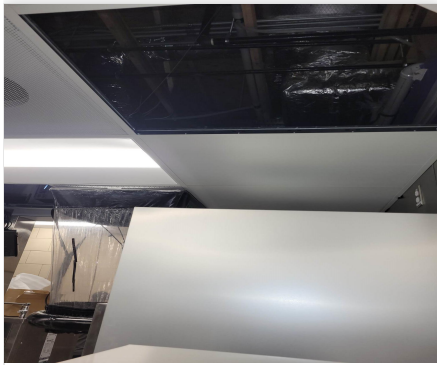
Issue Name : SGRD2-9 INACCESSIBLE DAMPER
Description : Fridges are in the way.
Created By : National TAB **Assigned To :** National TAB - Brianna Biggs
Status : Open
Priority : Low **Asset Tag :** SGRD9
Originated Date : 03/07/2026 - Christine Weale - National TAB
