**Report: Certified TAB Report**  
**Function: Test, Adjust, & Balance**  
**Date: 03/09/2026**  
**Completed By: National TAB**

**PROJECT**  
**03-02-26 CULVERS - MESA, AZ**

1830 E McKellips Road

Mesa, AZ 85203

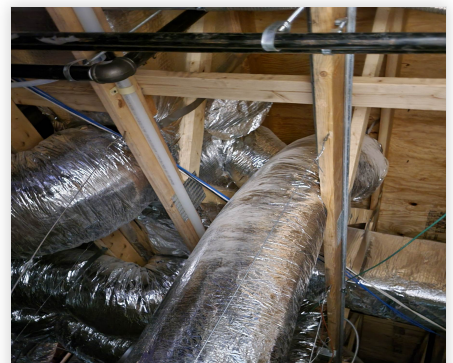
**Issue Name :** RIGID DUCT NOT INSTALLED  
**Description :** MSET details cookline duct flex to come from a rigid straight pipe. Duct is flex only on some branches and is not straight. Recommend installing straight pipe from main supply drop and duct coming down straight, not curvy, so no smoke issues arise in kitchen and flow balances properly.  
**Created By :** National TAB                      **Assigned To :** National TAB - Brianna Biggs  
**Status :** Open  
**Priority :** High                                      **Asset Tag :** RTU-2  
**Originated Date :** 03/05/2026 - Christine Weale - National TAB

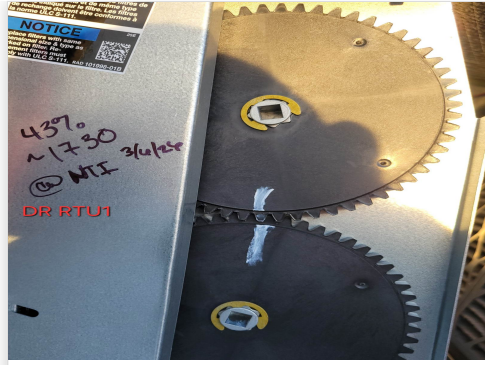
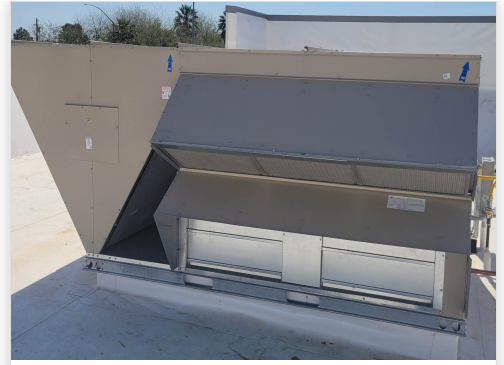
## Unit Data - PHOTO LOG

Unit Data		
	Design	Actual
MFG	LENNOX	LENNOX
Serial Num	-	5625M01622
Model Num	LGT210H5M	LGT210H5MM1Y
Type	RTU	RTU
Configuration	VERTICAL	VERTICAL
Num OA Filters 1	-	3
OA Filter Size 1	-	24.5X15
Num Final Filter 1	-	6
Final Filter Size 1	-	24X24X2

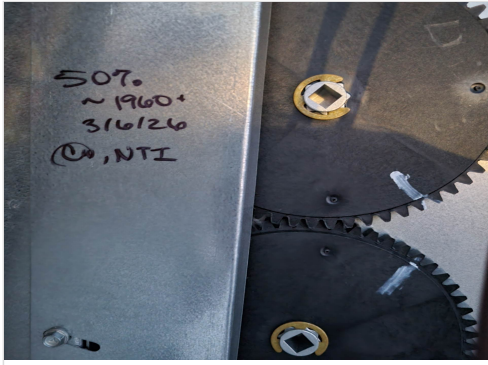
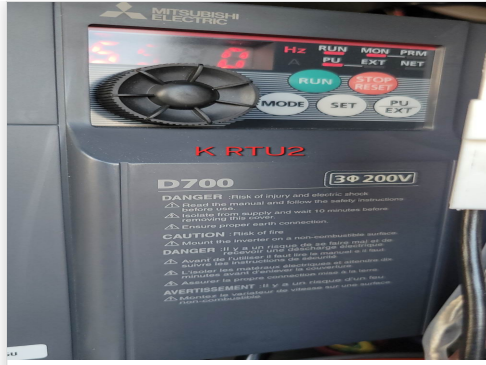
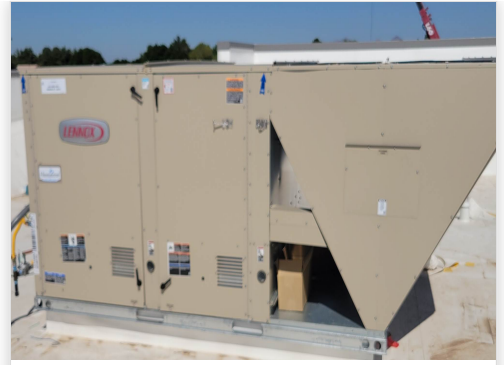
# Unit Data - PHOTO LOG

Unit Data		
	Design	Actual
MFG	LENNOX	LENNOX
Serial Num	-	5625M01652
Model Num	LGT240H5M	LGT240H5MM1Y
Type	RTU	RTU
Configuration	VERTICAL	VERTICAL
Num OA Filters 1	-	3
OA Filter Size 1	-	24.5X15
Num Final Filter 1	-	6
Final Filter Size 1	-	24X24X2

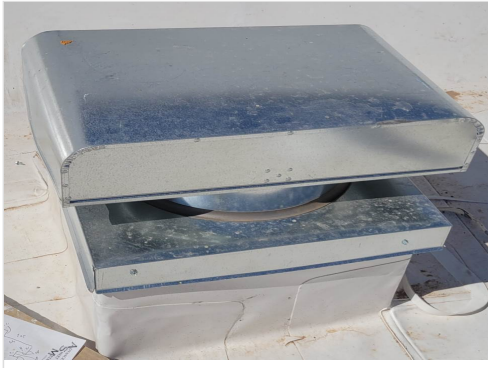
## Unit Data - PHOTO LOG

Unit Data		
	Design	Actual
MFG	ACCUREX	GREENHECK
Model Num	SP-B80	SP-B80
Serial Num	-	28318285
Type	CEILING	CEILING
Configuration	VERTICAL	VERTICAL

Notes:  
SPEED CTRLR NOT FUNCTIONING, SEE 'REMARKS'.

**Issue Name :** MSC ON MEF NOT FUNCTIONAL  
**Description :** Can't balance MEF due to motor speed ctrlr not affecting fan speed. Not anticipated to cause an issue, but GC has ordered a new one. I let them know they should set it to Medium once installed for best chance of being ~75cfm.  
**Created By :** National TAB                      **Assigned To :** National TAB - Brianna Biggs  
**Status :** Pending  
**Priority :** [Medium](#)                                      **Asset Tag :** MEF-1  
**Originated Date :** 03/06/2026 - Christine Weale - National TAB

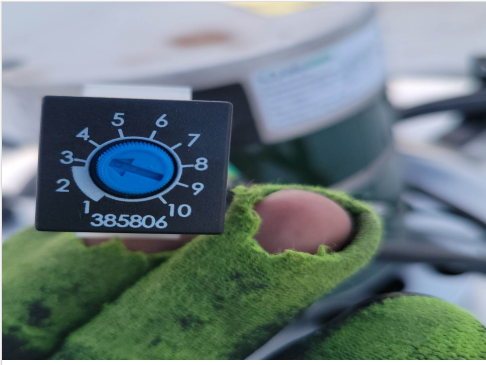
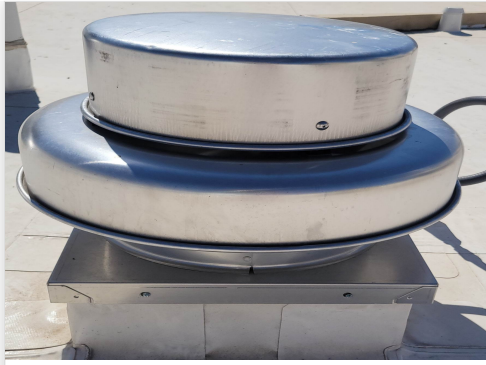
**Unit Data - PHOTO LOG**

Unit Data		
	Design	Actual
MFG	ACCUREX	ACCUREX
Model Num	XRED-090-VG	XRED-095-VG
Serial Num	-	28337871
Type	DOWNBLAST	DOWNBLAST
Configuration	VERTICAL	VERTICAL

**Issue Name :** NO BACKDRAFT DAMPER  
**Description :** TEF1, the RR exhaust, doesn't have a backdraft damper or birdscreen.  
**Created By :** National TAB                      **Assigned To :** National TAB - Brianna Biggs  
**Status :** Open  
**Priority :** InfoOnly                                      **Asset Tag :** PRV-1  
**Originated Date :** 03/07/2026 - Christine Weale - National TAB

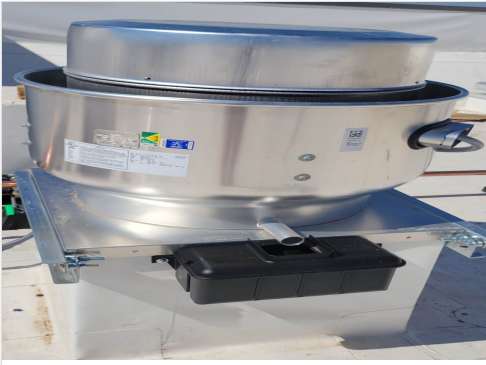
## Unit Data - PHOTO LOG

Unit Data		
	Design	Actual
<b>MFG</b>	ACCUREX	ACCUREX
<b>Model Num</b>	XCUE-140-10-VG	XCUE-140-10-VG
<b>Serial Num</b>	-	28335800
<b>Type</b>	UPBLAST	UPBLAST
<b>Configuration</b>	VERTICAL	VERTICAL

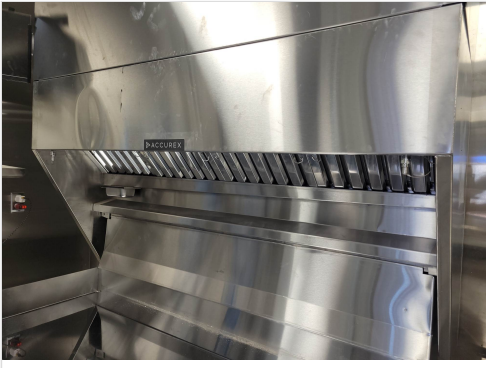
## Unit Data - PHOTO LOG

Unit Data		
	Design	Actual
MFG	ACCUREX	ACCUREX
Model Num	XXEP-64-S	XXEP-64.00-S
Job / Serial Num	-	28338229
Type	LOW PROX	LOW PROX
Hood length	64"	64"
Hood Width	23"	26"

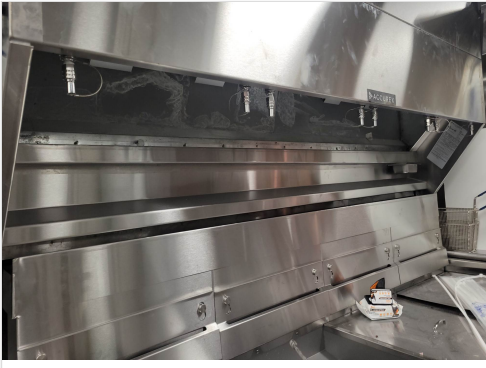
## Unit Data - PHOTO LOG

Unit Data		
	Design	Actual
MFG	ACCUREX	ACCUREX
Model Num	XCUE-140-VG	XXEP-83.00-S
Job / Serial Num	-	28338227
Type	LOW PROX	LOW PROX
Hood length	83"	83"
Hood Width	23"	26"
