**Report: Inspection TAB Report**  
**Function: Test, Adjust, & Balance**  
**Date: 03/07/2026**  
**Completed By: National TAB**

**PROJECT**  
**03-02-26 CULVERS - MESA, AZ**

Project: 03-02-26 CULVERS - MESA, AZ

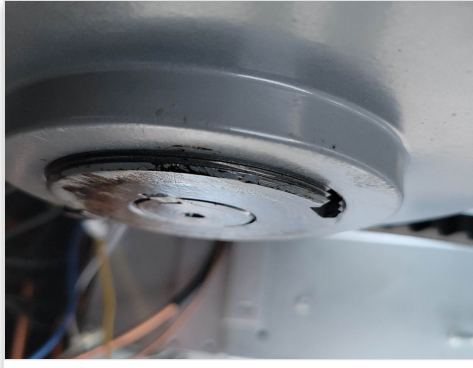
**Drive Data - PHOTO LOG**

Drive Data	
	Actual
Motor Sheave Size	6.25"
Motor Bore Size	1"
Motor Sheave SetPt	FLUSH
Fan Sheave Size	10.5"
Fan Sheave Bore	1.125"
Belt CL Distance	20.75"
Num of Belts	1
Belt Size	BX65
Belt Alignment	NA (FIXED FAN SHEAVE)

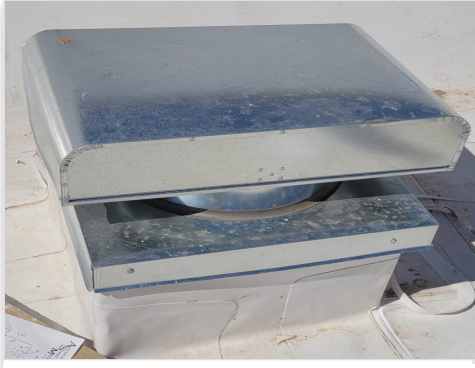
## Unit Data - PHOTO LOG

Unit Data		
	Design	Actual
MFG	ACCUREX	GREENHECK
Model Num	SP-B80	SP-B80
Serial Num	-	28318285
Type	CEILING	CEILING
Configuration	VERTICAL	VERTICAL

Notes:  
SPEED CTRLR NOT FUNCTIONING, SEE 'REMARKS'.

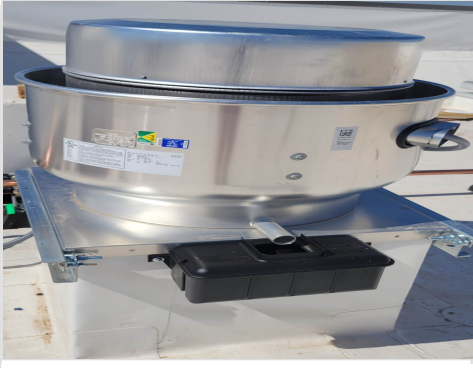
**Unit Data - PHOTO LOG**

Unit Data		
	Design	Actual
<b>MFG</b>	ACCUREX	ACCUREX
<b>Model Num</b>	XCUE-140-10-VG	XCUE-140-10-VG
<b>Serial Num</b>	-	28335800
<b>Type</b>	UPBLAST	UPBLAST
<b>Configuration</b>	VERTICAL	VERTICAL

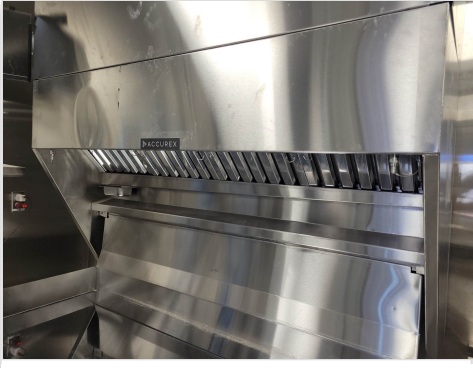
**Unit Data - PHOTO LOG**

Design	Actual
MFG	ACCUREX	ACCUREX
Model Num	XXEP-64-S	XXEP-64.00-S
Job / Serial Num	-	28338229
Type	LOW PROX	LOW PROX
Hood length	64"	64"
Hood Width	23"	26"

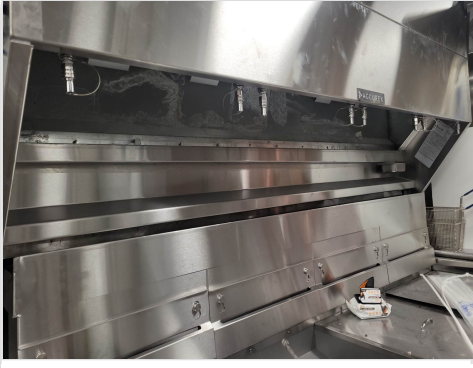
**Unit Data - PHOTO LOG**

Unit Data		
	Design	Actual
MFG	ACCUREX	ACCUREX
Model Num	XCUE-140-VG	XXEP-83.00-S
Job / Serial Num	-	28338227
Type	LOW PROX	LOW PROX
Hood length	83"	83"
Hood Width	23"	26"
