Report: TAB REPORT
Function: Test, Adjust, & Balance
Date: 12/19/2023

**12-25-23 CARMAX #7653 - KEARNEY MESA,
CA**

Project: 12-25-23 CARMAX #7653 - KEARNEY MESA, CA

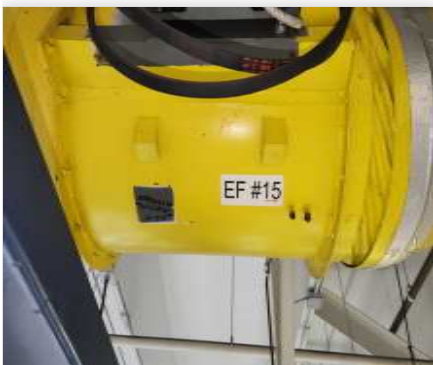
EF15_KEARNEY
12/19/2023

Issue Name : EF-15 airflow is below design
Description : EF-15 is operating at 2908 CFM out of 3600 CFM design and at maximum adjustment on the motor sheave. Before changing pulleys, recommended consulting the engineer of record to determine if this current airflow is acceptable. The measured ESP is currently 2.59" and increasing airflow to design would result in an ESP of 4" which could cause an issue.

- **12/19/2023 National TAB - Will Turnbough**
 - If pulley change is required, recommend a 2VP62 x 1-1/8" pulley set to 1 turn open. Will achieve an airflow of 3663 CFM via a fan law calculation. Requires (2) A51 size belts.
