Report: TAB Report
Function: Test, Adjust, & Balance
Date: 02/25/2025
Completed By: National TAB

PROJECT
03-17-25 CHIPOTLE #4476 ATHENS, OH

Project: 03-17-25 CHIPOTLE #4476 ATHENS, OH

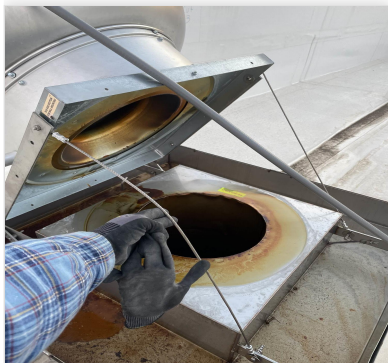
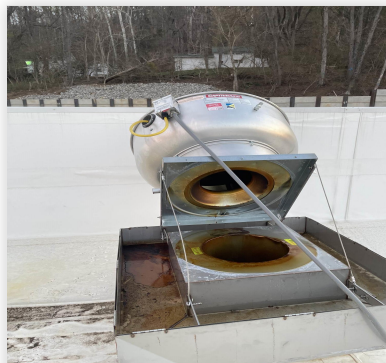
Issue Name : EF-1 fan lean support cable too long.
Description : EF-1 fan lean support cable is too long putting all weight on only one cable.
Created By : National TAB **Assigned To :** National TAB - Will Turnbough
Status : Open
Priority : Medium **Asset Tag :** EF1
Originated Date : 12/04/2024 - Cody Collett - National TAB

- **03/19/2025 National TAB - Jordan Best**
 - Return visit 03/19/25, issue still exists.

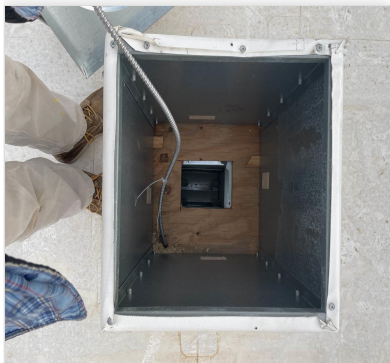
Issue Name : EF-2: Restroom Exhaust Missing Backdraft Damper
Description : Plans call for Backdraft damper to be installed in the restroom duct. Damper is not installed.
Created By : National TAB **Assigned To :** National TAB - Brianna Biggs
Status : Open
Priority : Medium **Asset Tag :**
Originated Date : 02/25/2025 - Michael McDonnell - National TAB

- **03/19/2025 National TAB - Jordan Best**
 - Return trip 03/19/25, issue still exists.

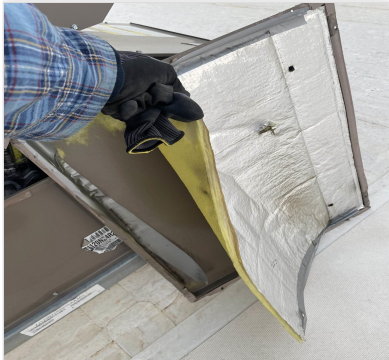
Issue Name : RTU-2 unit insulation causing obstruction.
Description : RTU-2 interior unit insulation on mixed air compartment door was detached from access door on arrival and was covering 1/4 of the filter bank area. Insulation was taped back on to access door by TAB tech as a temporary fix.
Created By : National TAB **Assigned To :** National TAB - Will Turnbough
Status : Open
Priority : Low **Asset Tag :** RTU2
Originated Date : 12/04/2024 - Cody Collett - National TAB

- **03/19/2025 National TAB - Jordan Best**
 - Return trip 03/19/25, issue still exists.

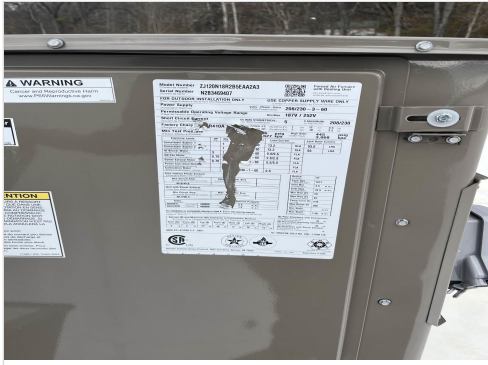
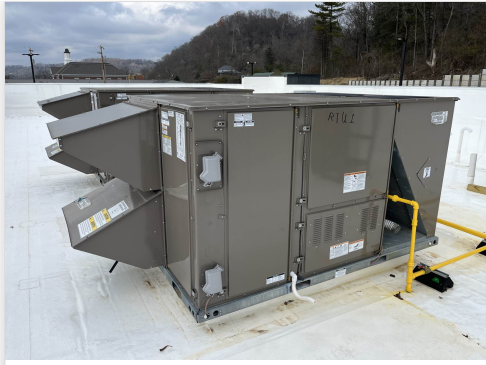
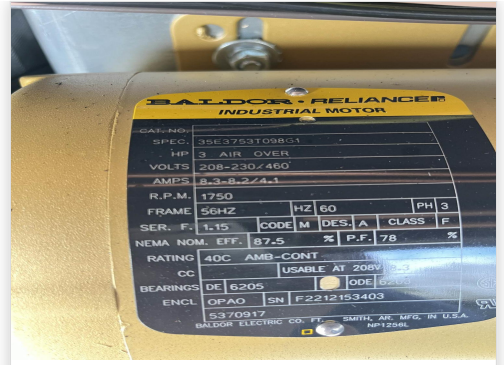
Unit Data - PHOTO LOG

Asset: RTU1

Unit Data		
	Design	Actual
MFG	YORK	YORK
Serial Num	-	N2B3469407
Model Num	ZJ120	ZJ120N18R2B
Type	RTU	RTU
Configuration	VERTICAL	VERTICAL
Num OA Filters 1	-	1
OA Filter Size 1	-	20.5X29"
Num Final Filter 1	-	4
Final Filter Size 1	-	20X24X2

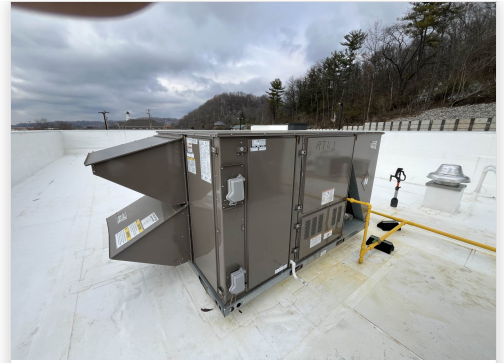
Unit Data - PHOTO LOG

Asset: RTU2

Unit Data		
	Design	Actual
MFG	YORK	YORK
Serial Num	-	N2F3701608
Model Num	ZJ120	ZJ120N244R2B
Type	RTU	RTU
Configuration	VERTICAL	VERTICAL
Num OA Filters 1	-	1
OA Filter Size 1	-	29"X20.5"
Num Final Filter 1	-	4
Final Filter Size 1	-	20X24X2

[2] INCORRECT DAMPERS INSTALLED OR GRILLES MISSING DAMPERS. TOTAL SUPPLY AIRFLOW WITHIN DESIGN, INDIVIDUAL DIFFUSERS NOT BALANCED. AREA SERVED IS LARGE OPEN AREA, NOT ANTICIPATED TO CAUSE ISSUE.

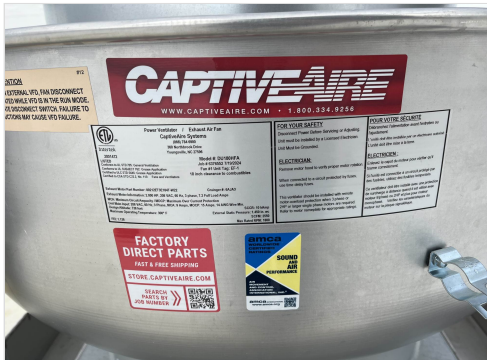
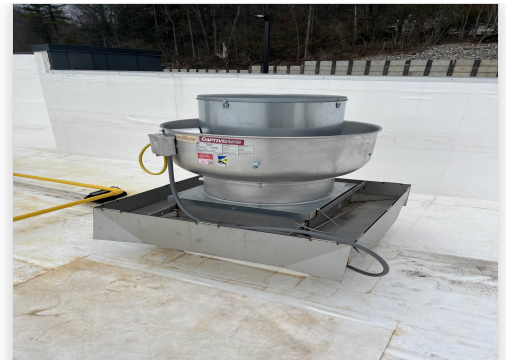
Unit Data - PHOTO LOG

Asset: EF1

Unit Data		
	Design	Actual
MFG	CAPTIVEAIRE	CAPTIVEAIRE
Model Num	DU180HFA	DU180HFA
Serial Num	-	6376552
Type	UPBLAST	UPBLAST
Configuration	VERTICAL	VERTICAL

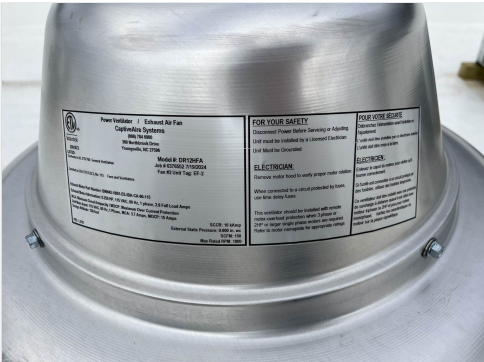
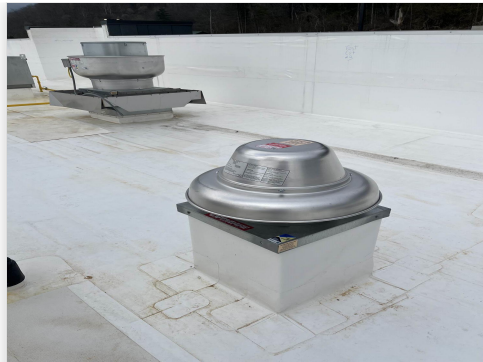
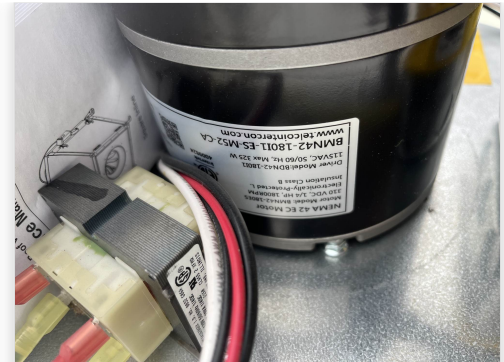
Unit Data - PHOTO LOG

Asset: EF2

Unit Data		
	Design	Actual
MFG	CAPTIVEAIRE	CAPTIVEAIRE
Model Num	DR12HFA	DR12HFA
Serial Num	-	6376552
Type	DOWNBLAST	DOWNBLAST
Configuration	VERTICAL	VERTICAL

[1] MISSING BACKDRAFT DAMPER

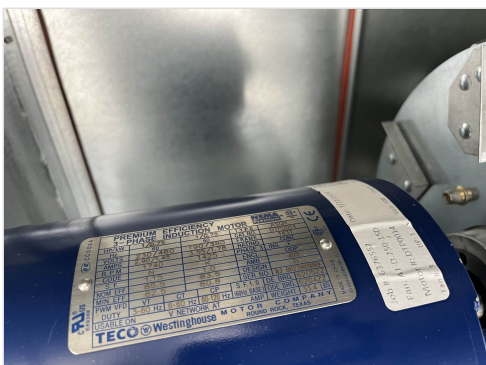
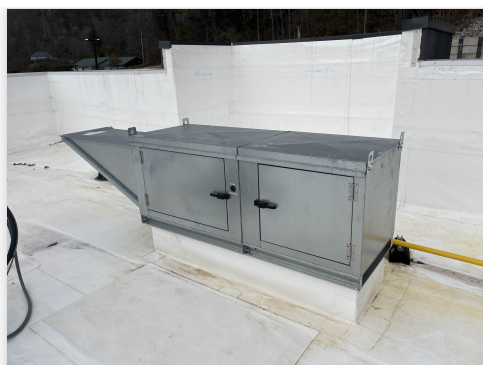
Unit Data - PHOTO LOG

Asset: MUA1

Unit Data		
	Design	Actual
MFG	CAPTIVEAIRE	CAPTIVEAIRE
Model Num	A1-D.250-15D	A1-D.250-15D
Serial Num	-	6376552
Type	MUA	MUA
Configuration	VERTICAL	VERTICAL

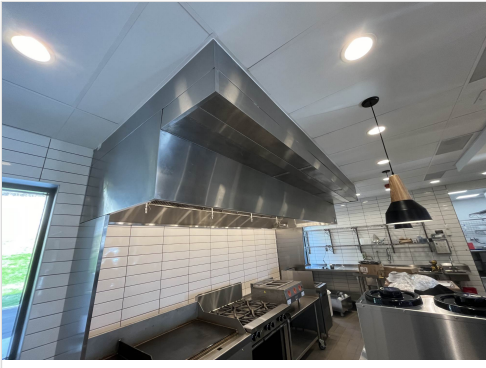
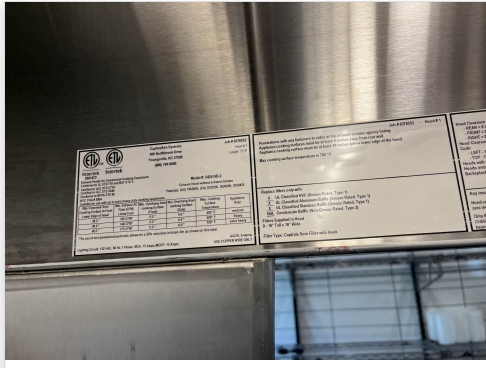
Unit Data - PHOTO LOG

Asset: HD1

Unit Data		
	Design	Actual
MFG	CAPTIVEAIRE	CAPTIVEAIRE
Model Num	5424 ND-2-ACPSP-F	5424 ND-2-ACPSP-F
Job / Serial Num	-	6376552
Type	TYPE I CANOPY	TYPE I CANOPY
Hood length	153"	153"
Hood Width	54"	54"
Supply Plenum Type	-	ACPSP
Supply Plenum Width	9"	9"
Supply Plenum Length	165"	165"
