Report: TAB REPORT  
Function: Test, Adjust, & Balance  
Date: 12/21/2022

**12-12 CHIPOTLE #36-4373 GARDEN VALLEY  
BLVD. & STEWART PARKWAY, OR  
(ROSEBURG)**

2060 NW STEWART PARKWAY

ROSEBURG, OR 97471

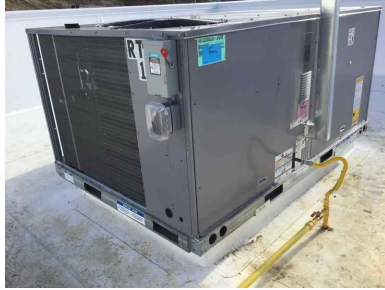
SYSTEM/UNIT: RTU-01

Design Airflow (CFM)		Final Airflow (CFM)	
Design Total	3400	Actual Total CFM	3193
Design Grille Total	3400	Actual Grille Total CFM	3193
Design Return	2900	Actual Return Air CFM	2682
Design Min O/A	500	Actual Min O/A CFM	511
<b>Unit Design Data</b>		<b>Unit Data</b>	
Submittal Make	Trane	Make (tag)	Carrier
Submittal Model #	YHC102F3RHA	Model # (tag)	48TCDD08A2
Submittal Airflow	Not Provided	Serial # (tag)	3422P36615
Sched./Sub. Volts	208	Location	Roof
Sched./Sub. Phase	3	Unit Discharge	Downblast
Sched./Sub. HP	Not Listed	Cooling Coil Location	Unit / Drawthru
Submittal BHP	Not Provided	Coil Area (sq ft)	Not Accessible
Filter MERV Rating (Sched/Sub)	Not Listed	Clg Coil Vel (FPM)	
<b>Design Static Pressures (in wg)</b>		<b>Fan Design Data</b>	
Design Ext SP	0.8	Submittal Motor RPM	Not Provided
Submittal Total SP	Not Provided	Submittal Fan RPM	-
Submittal Clg Coil Δ SP	-	<b>Fan Data</b>	
<b>Filter Data</b>		<b>Electrical Data</b>

Log: RTU-01 Final filters not installed

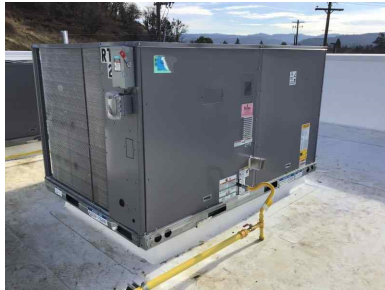
SYSTEM/UNIT: RTU-02

Design Airflow (CFM)		Final Airflow (CFM)	
Design Total	4000	Actual Total CFM	3807
Design Grille Total	4000	Actual Grille Total CFM	3807
Design Return	3000	Actual Return Air CFM	2790
Design Min O/A	1000	Actual Min O/A CFM	1017
		Fan CFM Test Method	Supply Outlet Total
		OA Method/Instrument	Face Vel/ADM-Velgrid
		OA Ak (sq ft)	3.880
		OA Damper Position	High Speed 3.05 / Low Speed 4.15
		RA Damper Position	Not Applicable
Unit Design Data		Unit Data	
Submittal Make	Trane	Make (tag)	Carrier
Submittal Model #	YHC120F3RHA	Model # (tag)	48TCDD12A2
Submittal Airflow	Not Provided	Serial # (tag)	3622P37841
Sched./Sub. Volts	208	Location	Roof
Sched./Sub. Phase	3	Unit Discharge	Downblast
Sched./Sub. HP	Not Listed	Cooling Coil Location	Unit / Drawthru
Submittal BHP	Not Provided	Coil Area (sq ft)	Not Accessible
Filter MERV Rating (Sched/Sub)	Not Listed	Clg Coil Vel (FPM)	
		Fan Service	Supply
		Fan Type	Centrifugal (BI)

Log: RTU-02 Final filters not installed

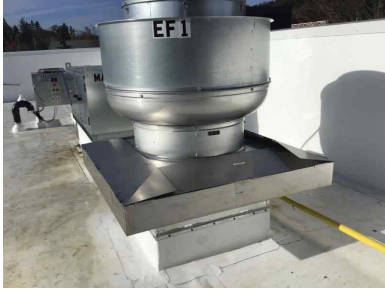
SYSTEM/UNIT: EF-01

Design Airflow (CFM)		Final Airflow (CFM)	
Design Airflow	3200	Actual Airflow	3237
Design Grille Airflow	Not Applicable	Actual Grille Airflow	See Kitchen Hood Sheet
Fan CFM Test Method		See Kitchen Hood Sheet	
Test Method Ak (sq ft)		See Kitchen Hood Sheet	
Unit Design Data		Unit Data	
Submittal Make	CAPTIVEAIRE	Make (tag)	Captive Aire
Submittal Model #	DU24OHFA	Model # (tag)	DU240HFA
Submittal Airflow	Not Provided	Serial # (tag)	5489655
Sched./Sub. Volts	208	Unit Location	Roof
Sched./Sub. Phase	3	Unit Discharge	Upblast
Sched./Sub. HP	Not Listed	Fan Service	Exhaust
Submittal BHP	Not Provided	Fan Type	Centrifugal (BI)
Design Static Pressures (in wg)		Fan Discharge	
Design External SP	1.2	Upblast	
Submittal Total SP	Not Provided	Fan Arrangement	
Motor Nameplate Data		SWSI	
Motor Make (tag)	TECO	Fan Design Data	
Motor Frame (tag)	213T	Submittal Motor RPM	Not Provided
Motor HP (tag)	3	Submittal Fan RPM	-
Motor RPM (tag)	1175	Fan Data

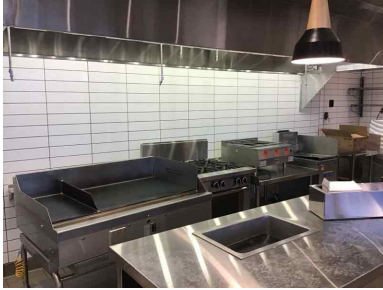
SYSTEM/UNIT: EF-01/HD-01

Design Airflow (CFM)		Final Airflow (CFM)	
Design Exhaust CFM	3200	Actual Exhaust CFM	3237

Test Section		Supplemental Data	
Smoke Generation Type	Smoke emitter	Space Offset Temp Riser 1	15
Cooking Equip Heat On	Gas range	Space Offset Temp Riser 2	15
Hood Capture %	100	Riser Temp F (idle) Riser 1	81.4
End Panels Installed (Y/N)	Y	Riser Temp F (idle) Riser 2	80.8
		Ambient Room Temp	67.3
		100% override functional	Yes

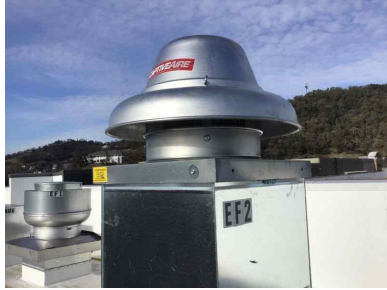
SYSTEM/UNIT: EF-02

Design Airflow (CFM)		Final Airflow (CFM)	
Design Airflow	150	Actual Airflow	222
Design Grille Airflow	150	Actual Grille Airflow	222
		Fan CFM Test Method	Inlet Total
		Test Method Ak (sq ft)	Not Applicable
Unit Design Data		Unit Data	
Submittal Make	CAPTIVEAIRE	Make (tag)	Captive Aire
Submittal Model #	DR12HFA	Model # (tag)	DR12HFA
Submittal Airflow	Not Provided	Serial # (tag)	5489655
Sched./Sub. Volts	115	Unit Location	Roof
Sched./Sub. Phase	1	Unit Discharge	Downblast
Sched./Sub. HP	Not Listed	Fan Service	Exhaust
Submittal BHP	Not Provided	Fan Type	Centrifugal (BI)
		Fan Discharge	Upblast
		Fan Arrangement	SWSI
Design Static Pressures (in wg)		Fan Design Data	
Design External SP	0.6	Submittal Motor RPM	Not Provided
Submittal Total SP	Not Provided	Submittal Fan RPM	-
Motor Nameplate Data		Fan Data	
Motor Make (tag)	Telco	Actual Fan RPM/Speed	Not Accessible
Motor Frame (tag)	Not Listed	Actual Motor RPM	Unable to determine

<b>Log:</b>	EF-02	12/20/2022	Guy Nunez	Speed controller not operating. Unable to set fan to design CFM.
-------------	-------	------------	-----------	--

<b>Issue ID:</b>	<b>0001</b>	<b>Status:</b>	<b>Open</b>	<b>Issue Priority:</b>	<b>High</b>
Equipment:	EF-02				Created Date: 20-Dec-22
<b>Issue Description:</b> Speed controller not operating. Unable to set fan to design CFM.					
Issue Type:	Installation				
Role Assignment:	General Contractor				
User Assignment:	Guy Nunez				
Comments / Signature:

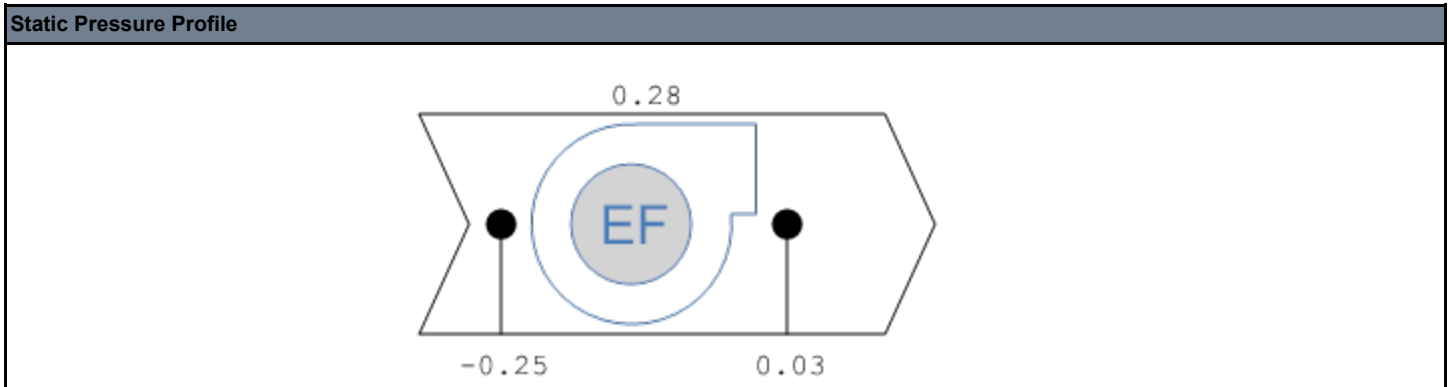
SYSTEM/UNIT: EF-02/Static Profile

System/Unit	Area Served	Type	Size / Area (in)	Design CFM	Prelim CFM	Final CFM	% Final	Instrument	Ak	Open (sq ft)	Final FPM
E-01	Restroom	CD	6/6	75	117	117	156	Capture Hood	1.000	1.000	117
E-02	Restroom	CD	6/6	75	105	105	140	Capture Hood	1.000	1.000	105
	<b>Totals:</b>	-	-	<b>150</b>	<b>222</b>	<b>222</b>	<b>148</b>	-	-	-	-

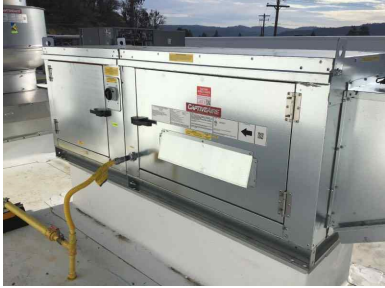
SYSTEM/UNIT: MAU-01

Design Airflow (CFM)		Final Airflow (CFM)	
Design Airflow	1950	Actual Airflow	1938
Design Grille Airflow	Not Applicable	Actual Grille Airflow	See Kitchen Hood Sheet
Fan CFM Test Method		See Kitchen Hood Sheet	
Test Method Ak (sq ft)		See Kitchen Hood Sheet	
Unit Design Data		Unit Data	
Submittal Make	CAPTIVEAIRE	Make (tag)	Captive Aire
Submittal Model #	A1-D.250-15D	Model # (tag)	A1-D.250-15D
Submittal Airflow	Not Provided	Serial # (tag)	5489655
Sched./Sub. Volts	208	Unit Location	Roof
Sched./Sub. Phase	3	Unit Discharge	Downblast
Sched./Sub. HP	Not Listed	Fan Service	Make-Up Air
Submittal BHP	Not Provided	Fan Type	Centrifugal (BI)
Design Static Pressures (in wg)		Fan Design Data	
Design External SP	0.5	Submittal Motor RPM	Not Provided
Submittal Total SP	Not Provided	Submittal Fan RPM	-
Motor Nameplate Data		Fan Data	
Motor Make (tag)	TECO	Actual Fan RPM/Speed	Not Accessible
Motor Frame (tag)	145T	Actual Motor RPM	Not Accessible
