**Report: Hood Certification
Function: Test, Adjust, & Balance
Date: 03/29/2024**

**PROJECT
03-25-24 Smashing Grapes Columbia, MD**

Project: 03-25-24 Smashing Grapes Columbia, MD

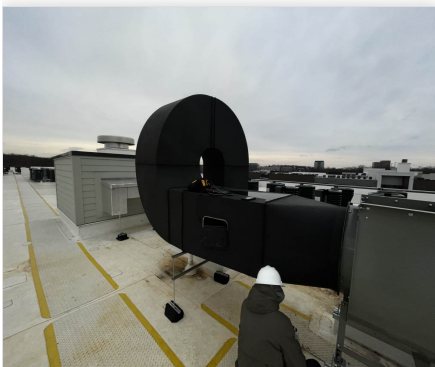
6E11AE31_91CC_449A_BA..
03/29/2024

Issue Name : KEF total airflow is low
Description : KEF (on the roof) total air flow is 35% design. Fan is currently running at FLA with a frequency of 48HZ. Was unable to confirm grease duct routing through out the 7 story building. Suction pressure was taken at the grease access door on the room and was measured at -0.0385" w.c. Recommend having Engineer on file review exhaust fan performance data.

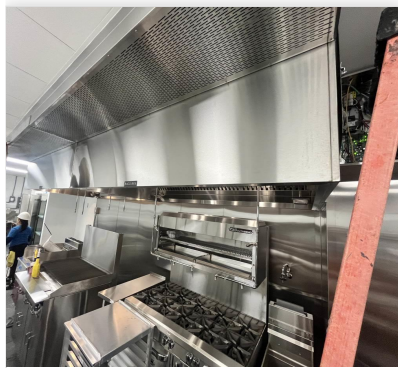
Hood Photos

Hood exhaust airflow is low. Fan is currently running at FLA.

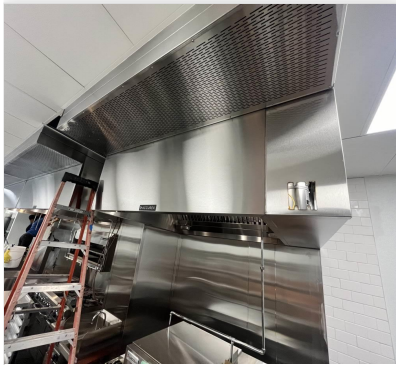
Hood Photos

Yes, it Some bulbs are not in.

No

Hood exhaust is low. Fan is currently running at FLA.
