Report: TAB Report
Function: Test, Adjust, & Balance
Date: 05/12/2025
Completed By: National TAB

03-31-25 WAWA #6300 WAYCROSS, GA

Project: 03-31-25 WAWA #6300 WAYCROSS, GA

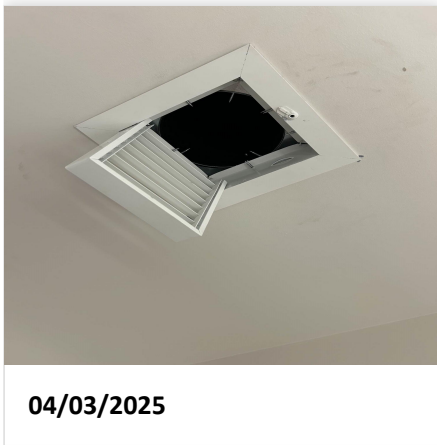
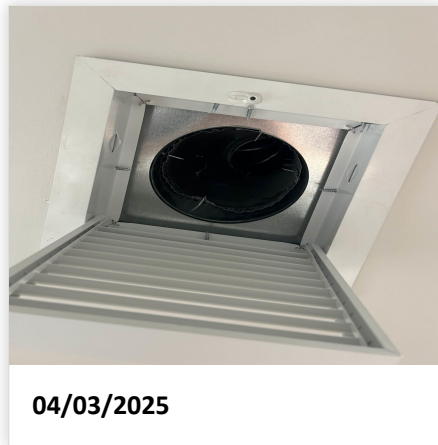
Project Issue File Details

Issue Name : EF-1 - No Dampers
Description : Restroom exhaust grilles do not have dampers installed. Recommend installing face-accessible dampers to allow for balancing.
Created By : National TAB **Assigned To :** National TAB - Will Turnbough
Status : Open
Priority : Urgent **Asset Tag :**
Originated Date : 04/03/2025 - Mark Johnson - National TAB

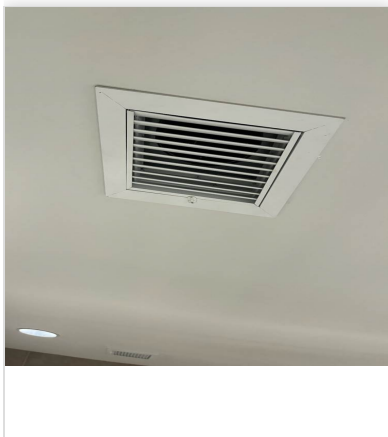
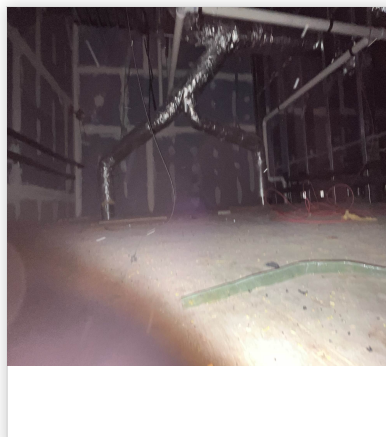
- **07/01/2025 National TAB - Ian Fuller**
 - Issue not resolved as of 7/1. Unable to balance individual diffusers.

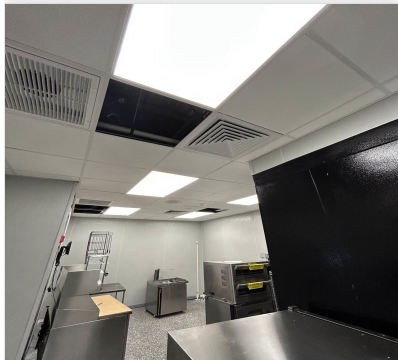
(RESOLVED) Diffuser 2-9 not per plan (should be LD-1 type grille)

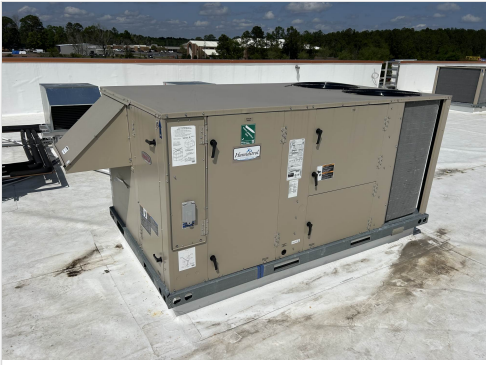
Unit Data - PHOTO LOG

Asset: RTU1

Unit Data		
	Design	Actual
MFG	LENNOX ENLIGHT	LENNOX ENLIGHT
Serial Num	-	5624H02036
Model Num	LCT102H4E	LCT102H4EG1Y
Type	RTU	RTU
Configuration	VERTICAL	VERTICAL
Num OA Filters 1	-	1
OA Filter Size 1	-	23x14
Num Final Filter 1	-	4
Final Filter Size 1	-	20x25x2

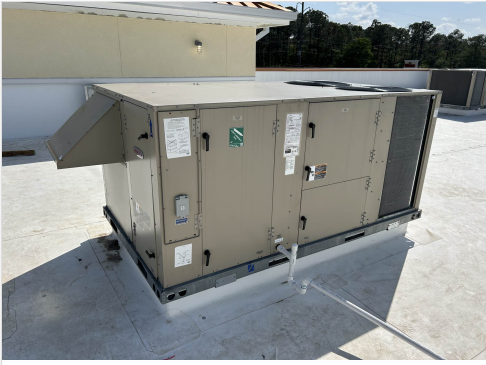
Unit Data - PHOTO LOG

Asset: RTU2

Unit Data		
	Design	Actual
MFG	LENNOX ENLIGHT	LENNOX ENLIGHT
Serial Num	-	5624H03687
Model Num	LCT120H4E	LCT120H4EN1Y
Type	RTU	RTU
Configuration	VERTICAL	VERTICAL
Num OA Filters 1	-	1
OA Filter Size 1	-	23x14
Num Final Filter 1	-	4
Final Filter Size 1	-	20x25x2

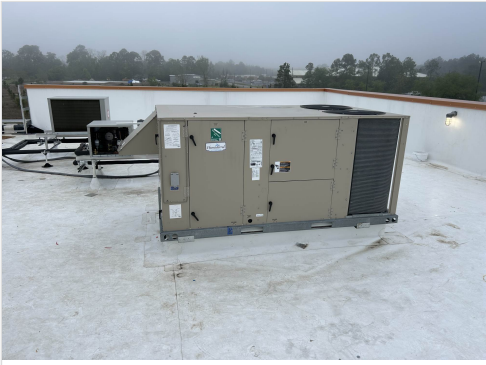
Unit Data - PHOTO LOG

Asset: RTU3

Unit Data		
	Design	Actual
MFG	LENNOX ENLIGHT	LENNOX ENLIGHT
Serial Num	-	5624H02039
Model Num	LCT092H4E	LCT092H4EG1Y
Type	RTU	RTU
Configuration	VERTICAL	VERTICAL
Num OA Filters 1	-	1
OA Filter Size 1	-	23x14
Num Final Filter 1	-	4
Final Filter Size 1	-	20x25x2

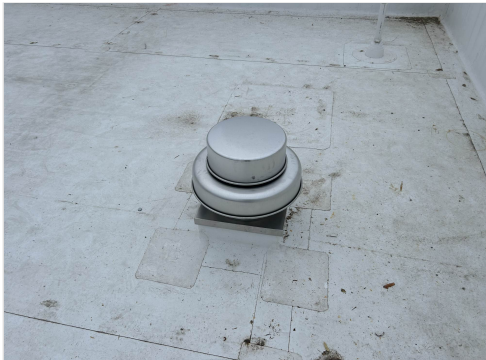
Unit Data - PHOTO LOG

Asset: EF1

Unit Data		
	Design	Actual
MFG	GREENHECK	GREENHECK
Model Num	G-080	G-080-VG-1-17-X
Serial Num	-	25794863
Type	DOWNBLAST	DOWNBLAST
Configuration	VERTICAL	VERTICAL

Asset	Notes	Date	Written By
EGRD1	No face dampers. Unable to balance individual diffusers.	06/12/2025	Ian Fuller

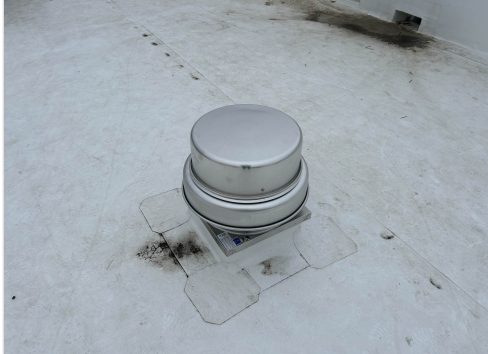
Unit Data - PHOTO LOG

Asset: EF2

Unit Data		
	Design	Actual
MFG	GREENHECK	GREENHECK
Model Num	G-120	G-120-4-VG-1-19-X
Serial Num	-	25794864
Type	DOWNBLAST	DOWNBLAST
Configuration	VERTICAL	VERTICAL
