**Report: TAB REPORT**  
**Function: Test, Adjust, & Balance**  
**Date: 04/05/2023**

**03-27-23 FREDDY'S - JASPER, AL**

Project: 03-27-23 FREDDY'S - JASPER, AL

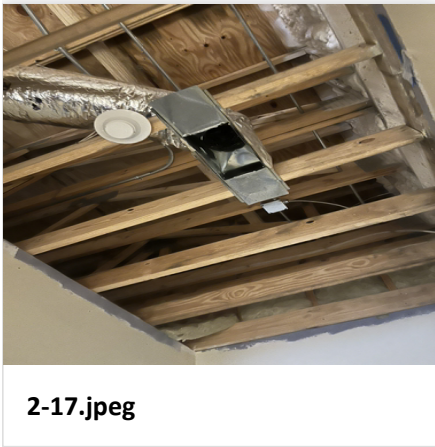
**Issue Name :** Diffuser 2-17 incorrect placement

**Description :** Currently diffuser 2-17 is installed on ceiling when it should be on side of the wall. Diffuser face is currently not installed.
