**Report: TAB REPORT  
Function: Test, Adjust, & Balance  
Date: 04/05/2023**

**PROJECT  
03-27-23 FREDDY'S - JASPER, AL**

ERC Development, LLC

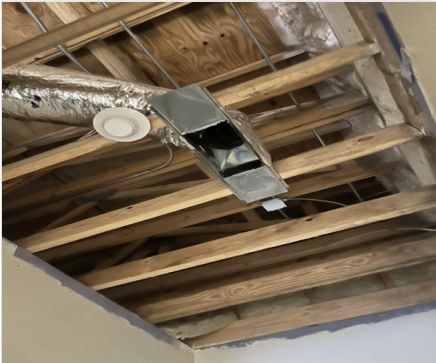
2-17.jpeg

| Issue Name : | Diffuser 2-17 incorrect placement | | |
| Description : | Currently diffuser 2-17 is installed on ceiling when it should be on side of the wall. Diffuser face is currently not installed. | | |

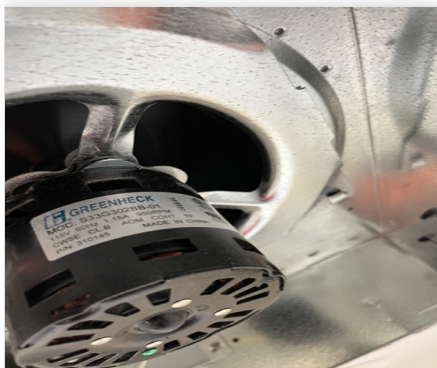
**EF1.jpeg**

| <b>Issue Name :</b> | EF1 and EF2 are above design CFM | | |
| <b>Description :</b> | EF1 is currently at 174 CFM when design is at 150 CFM (116% of design). EF2 is currently at 116 CFM when design is at 90 CFM (129% of design). Fans are not adjustable and cannot be reduced to design airflow. | | |
