**Report: TAB REPORT**  
**Function: Test, Adjust, & Balance**  
**Date: 04/05/2023**

**PROJECT**  
**03-27-23 FREDDY'S - JASPER, AL**

Project: 03-27-23 FREDDY'S - JASPER, AL

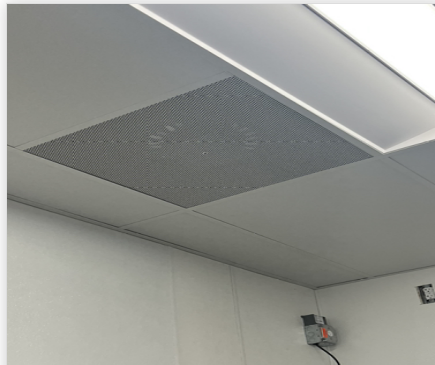
**Issue Name :** Diffuser 1-2 and 1-9 incorrect grille type.

**Description :** Both diffusers call for a type LDA diffuser. Currently PCD type diffusers are installed. Both diffusers are missing deflector plates if PCD were to remain. Diffusers have been ordered; temporary ones are in.

All diffusers and grilles are installed and match design?	NO. DIFFUSER 1-2 AND 1-9 DO NOT MATCH DESIGN. SUPER SAID THEY WILL BE INSTALLED ON A LATER DATE.
All hood filters installed and accounted for?	YES
Hoods are wired and have power?	YES
Hood is free of alarms?	YES
Thermostats have power?	YES
Have trades/general contractor been notified about any issues and are they created on FaciliBuild?	YES

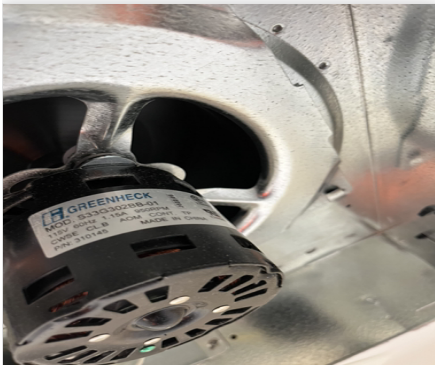
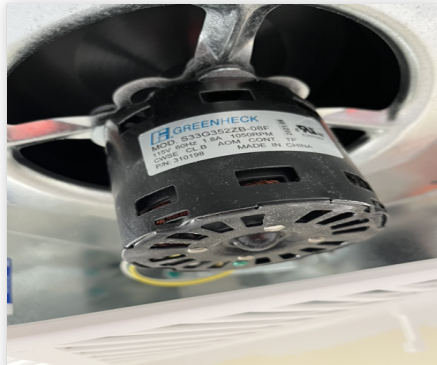
**Issue Name :** EF1 and EF2 are above design CFM

**Description :** EF1 is currently at 174 CFM when design is at 150 CFM (116% of design). EF2 is currently at 116 CFM when design is at 90 CFM (129% of design). Fans are not adjustable and cannot be reduced to design airflow.

Notes: NO SPEED CONTROLLER
