**Report: TAB REPORT  
Function: Test, Adjust, & Balance  
Date: 04/05/2023**

**PROJECT  
03-27-23 FREDDY'S - JASPER, AL  
NEED  
NEED, AK**

**Client  
ERC Development, LLC**

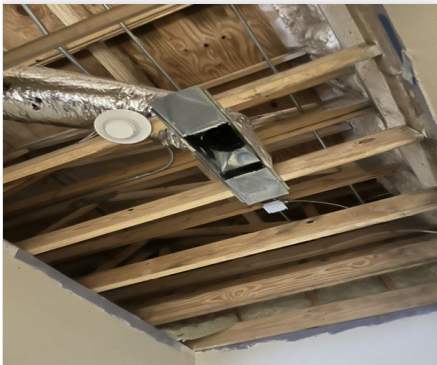
**2-17.jpeg**

| <b>Issue Name :</b> | Diffuser 2-17 incorrect placement | | |
| <b>Description :</b> | Currently diffuser 2-17 is installed on ceiling when it should be on side of the wall. Diffuser face is currently not installed. | | |

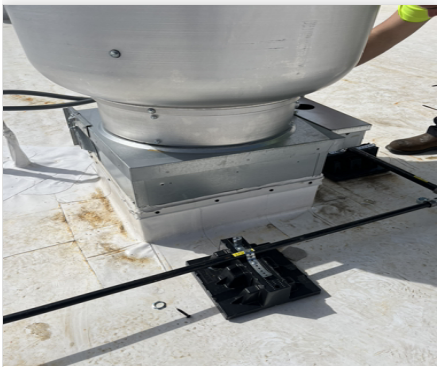
KEF2.jpeg

**Issue Name :** KEF1 & 2 is not secured to curb with screws.  
**Description :** Recommended to install.  
**Created By :** National TAB **Assigned To :** National TAB - Will Turnbough  
**Status :** Open  
**Originated Date :** 03/29/2023 - Ian Fuller - National TAB

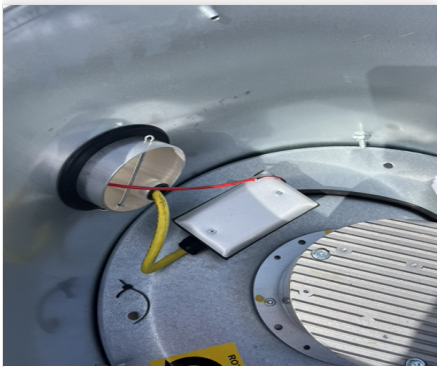
KEF2Conduit.jpeg

**Issue Name :** KEF2 wire is not ran through conduit  
**Description :** Recommended to install conduit.  
**Created By :** National TAB **Assigned To :** National TAB - Will Turnbough  
**Status :** Open  
**Originated Date :** 03/29/2023 - Ian Fuller - National TAB
