**Report: TAB REPORT**  
**Function: Test, Adjust, & Balance**  
**Date: 04/05/2023**

**03-27-23 FREDDY'S - JASPER, AL**

ERC Development, LLC

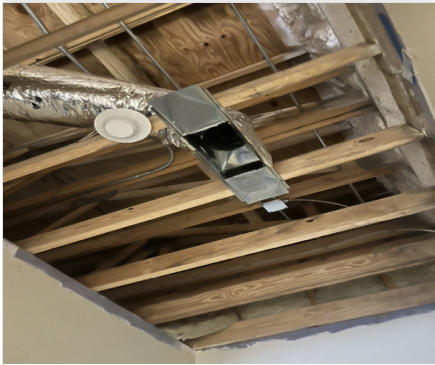
2-17.jpeg

**Issue Name :** \*NON-CRITICAL\* Diffuser 2-17 is installed in wrong area

**Description :** Currently diffuser 2-17 is installed on ceiling when it should be on side of the wall. Diffuser is also missing the face.

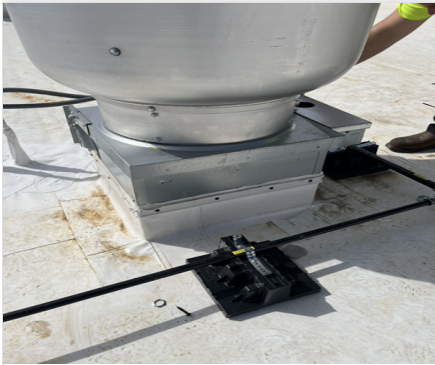
KEF2.jpeg

**Issue Name :** \*NON-CRITICAL\* KEF1 & 2 is not secured to curb with screws.  
**Description :** Recommended to install.  
**Created By :** National TAB **Assigned To :** National TAB - Will Turnbough  
**Status :** Open  
**Originated Date :** 03/29/2023 - Ian Fuller - National TAB

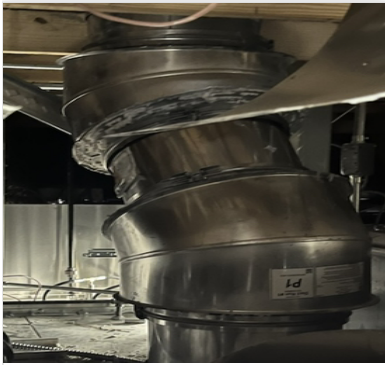
KEF1Duct.jpeg

**Issue Name :** \*NON-CRITICAL\* KEF1 grease ductwork does not have fyrewrap material  
**Description :** (RESOLVED) Shown on M3.0 kitchen hood exhaust fan detail 3. Duct is not protected with materials as approved for 1 hour fire resistance.  
**Created By :** National TAB **Assigned To :** National TAB - Will Turnbough  
**Status :** Closed  
**Originated Date :** 03/29/2023 - Ian Fuller - National TAB

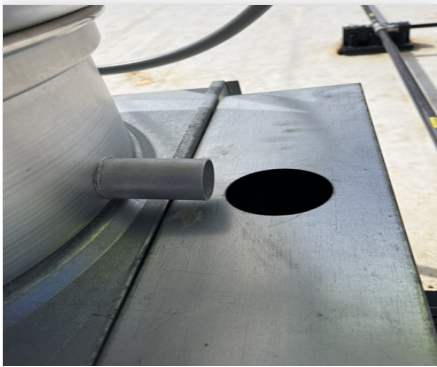
KEF2DrainPipe.jpeg

**Issue Name :** \*NON-CRITICAL\* KEF2 drain pipe is not centered to drain pain.  
**Description :** Recommended to install pvc pipe into center of hole.  
**Created By :** National TAB **Assigned To :** National TAB - Will Turnbough  
**Status :** Open  
**Originated Date :** 03/29/2023 - Ian Fuller - National TAB

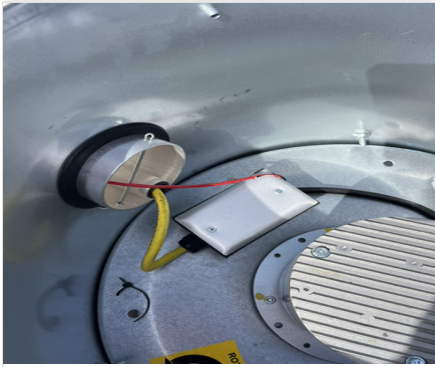
KEF2Conduit.jpeg

**Issue Name :** \*NON-CRITICAL\* KEF2 wire is not ran through conduit  
**Description :** Recommended to install conduit.  
**Created By :** National TAB **Assigned To :** National TAB - Will Turnbough  
**Status :** Open  
**Originated Date :** 03/29/2023 - Ian Fuller - National TAB
