Report: TAB REPORT
Function: Test, Adjust, & Balance
Date: 12/03/2024
Completed By: National TAB

PROJECT
12-02-24 CULVERS OLATHE, KS

Project: 12-02-24 CULVERS OLATHE, KS

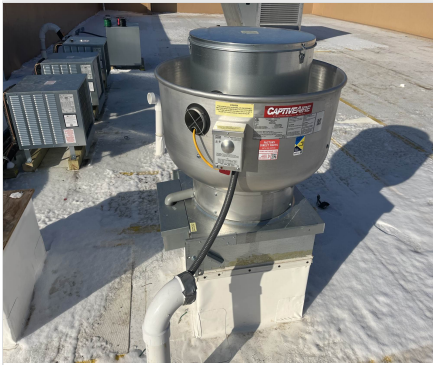
Issue Name : PRV2/PRV3 electric whip too short to lean back
Description : Electric whip is too short for units to be leaned back which will cause difficulty when cleaning the grease ducts.
Created By : National TAB **Assigned To :** National TAB - Jacob Davidson
Status : Open
Priority : Medium **Asset Tag :**
Originated Date : 12/02/2024 - Jacob Davidson - National TAB

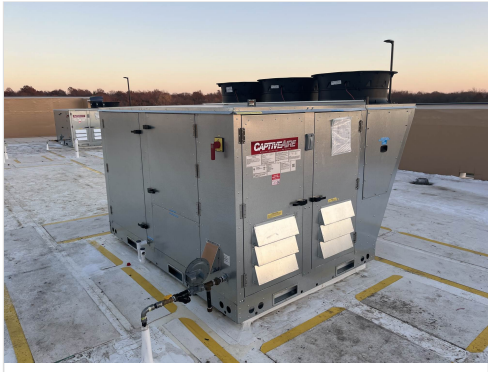
Unit Data - PHOTO LOG

Asset: RTU1

AREA: DINING

Notes:
Motor FLA is 24.3A at 230V but unit label FLA is 27.0A at 208V. Unit is wired for 208V so using 27.0A FLA

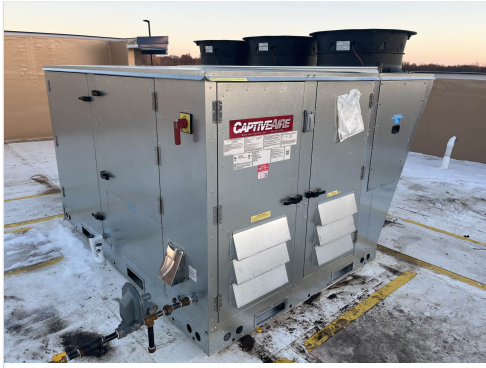
Unit Data - PHOTO LOG

Asset: RTU2

AREA: KITCHEN

Notes:
Motor FLA is 24.3A at 230V but unit label FLA is 27.0A at 208V. Unit is wired for 208V so using 27.0A FLA

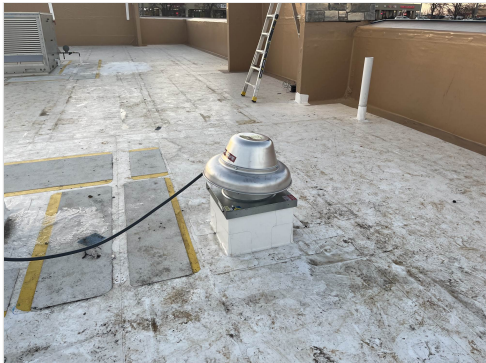
Unit Data - PHOTO LOG

Asset: PRV1

AREA: RESTROOMS

Test Data		
	Design	Actual
CFM	300	290
Fan RPM	1298	1232
Fan Rotation	-	CCW
Motor RPM	-	1232
System SetPt	-	65%
RL Voltage	-	121V
RL Amperage	-	NOT SAFE
Total ESP	0.50"	0.19"
Fan Inlet SP	-	-0.19"
Fan Discharge SP	-	ATM

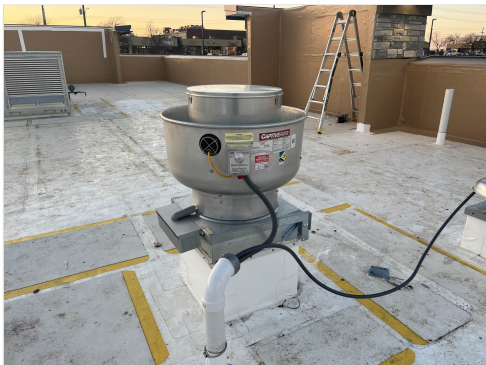
Unit Data - PHOTO LOG

Asset: PRV2

AREA:HD1

Test Data		
	Design	Actual
CFM	1500	1612
Fan RPM	1406	1206
Fan Rotation	-	CCW
Motor RPM	-	1206
System SetPt	-	67P
RL Voltage	-	119V
RL Amperage	-	9.2A
Total ESP	1.412"	0.89"
Fan Inlet SP	-	-0.89"
Fan Discharge SP	-	ATM

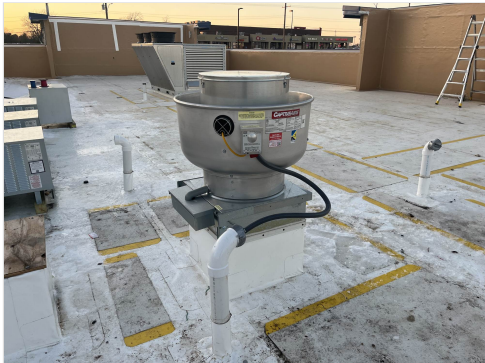
Unit Data - PHOTO LOG

Asset: PRV3

AREA:HD2

Test Data		
	Design	Actual
CFM	1500	1537
Fan RPM	1348	1206
Fan Rotation	-	CCW
Motor RPM	-	1206
System SetPt	-	67P
RL Voltage	-	119V
RL Amperage	-	8.3A
Total ESP	1.250"	0.62"
Fan Inlet SP	-	-0.62"
Fan Discharge SP	-	ATM

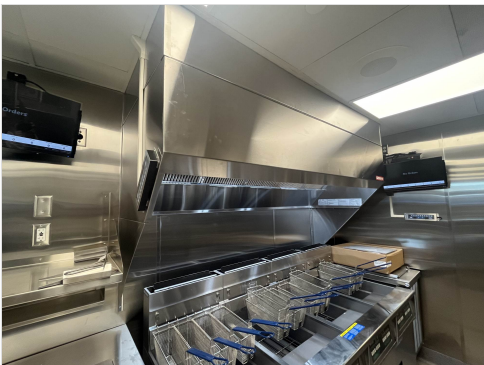
Unit Data - PHOTO LOG

Asset: HD1

AREA:FRYERS

Test Data Exhaust		
	Design	Actual
Filter Type	CAPTRATE SOLO	CAPTRATE SOLO
Filter Size 1	16X16	16X16
Filter Qty 1	5	5
Filter AK factor size 1	1.62	1.62
Filter Total AK Area	8.1	8.1
Filter1 FPM	-	190
Filter2 FPM	-	197
Filter3 FPM	-	200
Filter4 FPM	-	195
Filter5 FPM	-	215
Filter Ave FPM(corr)	-	199
CFM	1500	1612

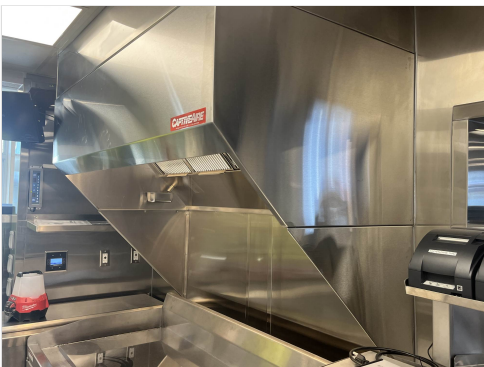
Unit Data - PHOTO LOG

Asset: HD2

AREA:GRIDDLE

Test Data Exhaust		
	Design	Actual
Filter Type	CAPTRATE SOLO	CAPTRATE SOLO
Filter Size 1	16X16	16X16
Filter Qty 1	4	4
Filter AK factor size 1	1.62	1.62
Filter Total AK Area	6.48	6.48
Filter1 FPM	-	231
Filter2 FPM	-	249
Filter3 FPM	-	235
Filter4 FPM	-	233
Filter Ave FPM(corr)	-	237
CFM	1500	1536
