Report: TAB Report
Function: Test, Adjust, & Balance
Date: 10/30/2025
Completed By: National TAB

10-20-25 WAWA #8084 SPRINGFEILD, PA

675 BALTIMORE PIKE

Project: 10-20-25 WAWA #8084 SPRINGFEILD, PA

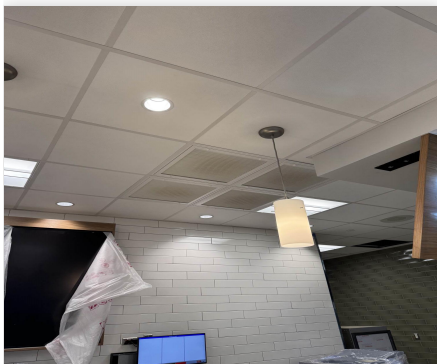
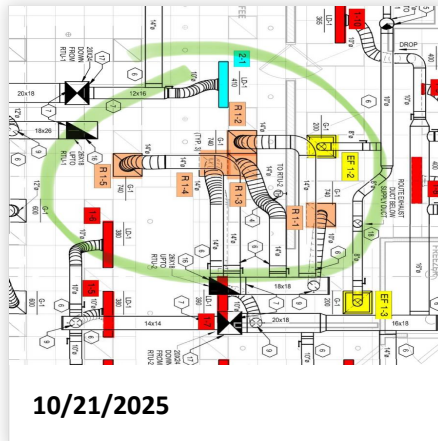
Issue Name : RTU-1 Missing Return Grille and Grille out of place
Description : The return grilles for RTU-1 do not match design. There is one grille missing, and another not placed where intended by design. Recommend adding the the missing grille and organizing the grilles within planned design.
Created By : National TAB **Assigned To :** National TAB - Will Turnbough
Status : Open
Priority : Medium **Asset Tag :**
Originated Date : 10/21/2025 - Ryan Ash - National TAB

Notes:
[1] RTU-1 on the return side is missing a Grille and one Grille is out of place. See Issue.

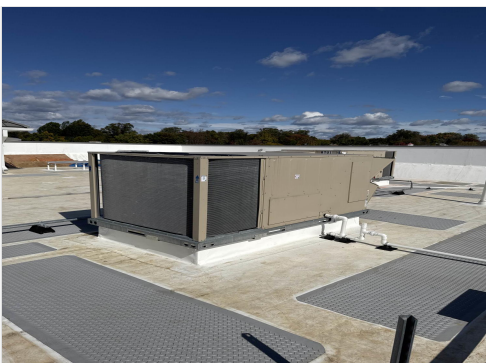
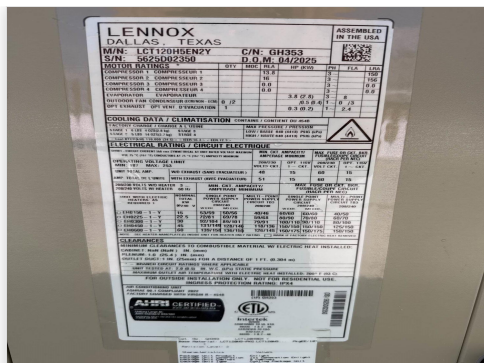
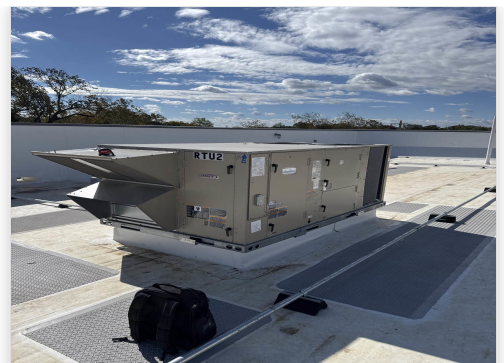
Unit Data - PHOTO LOG

Unit Data		
	Design	Actual
MFG	LENNOX ENLIGHT	LENNOX ENLIGHT
Serial Num	-	5625D02350
Model Num	LGT120H4E	LGT120H4E
Type	RTU	RTU
Configuration	VERTICAL	VERTICAL
Num OA Filters 1	-	2
OA Filter Size 1	-	14X23
Num Final Filter 1	-	4
Final Filter Size 1	-	20X25X2

Test Data		
	Design	Actual
SF CFM	4000	3998
SF RPM	-	1460
RA CFM	3700	3695
OA CFM	300	303
RL Voltage	-	213.6/214.4/214.3
RL Amperage	-	4.7/4.8/4.8
SF Rotation	-	CW
SF System SetPt	-	82%
RA Damper Position	-	MECHANICAL LINKAGE
Min OA Damper Position	-	18%
Min OA Damper Type	-	ECONOMIZER

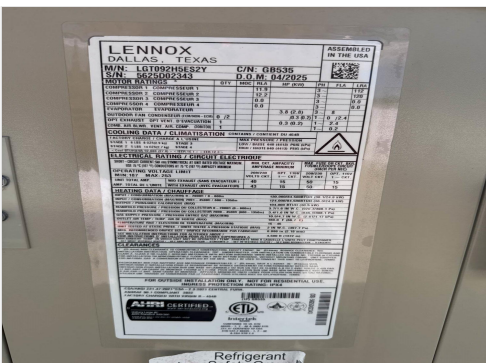
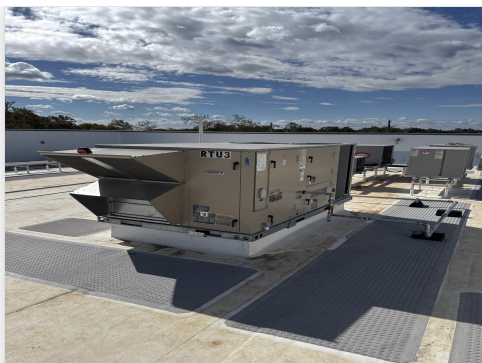
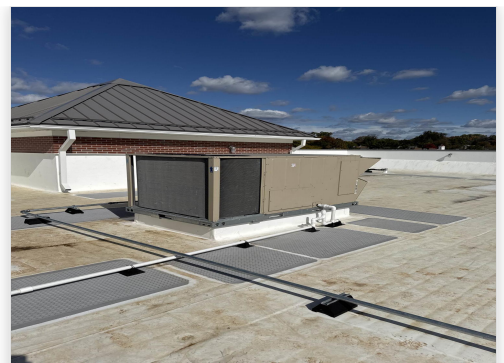
Unit Data - PHOTO LOG

Unit Data		
	Design	Actual
MFG	LENNOX ENLIGHT	LENNOX ENLIGHT
Serial Num	-	5625D02343
Model Num	LGT092H4E	LGT092H4E
Type	RTU	RTU
Configuration	VERTICAL	VERTICAL
Num OA Filters 1	-	2
OA Filter Size 1	-	14X23
Num Final Filter 1	-	4
Final Filter Size 1	-	20X25X2

Test Data		
	Design	Actual
SF CFM	3000	3117
SF RPM	-	1157
RA CFM	2700	2809
OA CFM	300	308
RL Voltage	-	214.6/213.8/214.2
RL Amperage	-	2.8/2.8/2.7
SF Rotation	-	CW
SF System SetPt	-	65%
RA Damper Position	-	MECHANICAL LINKAGE
Min OA Damper Position	-	13%
Min OA Damper Type	-	ECONOMIZER

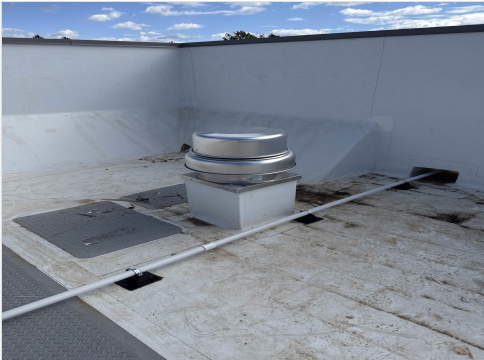
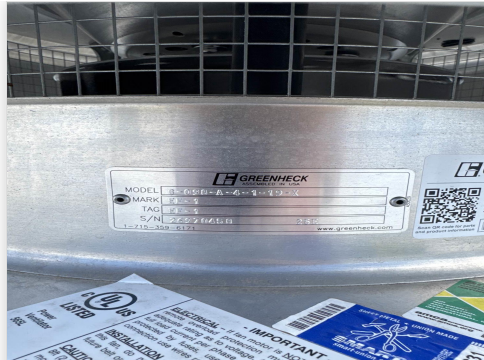
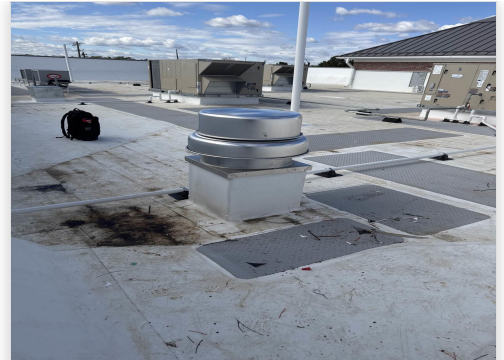
Unit Data - PHOTO LOG

Unit Data		
	Design	Actual
MFG	PENNBARRY	PENNBARRY
Model Num	DX10Q	DX10Q
Serial Num	-	26970458
Type	DOWNBLAST	DOWNBLAST
Configuration	VERTICAL	VERTICAL

Test Data		
	Design	Actual
CFM	500	520
Fan RPM	-	NA
Fan Rotation	-	CCW
Motor RPM	-	NA
System SetPt	-	MARKED ON DIAL
RL Voltage	-	NA
RL Amperage	-	NA
Total ESP	0.250"	0.47"
Fan Inlet SP	-	-0.47"
Fan Discharge SP	-	ATM

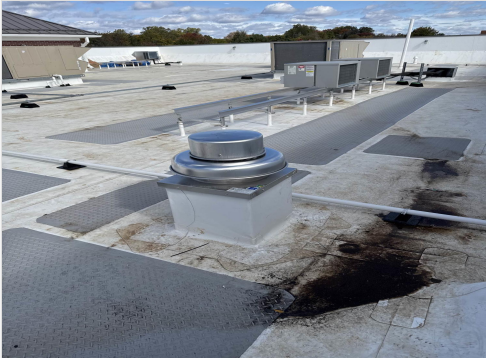
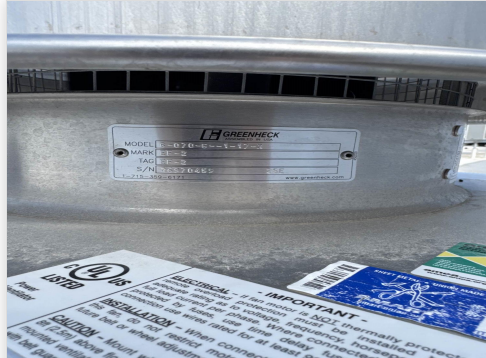
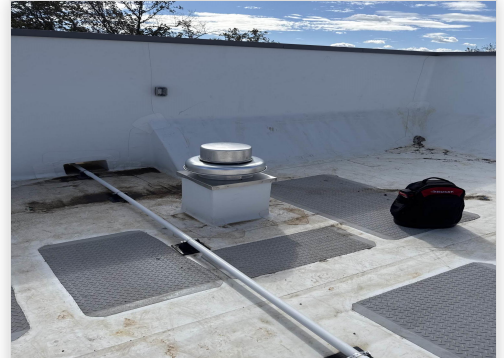
Unit Data - PHOTO LOG

Unit Data		
	Design	Actual
MFG	PENNBARRY	PENNBARRY
Model Num	DX08Q	DX08Q
Serial Num	-	26970459
Type	DOWNBLAST	DOWNBLAST
Configuration	VERTICAL	VERTICAL

Test Data		
	Design	Actual
CFM	200	201
Fan RPM	-	NA
Fan Rotation	-	CCW
Motor RPM	-	NA
System SetPt	-	MARKED ON DIAL
RL Voltage	-	NA
RL Amperage	-	1.0 A
Total ESP	0.125"	0.17"
Fan Inlet SP	-	-0.17"
Fan Discharge SP	-	ATM

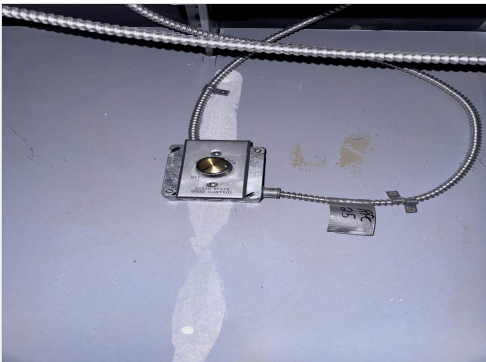
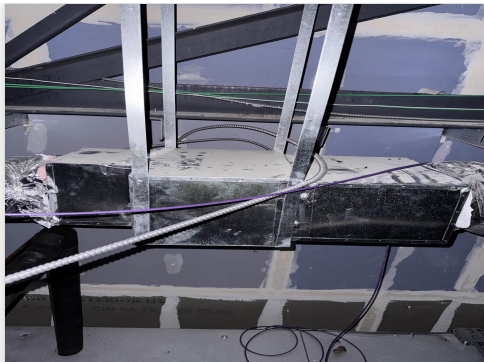
Unit Data - PHOTO LOG

Unit Data		
	Design	Actual
MFG	PENNBARRY	PENNBARRY
Model Num	Z3H	Z3H
Type	INLINE	INLINE
Configuration	VERTICAL	VERTICAL

Test Data		
	Design	Actual
CFM	60	62
System SetPt	-	MARKED ON DIAL [HIGHEST SPEED]
