**Report: TAB REPORT**  
**Function: Test, Adjust, & Balance**  
**Date: 10/17/2024**  
**Completed By: National TAB**

## 10-14-24 ULTA 1697 SELMA, NC

Rectenwald Brothers Construction

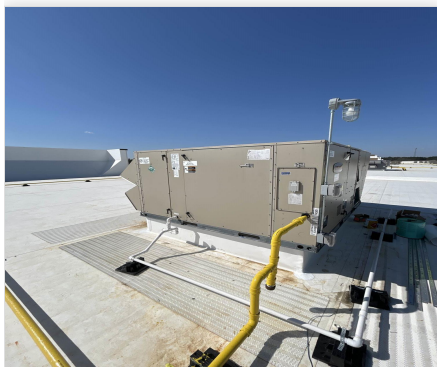
**Issue Name :** RTU 2 hitting max amps with low airflow  
**Description :** RTU-2 unit is running at Max amps. The pulley is 5 turns out. After reading all supply diffusers. We are currently at 68% total airflow of design.  
**Created By :** National TAB                      **Assigned To :** National TAB - Dan Hertenstein  
**Status :** Open  
**Priority :** Urgent                                      **Asset Tag :**  
**Originated Date :** 10/15/2024 - Jearod Ferrette - National TAB

RTU-2 IS RATED FOR 4 AMPS, IT IS CURRENTLY RUNNING AT 4.24 AMPS WITH MAX TURNS OUT ON PULLEY.

Traversed RTU-2 from the main drop and was reading 4245 CFM's. Suggest inspection for leakage due to difference in CFM's. DIFFUSER 24 DAMPER IS CLOSED AND UNACCESSILBE.

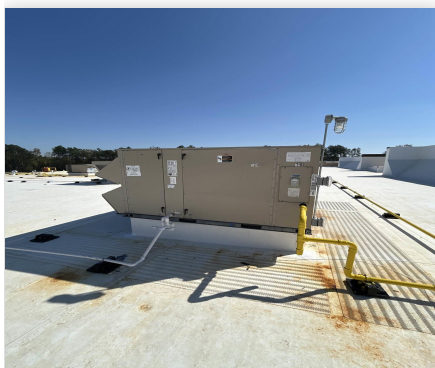
**Issue Name :** RTU-1 Motor at max amps. The Pulley is at 2 turns out with belt over hang.

**Description :** RTU-1 unit is running at Max amps. The pulley is 2 turns out. After reading all supply diffusers. We are currently at 84% total airflow of design.

THIS UNIT IS RUNNING AT 3.4 APMS WITH 2 TURNS OUT. THE MOTOR BELT HAS OVERHANG ON THE PULLY AND TIGHT. CURRENTLY AT 84% DESIGN OF AIRFLOW. DIFFUSERS 3,8 AND 9 ARE READING LOW. ALL DAMPERS ARE 100% OPEN.

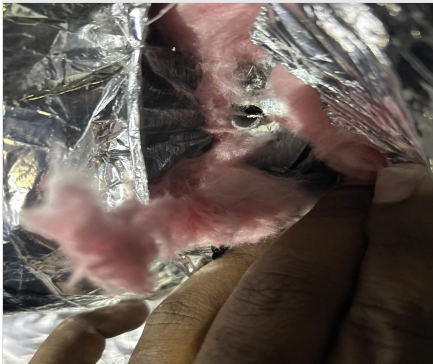
**Issue Name :** RTU-3 missing damper on supply diffuser SGRD2 & 7  
**Description :** Missing supply damper on RTU 3 SGRD 2 & SGRD 7  
**Created By :** National TAB                      **Assigned To :** National TAB - Dan Hertenstein  
**Status :** Open  
**Priority :** High                                      **Asset Tag :**  
**Originated Date :** 10/15/2024 - Jearod Ferrette - National TAB

RTU-3 SUPPLY DIFFUSERS ARE MISSING DAMPERS ON SGRD 3 AND SGRD 7. THIS UNIT IS SET TO TOTAL DESIGN AIRFLOW. ONCE DAMPERS ARE INSTALLED, IT CAN BE BALANCED. HIGH WINDS OF ROOF MAY HAVE AFFECTED THE OUTSIDE AIR MEASUREMENT.

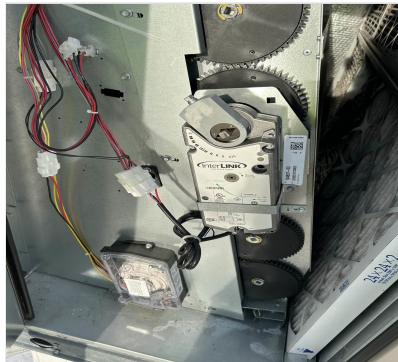
ALL RTU'S DAMPERS ARE NON-OPERATIONAL. RTU 1/2 ARE MANUALLY SET AND MARKED
