**Report: PRELIMINARY TAB REPORT**

**Function: Test, Adjust, & Balance**

## 10-14-24 ULTA 1697 SELMA, NC

Eastfield Crossing

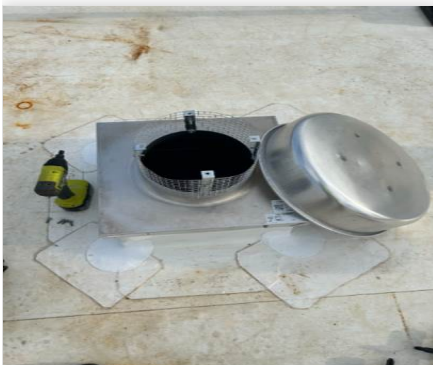
10/17/2024

**Issue Name :** EF-1 not installed  
**Description :** EF-1 is not installed. Unable to balance the fan. It should be installed on 10/18.  
**Created By :** National TAB                      **Assigned To :** National TAB - Dan Hertenstein  
**Status :** Open  
**Priority :** Urgent                                      **Asset Tag :** EF1  
**Originated Date :** 10/14/2024 - Jearod Ferrette - National TAB

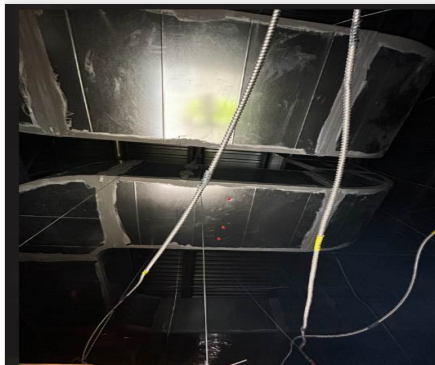
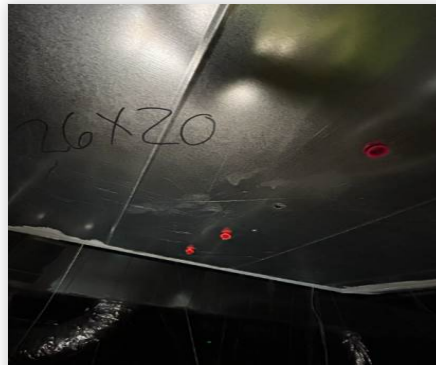
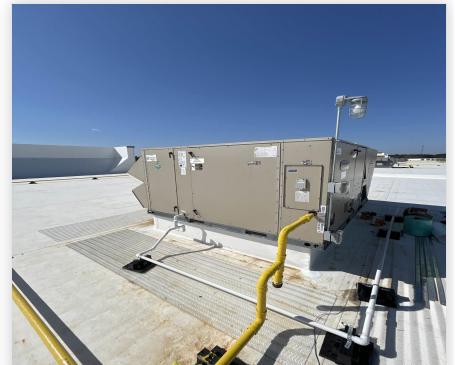
**Issue Name :** RTU-2 airflow is 72% of design  
**Description :** RTU-2 airflow is 72% of design (3435 CFM at diffusers) with motor at FLA. The duct is installed as 24"x18" inner dimensions but plans show 30"x20". Duct traversed as 3819 CFM. Velocity is 1273 FPM which is high. There is also an additional 90 degree transition installed. A larger motor would be required to achieve design.  
**Created By :** National TAB                      **Assigned To :** National TAB - Dan Hertenstein  
**Status :** Open  
**Priority :** Urgent                                      **Asset Tag :** RTU2  
**Originated Date :** 10/15/2024 - Jearod Ferrette - National TAB

Notes:  
DUCT IS INSTALLED AS SMALLER THAN DESIGNED AND AN ADDITIONAL 90 DEGREE ELBOW IS INSTALLED.

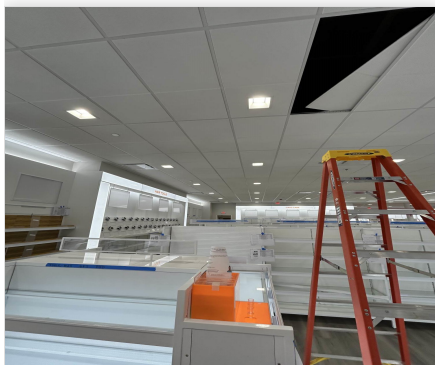
**Issue Name :** RTU-2 diffuser 24 damper is closed  
**Description :** Damper for diffuser 24 is closed and not accessible. There is a shelf that is directly underneath the damper. Damper is also installed on the top of the duct. It needs to be opened and a face accessible opposed blade damper is recommended in case further balancing is required.  
**Created By :** National TAB                      **Assigned To :** National TAB - Dan Hertenstein  
**Status :** Open  
**Priority :** Low                                      **Asset Tag :** RTU2  
**Originated Date :** 10/15/2024 - Jearod Ferrette - National TAB

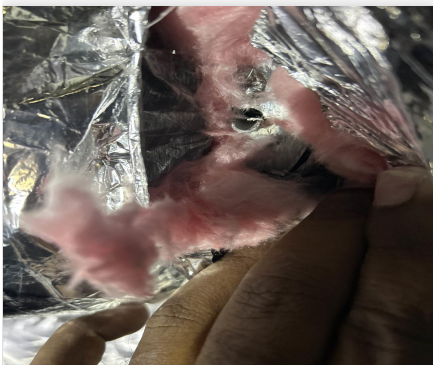
**Issue Name :** RTU-3 missing damper on supply diffuser SGRD2 & 7  
**Description :** Missing supply damper on RTU-3 SGRD 2 & SGRD 7. Needs to be installed to complete balancing.  
**Created By :** National TAB                      **Assigned To :** National TAB - Dan Hertenstein  
**Status :** Open  
**Priority :** High                                      **Asset Tag :** RTU3  
**Originated Date :** 10/15/2024 - Jearod Ferrette - National TAB

Notes:  
RTU-3 SUPPLY DIFFUSERS ARE MISSING DAMPERS ON SGRD 3 AND SGRD 7.

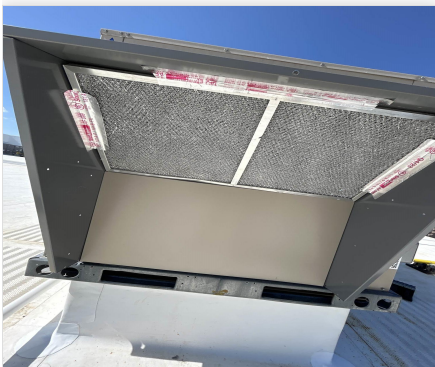
**Issue Name :** RTU-4 outside filters not properly installed  
**Description :** RTU 4 outside filters are not properly installed. Being held by tape.  
**Created By :** National TAB                      **Assigned To :** National TAB - Dan Hertenstein  
**Status :** Open  
**Priority :** Medium                                      **Asset Tag :** RTU4  
**Originated Date :** 10/14/2024 - Jearod Ferrette - National TAB
