Report: PRELIMINARY TAB REPORT

Function: Test, Adjust, & Balance

04-14-25 ULTA 1697 SELMA, NC

Rectenwald Brothers Construction

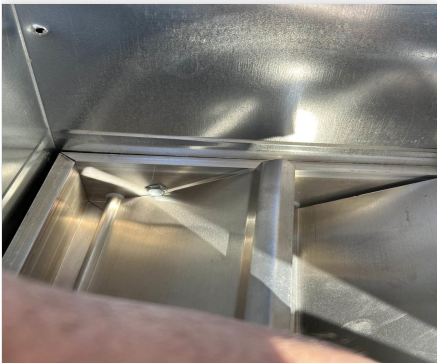
Issue Name : EF-1 backdraft damper
Description : Screw, preventing backdraft damper to open fully.
Created By : National TAB **Assigned To :** National TAB - Dan Hertenstein
Status : Open
Priority : Urgent **Asset Tag :** EF1
Originated Date : 01/08/2025 - Jearod Ferrette - National TAB

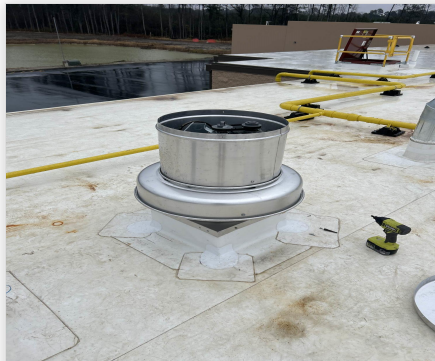
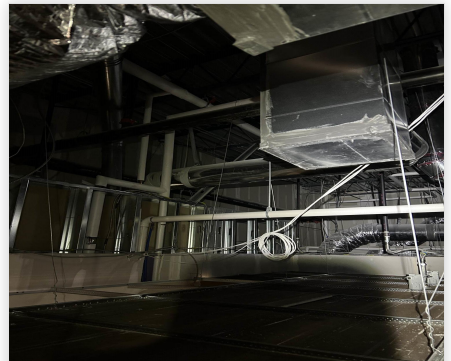
Issue Name : EF-1 curbed wrong
Description : EF-1 fan curbed to the wrong ductwork. The fan is installed to the water heater exhaust. Also, the motor is at max amps, going to a 10" round duct. Currently getting 522 cfm. EF-1 is design for 1750 cfm. The Greenheck GB-130 website states that max flow is 1249 cfm.
Created By : National TAB **Assigned To :** National TAB - Dan Hertenstein
Status : Open
Priority : Urgent **Asset Tag :** EF1
Originated Date : 01/08/2025 - Jearod Ferrette - National TAB

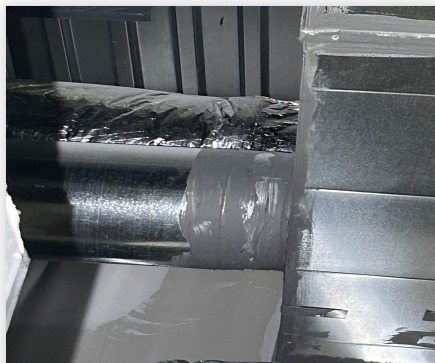
Issue Name : EF-2 Restroom fan unable to access
Description : EF-2 speed controller is located above hard ceiling and is inaccessible. Unable to reach from other side with ladder due to piping obstructing access. The unit is running at 117% of design.
Created By : National TAB **Assigned To :** National TAB - Dan Hertenstein
Status : Open
Priority : High **Asset Tag :**
Originated Date : 10/14/2024 - Jearod Ferrette - National TAB

Notes:
 NO ACCESS TO EF-2 CONTROLS TO SLOW UNIT DOWN. DAMPERS ARE NOT INSTALL. FAN IS 117% TOTAL AIRFLOW OF DESIGN.

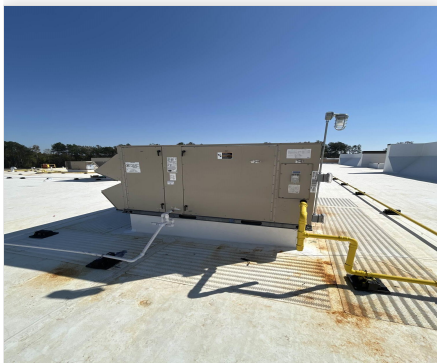
Issue Name : RTU-1 airflow is 84% of design
Description : RTU-1 airflow is 84% of design. The pulley cannot be increased further without the belt sitting too high up on the pulley. A pulley change is recommended.
Created By : National TAB **Assigned To :** National TAB - Dan Hertenstein
Status : Open
Priority : High **Asset Tag :** RTU1
Originated Date : 10/15/2024 - Jearod Ferrette - National TAB

THIS UNIT IS RUNNING AT 3.4 AMPS AT 2 TURNS OUT ON THE PULLEY. CANNOT INCREASE SPEED FURTHER WITHOUT BELT SITTING TOO HIGH ON THE PULLEY. PULLEY CHANGE IS REQUIRED

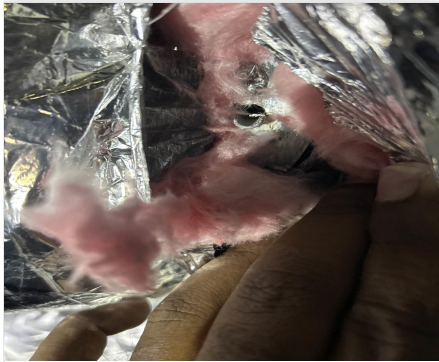
Issue Name : RTU-3 missing damper on supply diffuser SGRD2 & 7
Description : Missing supply damper on RTU-3 SGRD 2 & SGRD 7. Needs to be installed to complete balancing.
Created By : National TAB **Assigned To :** National TAB - Dan Hertenstein
Status : Open
Priority : High **Asset Tag :** RTU3
Originated Date : 10/15/2024 - Jearod Ferrette - National TAB

Notes:
RTU-3 SUPPLY DIFFUSERS ARE MISSING DAMPERS ON SGRD 3 AND SGRD 7.

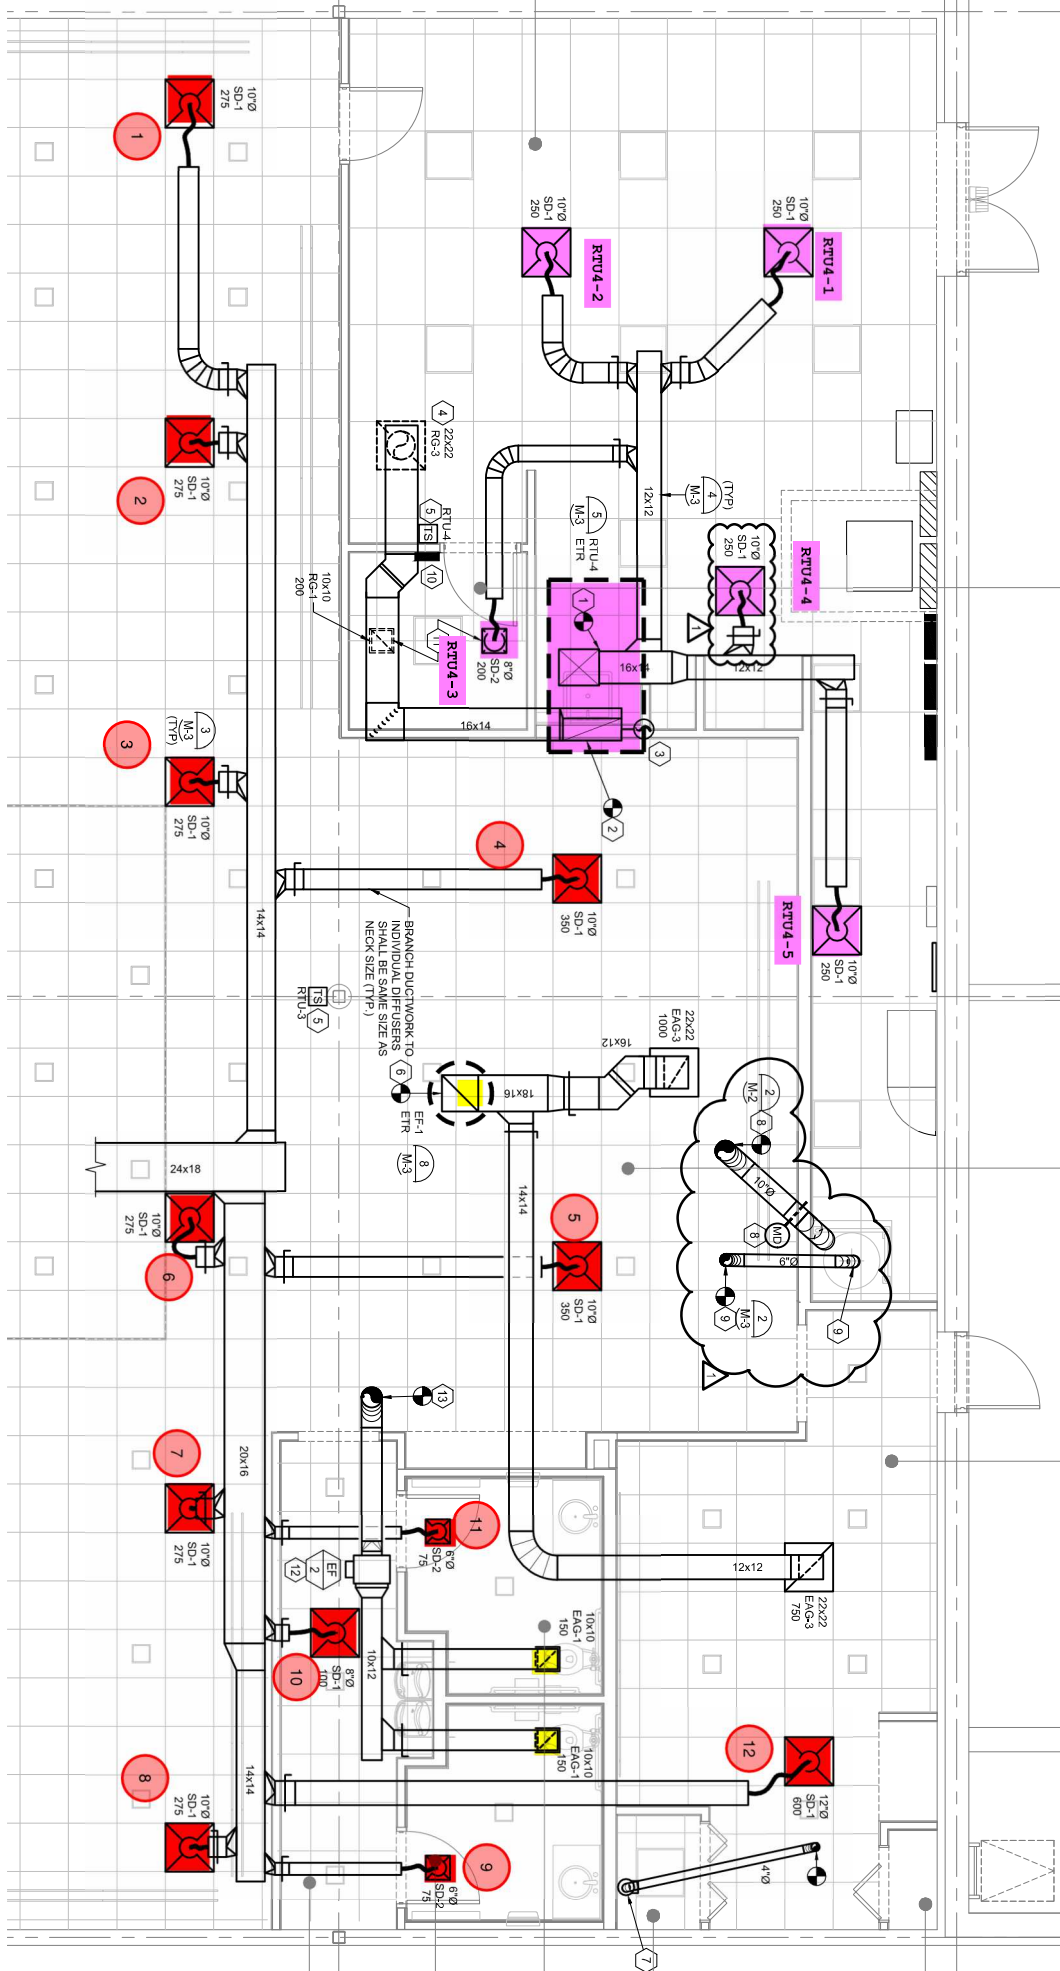
BRANCH DUCTWORK TO
INDIVIDUAL DIFFUSERS
SHALL BE SAME SIZE AS
NECK SIZE (TYP.)

PROVIDE ZONE TEMPERATURE
SENSOR WITH INSULATED
BACKING
