**Report: TAB Report**  
**Function: Test, Adjust, & Balance**  
**Date: 09/11/2025**  
**Completed By: National TAB**

**PROJECT**  
**04-14-25 ULTA 1967 SELMA, NC**

# National TAB

Project: 04-14-25 ULTA 1967 SELMA, NC

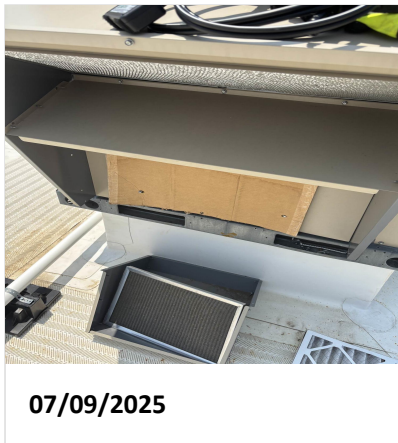
RTU 1/2 ARE MANUALLY SET AND MARKED. RTU 4 economizer is blocked and won't open.

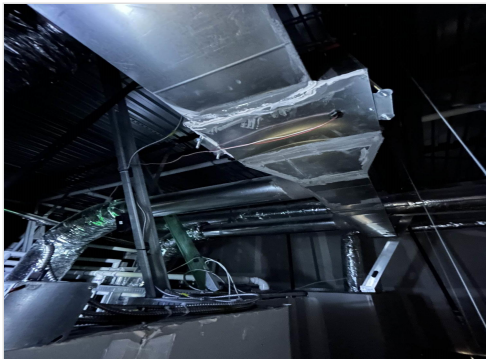
### Unit Data - PHOTO LOG

Test Data		
	Design	Actual
CFM	300	307
Fan RPM	-	NO ACCESS
Fan Rotation	-	CCW
Motor RPM	-	NO ACCESS
System SetPt	-	SPEED B, 7
RL Voltage	-	NO ACCESS
RL Amperage	-	NO ACCESS
Total ESP	0.50"	0.48"
Fan Inlet SP	-	0.48"
Fan Discharge SP	-	ATM
