**Report: TAB**

**Function: Test, Adjust, & Balance**

**Date: 06/23/2025**

## 06-23-25 WHATABURGER #1586 INDIAN LAND, SC

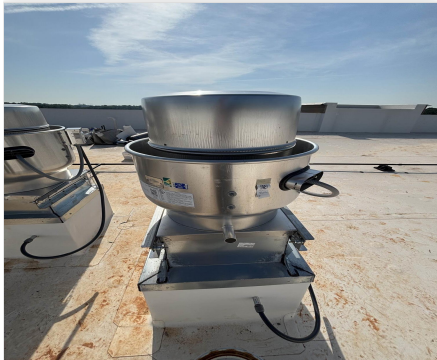
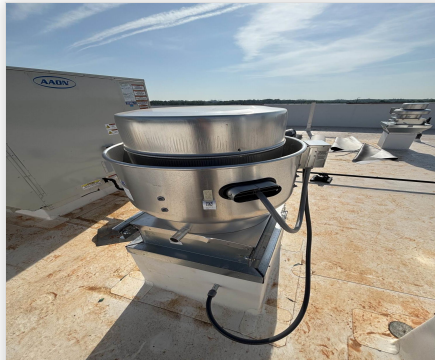
**Issue Name :** K-EF GREASE CUPS NOT INSTALLED  
**Description :** Neither grease cups for KEF-1 and 2 are installed. Recommend installing immediately.  
**Created By :** National TAB                      **Assigned To :** National TAB - Brianna Biggs  
**Status :** Open  
**Priority :** **Urgent**                                      **Asset Tag :**  
**Originated Date :** 06/25/2025 - Chistian Moller - National TAB

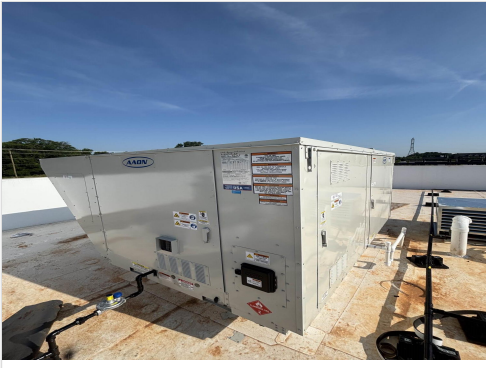
## Unit Data - PHOTO LOG

Unit Data		
	Design	Actual
MFG	AAON	AAON
Serial Num	-	202503-BNGP121881
Model Num	RNA-020-C-A-8-BAB04	RN-020-3-0-FABY-S0-21-000-A
Num OA Filters 1	-	3
OA Filter Size 1	-	20X25
Num OA Filters 2	-	6
OA Filter Size 2	-	20X25X2

Test Data		
	Design	Actual
SF CFM (Traverse)	-	3782
SF CFM	3850	3700
SF RPM	1034	DD/48Hz
MOTOR RPM	-	DD/48Hz
RA CFM (Traverse)	-	1456
RA CFM	1390	1398
OA CFM	2460	2302
RL Voltage	-	230
RL Amperage	-	10.6
SF System SetPt	-	48Hz
RA Damper Position	-	1.5"
Min OA Damper Position	-	1.75"
Min OA Damper Type	-	ECON

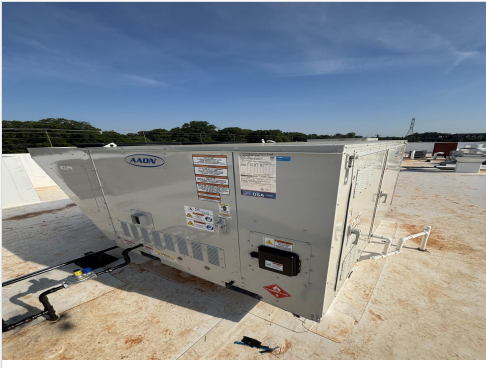
## Unit Data - PHOTO LOG

Unit Data		
	Design	Actual
MFG	AAON	AAON
Serial Num	-	202503-ANGK121870
Model Num	RN-013-8-0-GB04-3F9	RN-013-3-0-FABY-S0-21-000-A
Num OA Filters 1	-	2
OA Filter Size 1	-	20X24
Num OA Filters 2	-	4
OA Filter Size 2	-	20X25X2

Test Data		
	Design	Actual
SF CFM (Traverse)	-	2036
SF CFM	2050	2002
SF RPM	1172	DD/43Hz
MOTOR RPM	-	DD/43Hz
RA CFM (Traverse)	-	522
RA CFM	500	537
OA CFM	1550	1465
RL Voltage	-	208
RL Amperage	-	7.5
SF System SetPt	-	43Hz
RA Damper Position	-	0.5"
Min OA Damper Position	-	3.0"
Min OA Damper Type	-	ECON

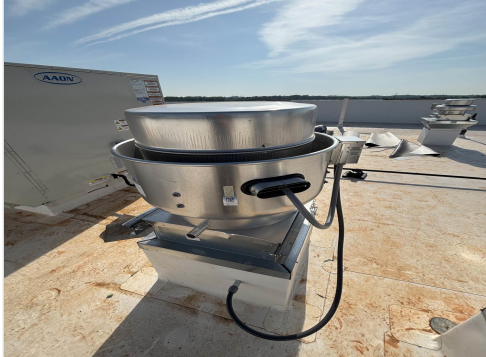
## Unit Data - PHOTO LOG

Unit Data		
	Design	Actual
MFG	GREENHECK	GREENHECK
Model Num	CUE-140-VG	CUE-140-7-VG-1-22-G
Serial Num	-	26276046 25C
Type	UPBLAST	UPBLAST
Configuration	VERTICAL	VERTICLE

Test Data		
	Design	Actual
CFM	1994	1763
Fan RPM	-	DD-100%
Fan Rotation	-	CW
Motor RPM	-	DD/100%
System SetPt	-	100%
RL Voltage	-	NR
RL Amperage	-	5.2
Total ESP	1.00"	0.54"
Fan Inlet SP	-	-0.54"
Fan Discharge SP	-	ATM

**Issue Name :** KEF-1 LOW AIRFLOW  
**Description :** KEF-1 is running at full capacity and near full load amps yet is under design airflow. Rotation, amps, and pressure (0.64" actual vs 1.0" design) were checked twice to confirm flow.  
**Created By :** National TAB                      **Assigned To :** National TAB - Brianna Biggs  
**Status :** Open  
**Priority :** Urgent                                      **Asset Tag :** KEF1  
**Originated Date :** 06/23/2025 - Chistian Moller - National TAB

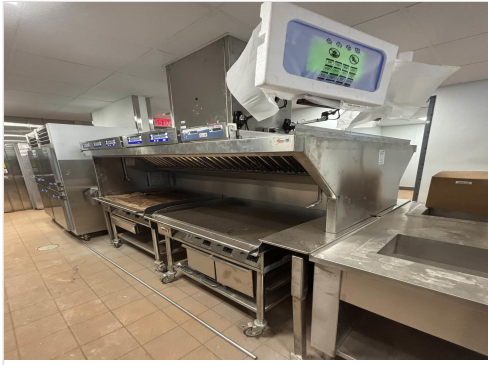
## Unit Data - PHOTO LOG

Unit Data		
	Design	Actual
MFG	NA	H&K INTERNATIONAL
Model Num	NA	HKD027
Job / Serial Num	-	8157746-001
Type	-	TYPE I ISLAND
Hood length	-	83"
Hood Width	-	30"

Test Data Exhaust		
	Design	Actual
Filter Type	-	BAFFLE
Filter Size 1	-	12X16
Filter Qty 1	-	8
Filter AK factor size 1	-	1.16
Filter Total AK Area	-	9.28
Filter1 FPM	-	168
Filter2 FPM	-	191
Filter3 FPM	-	182
Filter4 FPM	-	194
Filter5 FPM	-	165
Filter6 FPM	-	205
Filter7 FPM	-	214
Filter8 FPM	-	201
Filter Ave FPM(corr)	-	190
CFM	1994	1763

Notes:  
KEF-1 IS RUNNING AT MAX SPEED, CFM'S FOR THE HOOD CANNOT BE INCREASED.
