Report: TAB

Function: Test, Adjust, & Balance

06-23-25 WHATABURGER #1586 INDIAN LAND, SC

Project: 06-23-25 WHATABURGER #1586 INDIAN LAND, SC

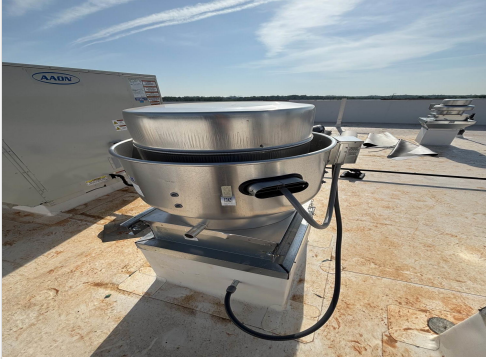
Unit Data - PHOTO LOG

Issue Name : KEF-1 LOW AIRFLOW
Description : KEF-1 is running at full capacity and near full load amps yet is under design airflow. Rotation, amps, and pressure (0.64" actual vs 1.0" design) were checked twice to confirm flow.
Created By : National TAB **Assigned To :** National TAB - Brianna Biggs
Status : Open
Priority : Urgent **Asset Tag :** KEF1
Originated Date : 06/23/2025 - Chistian Moller - National TAB

Asset: KEF1

AREA:GRILL HOOD FAN

Unit Data		
	Design	Actual
MFG	GREENHECK	GREENHECK
Model Num	CUE-140-VG	CUE-140-7-VG-1-22-G
Serial Num	-	26276046 25C
Type	UPBLAST	UPBLAST
Configuration	VERTICAL	VERTICLE

Test Data		
	Design	Actual
CFM	1994	1763
Fan RPM	-	DD-100%
Fan Rotation	-	CW
Motor RPM	-	DD/100%
System SetPt	-	100%
RL Voltage	-	NR
RL Amperage	-	5.2
Total ESP	1.00"	0.54"
Fan Inlet SP	-	-0.54"
Fan Discharge SP	-	ATM
